## CHAPTER 4

## Historical Overview and Contexts

## Conditions Assessment

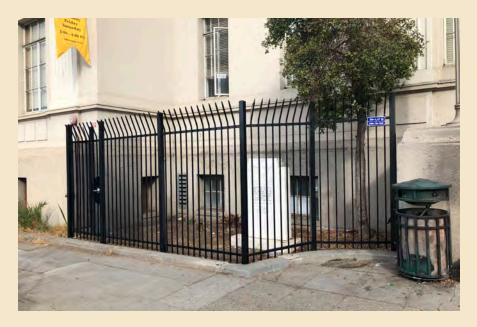
Figure 7.1 A recently installed metal fence at the primary façade is incompatible with the building.

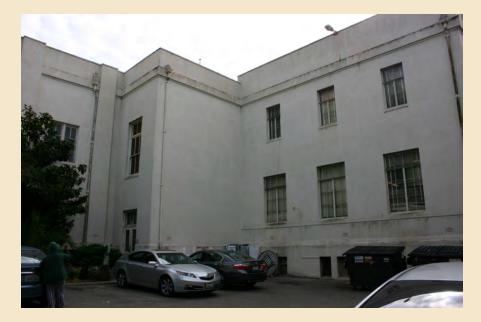
Figure 7.2
The west courtyard is currently poorly utilized as parking and a substandard entry to the Dorothy Day homeless shelter in the building's basement.

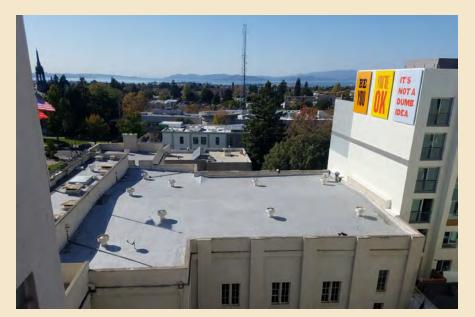
Potential roof failure and depression at northeast corner (Figure 7.3)
As viewed from the fifth floor of an adjacent building (1947 Center Street), the roof at the northeast corner of the east stairwell is depressed and discolored. (tidelines from a history of standing water)

Figure 7.3
As viewed from the fifth floor of 1947
Center Street, the roof of the building appears in fair condition, but requires additional investigation.

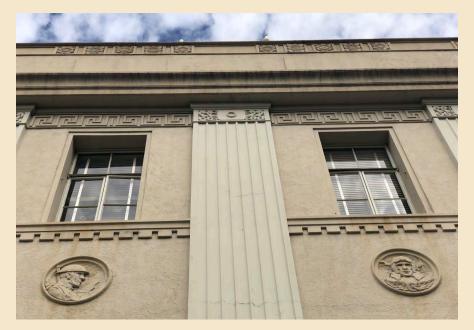
Consistent horizontal cracking in exterior cement plaster (all facades) (Figure 7.4)

On the south façade, there is consistent horizontal cracking through the cement plaster second story window spandrel panels and decorative pilasters. A cursory review of the building drawings indicates that this cracking roughly aligns with the second story floor diaphragm. At the west façade of the auditorium, an extensive horizontal crack originates from the header of the highest window on the façade. At the rear (north) elevation of the west building wing and at the east wall of the east stairwell, long cracks roughly align with the level of the first-floor framing. A larger web of cracking appears at the rear (north) elevation of the east building wing. These consistent cracking patterns may be the result of building settlement or indicative of a larger-scale failure of the overall building system.

Failure of joint between lower concrete retaining walls and upper wood-framed walls (east façade) (Figure 7.5)

The top corner edge of the lower concrete retaining wall is cracked or spalled with exposed and rusting rebars at many stretches of the east courtyard façade.

Rust staining from water runoff at window spandrel panels (south façade) (Figure 7.4)

A typical rust-colored water staining panel over the decorative plaster medallions on the east façade are indicative of water infiltrating the wall. Rust runoff may be occurring from windows above or from medallion anchors; additional investigation required.

Figure 7.5
At the east courtyard the top of the concrete stem wall has consistently begun to spall, as seen here at the most severe example.

Figure 7.4
Rust staining and consistent cracking along the east façade may be indicative of water intrusion and warrants further investigation.

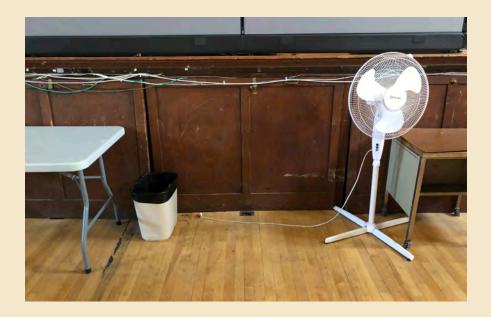
Figure 7.21
The wood stage apron doors do not function appropriately and have significant impact damage.

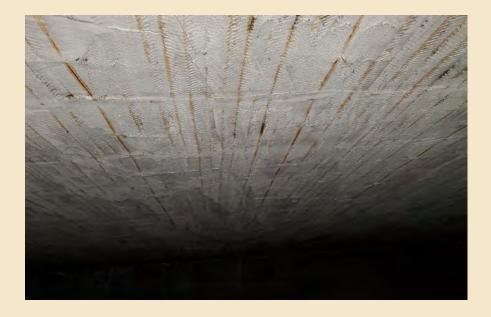
Figure 7.22 Rusting lath in plainly visible through the plaster in the fly loft above the stage.

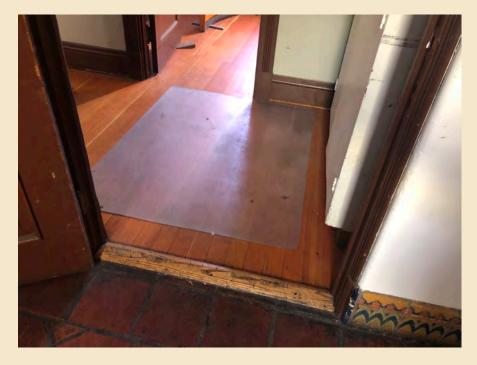
Figure 7.24
The Women's Rest Room has been divided to create a new entry hall to Lodge Room #1.

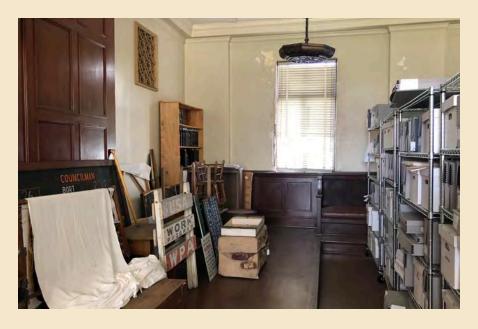
Figure 7.30
The built-in platform, benches and decorative wood paneling in Lodge Room #2 are in fair shape. The window header and jamb in the northwest corner show signs of water intrusion.

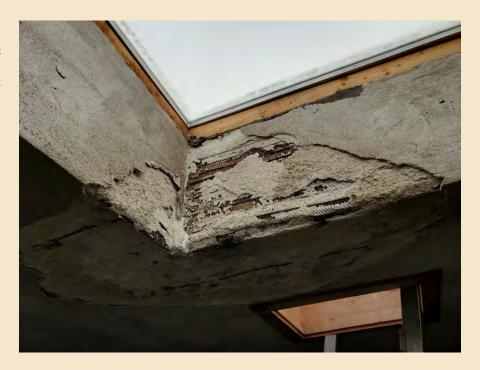
Figure 7.38
The original skylight in the southern roof of the building was replaced at some time (seen here from the attic).
The new skylight may be leaking.

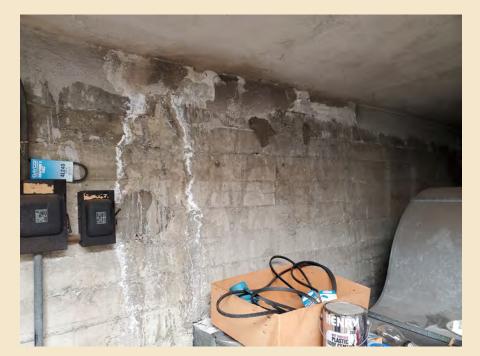
Figure 7.39
The buildup of efflorescence and staining at the north wall of the front attic is indicative of water issues in the roof above.

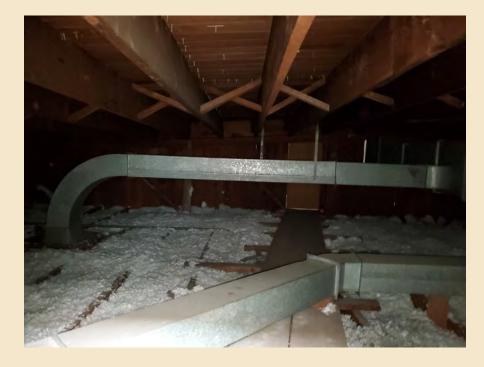
Figure 7.40
The attic over the main corridor and auditorium appear to be weather tight in their current state.
