CHAPTER **5**

Conditions Assessment

Siegel & Strain Architects, Architectural Conservation, Inc. and architecture + history, llc completed a series of site visits to the Berkeley City Hall, Maudelle Shirek Building in November and December, 2019 in order to observe and record typical building deficiencies, confirm the character defining features of the building, and to generally understand the building chronology. Observations were visual only, made from the ground and from easily accessed spaces only. Binoculars were used to see elevated features; although partially viewed from the lower attic windows to observe water drainage system, the roof was not accessed. No material testing, sampling or selective demolition occurred.

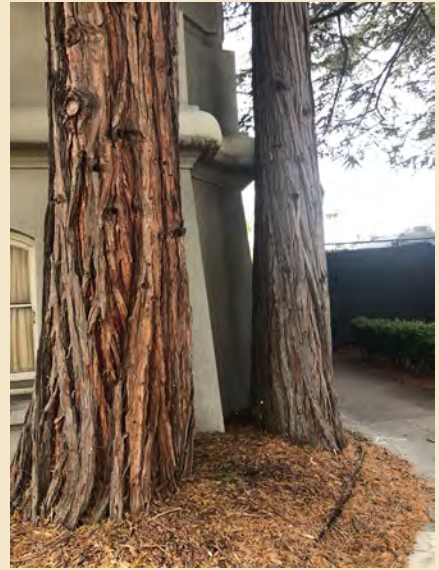
Figure 7.1

Incense Cedars (quantity 6) are planted at an inadequate distance from the east elevation building foundation, have grown taller than originally intended, and pose a structural and physical hazard to the building. (Figure 7.1)

The incense cedars, originally low to the ground, are now taller than the building. Their roots may be damaging the building foundations and their trunks and branches are too close to the building face. Dirt, water, tannins, rust, bio growth, and organic debris has accumulated on the building as a result.

Six Incense Cedars are planted at the east elevation are too close to the foundation and have grown larger than originally intended. Grade is in close contact with the base of the building, typical at all elevations.

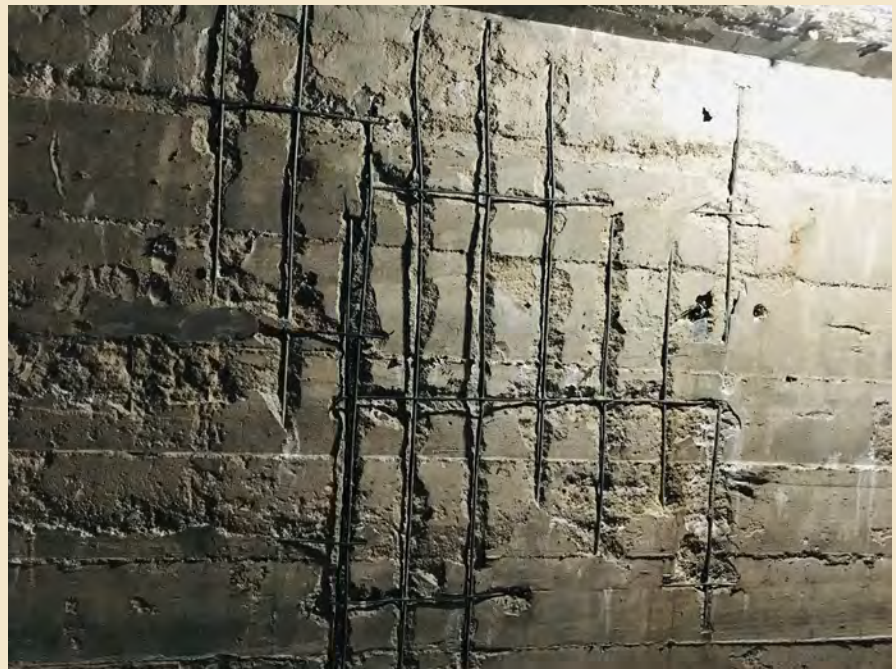
The three-inch thick concrete roof deck had very little coverage depth over the metal mesh reinforcement. The structural integrity of the slab, and the presence of water vapor in it are unknown. Additional investigation is required.

Deterioration of concrete roof slab and reinforcement (Figure 7.2)

Extensive and consistent spalling, efflorescence and rust staining at the underside of the existing roof slab is indicative of the passage of water vapor through the roof slab, inadequate coverage of the wire mesh slab reinforcement, and potential instability of the roof construction. The exposed wire mesh may, in some locations, be an original install condition, likely the result of the combination of inadequate concrete mix, minimal coverage depth over the wire mesh, and air pockets within the concrete pour. The slab appears to be sagging in places.

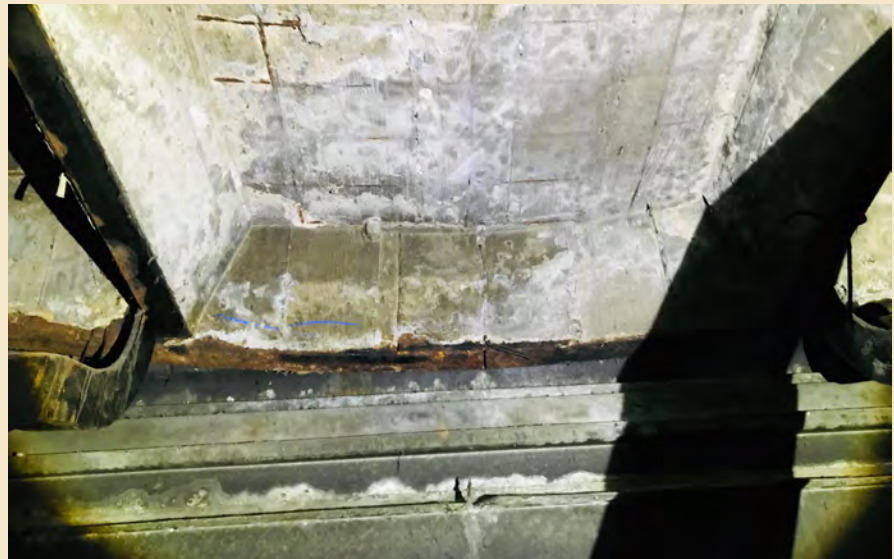
Extensive efflorescence and water staining at the concrete roof deck and rusting at the structural steel support members of the roof spire may have compromised the integrity of the structure. Additional investigation is required.

The decorative metal components of the roof spire are in good condition, however the structural framing upon which it is supported appears to be in poor condition and potentially inadequate. Note that some historical documents, including the original 1907 drawings, refer to this element as the tower and other portions of this report also refer to it as a cupola.

- Substantial rust at structural steel beams and significant spalling of concrete encasing the beams
- Widespread efflorescence at underside of concrete roof deck
- Inappropriate previous repairs including wood blocking and spray foam

A study should be conducted by licensed engineers selected for their demonstrated expertise in structural assessment of historically significant structures. Study to determine how to strengthen the spire and the attachment to the roof without damaging its historic fabric. The spire may need to be temporarily removed from the roof to perform structural repairs. *(Per 2019 IDA Seismic Evaluation)*

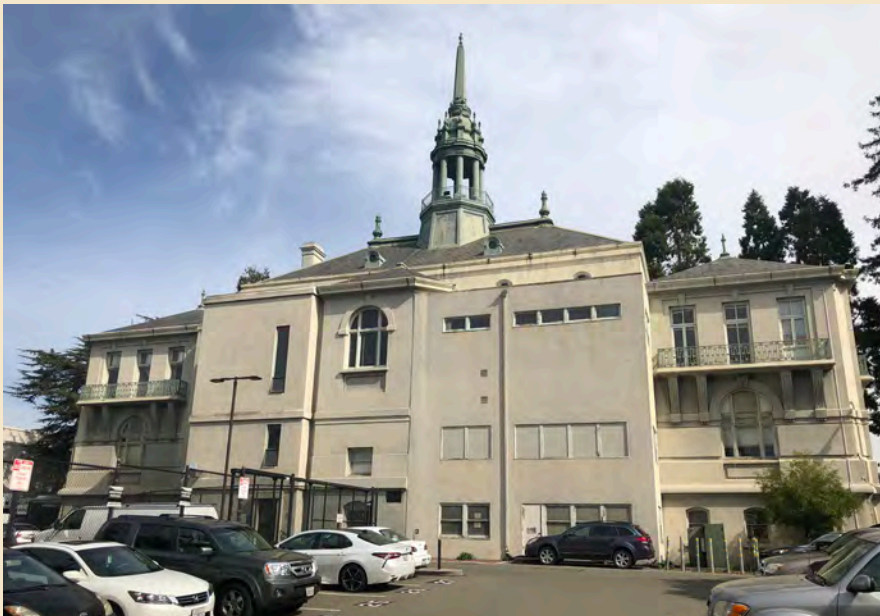
Figure 7.4
The original stair tower of the rear (west) façade has been engulfed by two additions, rendering the historic façade unreadable.

The building additions (ca. 1950) to either side of the main staircase tower are poorly located, are inappropriately scaled, and generally detract from the overall facade. Although the interiors of the additions were not surveyed, anecdotal evidence tells us that these areas leak badly.

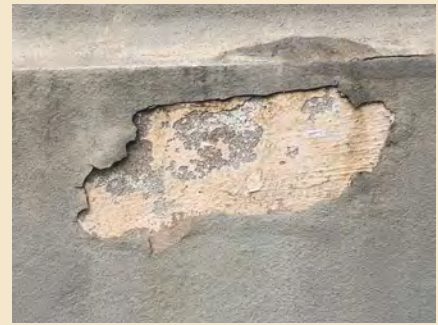
Figure 7.5
At this location on the east elevation, exterior wall coatings have peeled away indicating the many layer of coatings over time.

Buildup of exterior wall renders and coatings over time (building wide) may require replacement (Figure 7.5)

There is a buildup of exterior finishes on the cementitious plaster walls. The existing coating has shifted in color inconsistently and appears blotchy. Additionally, it is dirty, peeling and in some locations has completely failed.

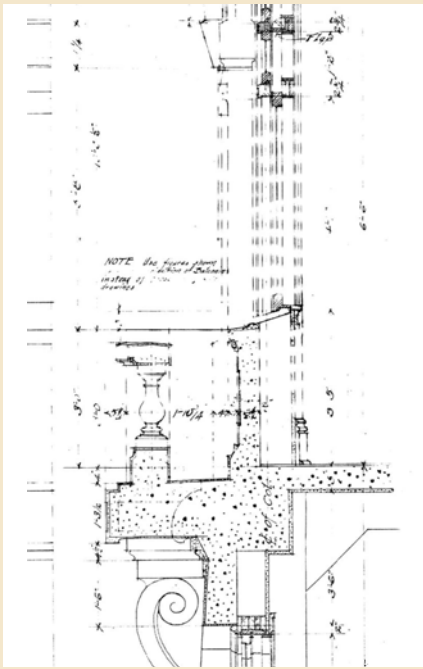
Figure 7.6
The original construction drawings show a sloped balcony floor. It is unclear how the balconies drain. Additionally, no drip edges are installed.

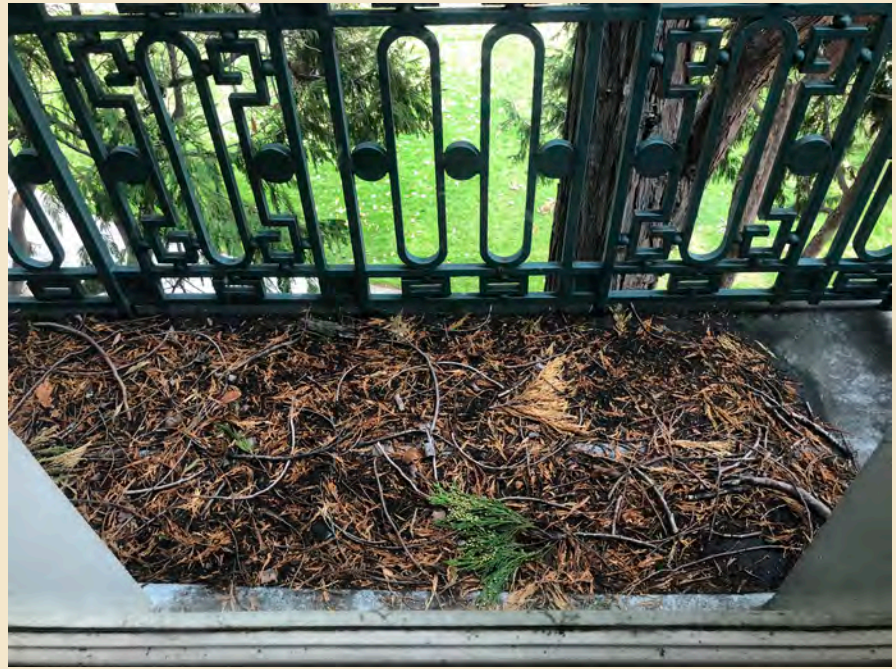
Figure 7.7
Trees in close proximity to the building have caused debris to build up on the balcony floors.

Consider removing trees causing buildup in balconies (see site recommendations).

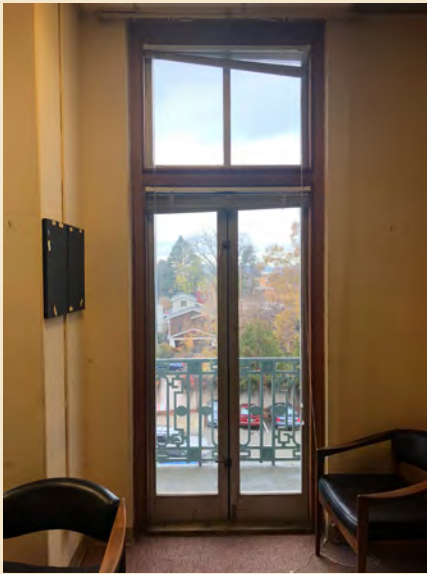
Figure 7.8
At the second floor south wing, the double hung wood windows have been replaced with inappropriate aluminum casement windows.

Following window survey, restore wood windows to operable condition. In kind replacement of some windows should be anticipated in some locations.

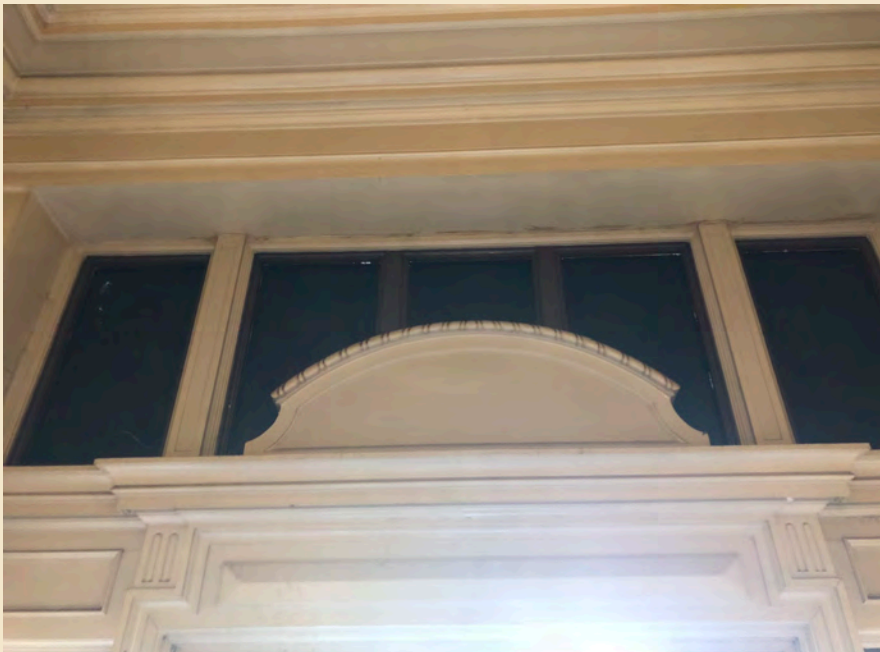
Figure 7.10
The transom of the building's primary (east) entry has been back painted.

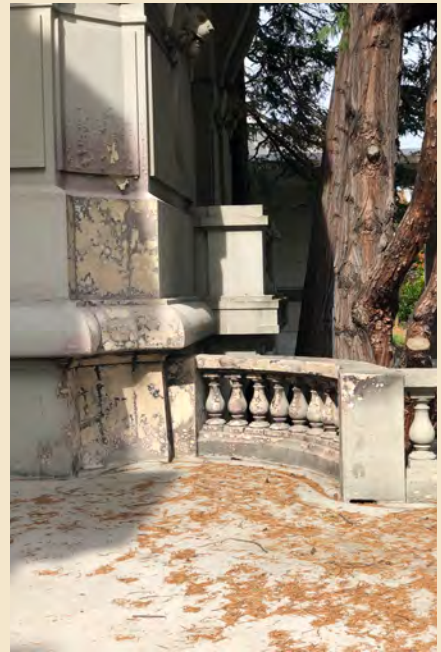
Figure 7.9
A fire started at the north alcove of the entry terrace has damaged the building's exterior finishes.

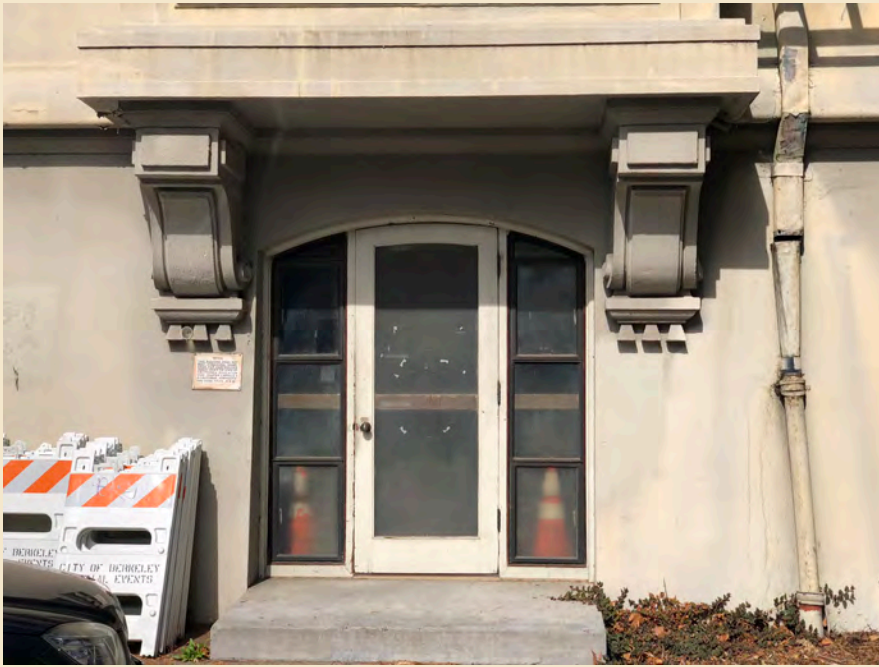
Figure 7.11
At the south entry doors, the original wood side lites have been replaced with inappropriate metal sash.

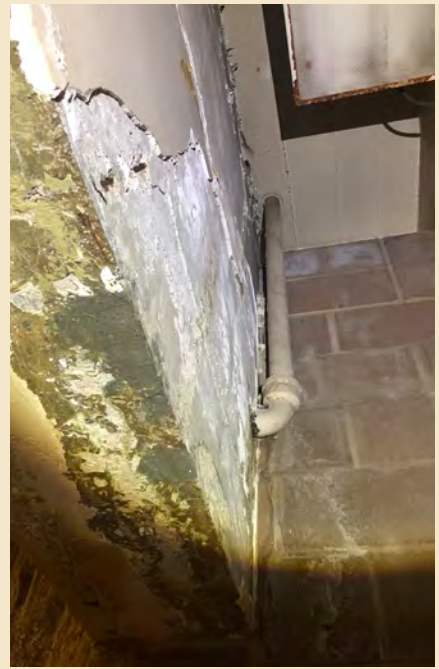
Figure 7.12
Excessive water infiltration at this overhead concrete beam in the basement has caused ferric jacking at the rebar and widespread efflorescence.

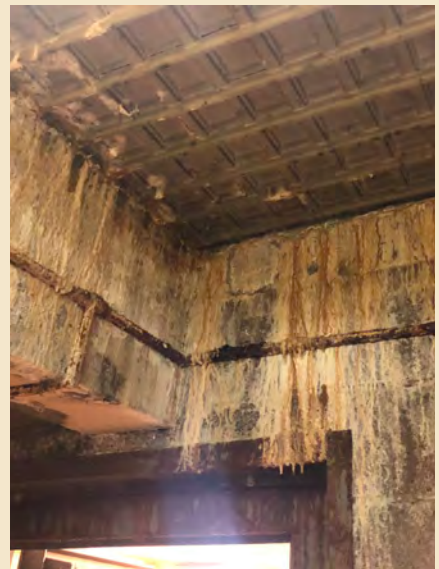
*Electrical conduit and fixtures in direct contact with salt laden water infiltration. **Potentially dangerous** (Figure 7.13)*

Figure 7.13
The original sidewalk lites of the front entry terrace were poorly infilled with concrete. Salt laden water infiltration has built up over time on the concrete surfaces and electrical conduit below the entry terrace, creating a dangerous condition.

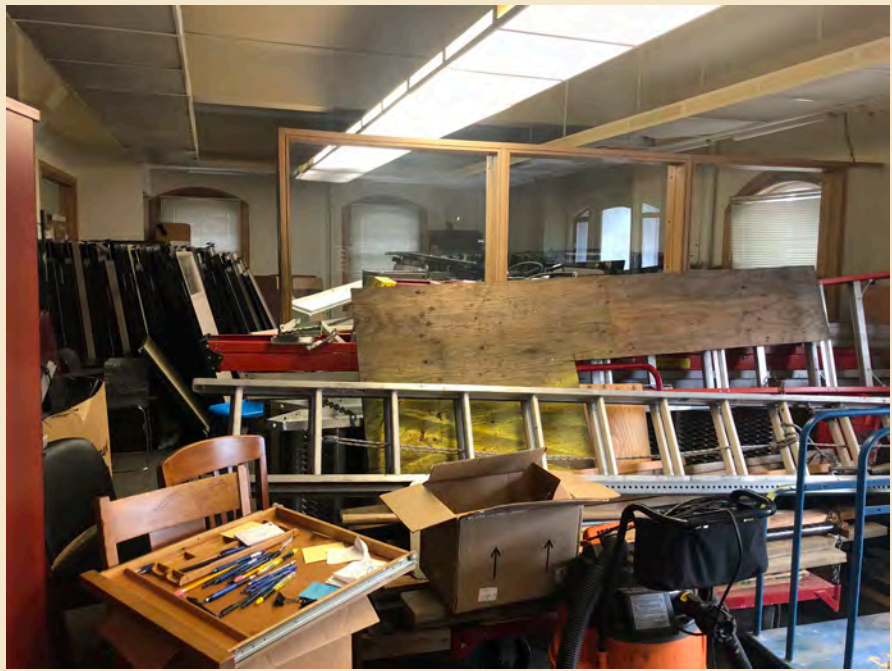
Figure 7.14
The basement space has been divided into many spaces, are filled with furniture and debris, are dimly lit, and difficult to navigate. All debris and storage should be removed, and contemporary construction removed such that a proper condition survey can be conducted.

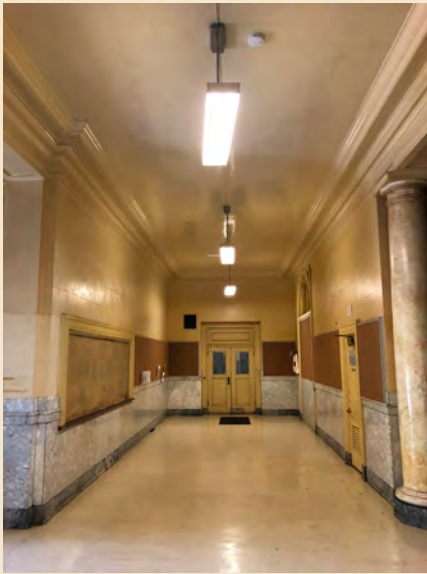
Figure 7.15
Although the original layout and materials of the main entry corridor remain, a number of alterations have altered the appearance and feeling of the space.

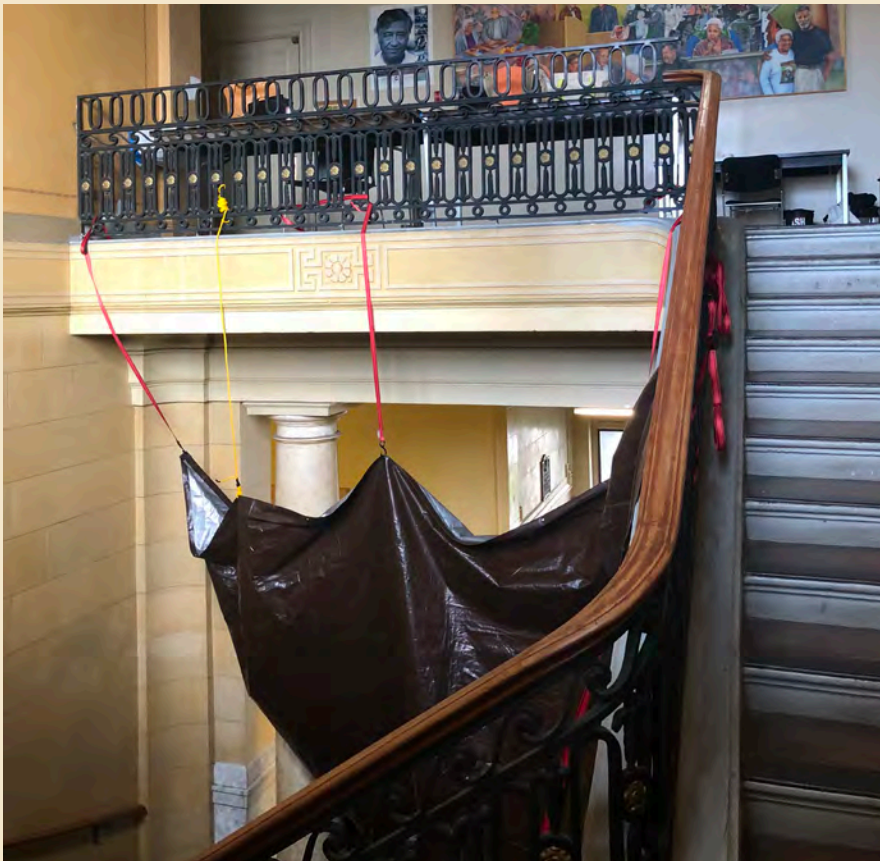
Figure 7.16
The double height space with stairs below at the main staircase will make access to the ceiling and original pendant light fixture difficult.

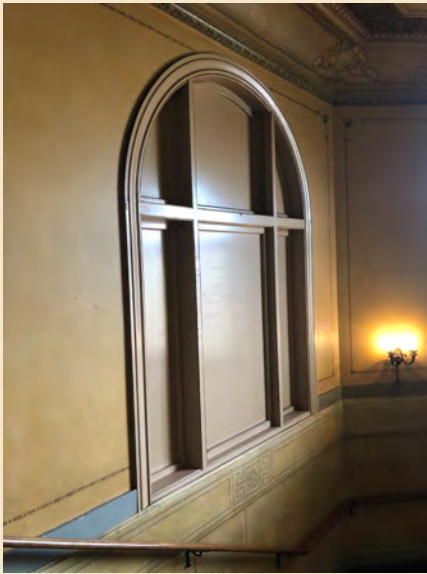
Figure 7.17
The additions to the north and south of the stair tower caused the original windows to be infilled, changing the character of the space.

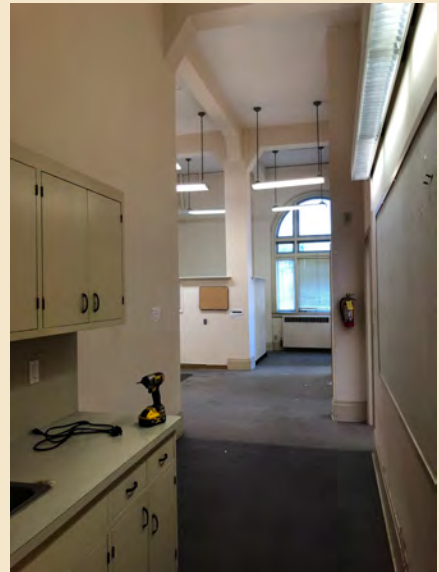
Figure 7.18

The inconsiderate division of this historically open space at the north wing has changed the feeling of the space.

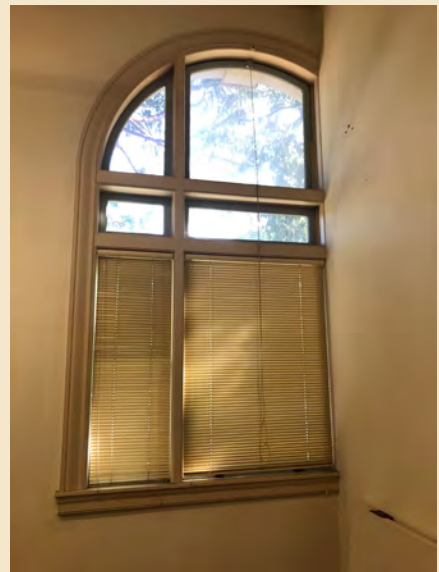
Figure 7.19

Contemporary infill walls awkwardly divide the large arched window openings.

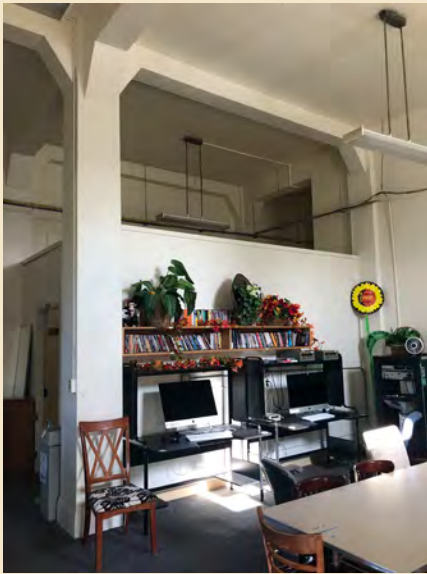
Figure 7.20
Infill walls at the south wing are not full height in the space, allowing the open nature of the original space and the concrete ceiling and beams to be expressed.

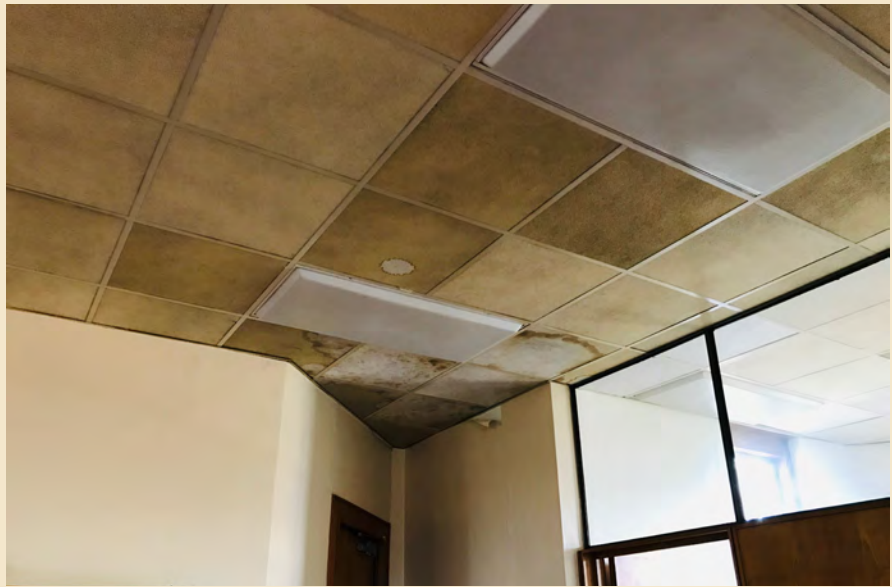
Figure 7.23
The south wing also shows evidence of water damage along much of its north wall.

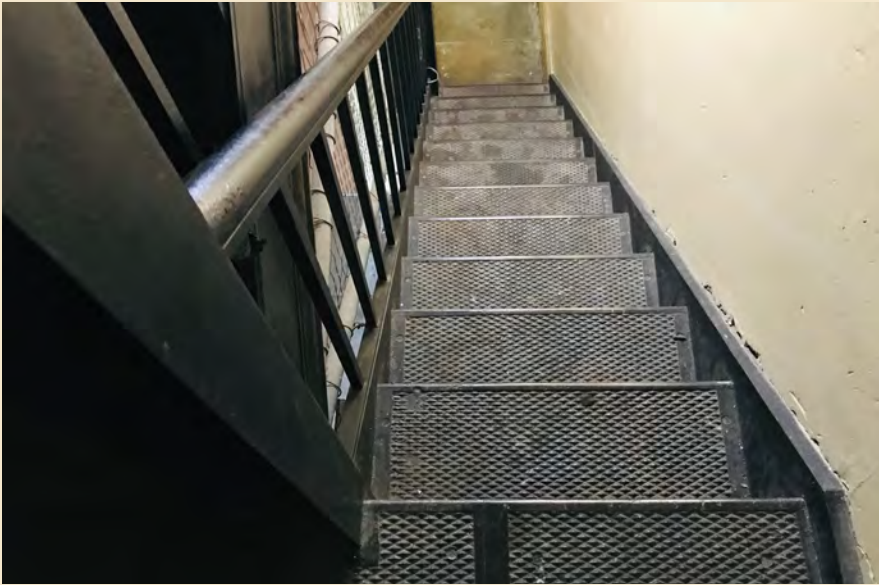
Figure 7.24
The cast iron stair to the second floor is original but does not meet current building code standards.
