City of Berkeley
Berkeley Municipal Pier
DRAFT Structural Assessment Report

November 2017

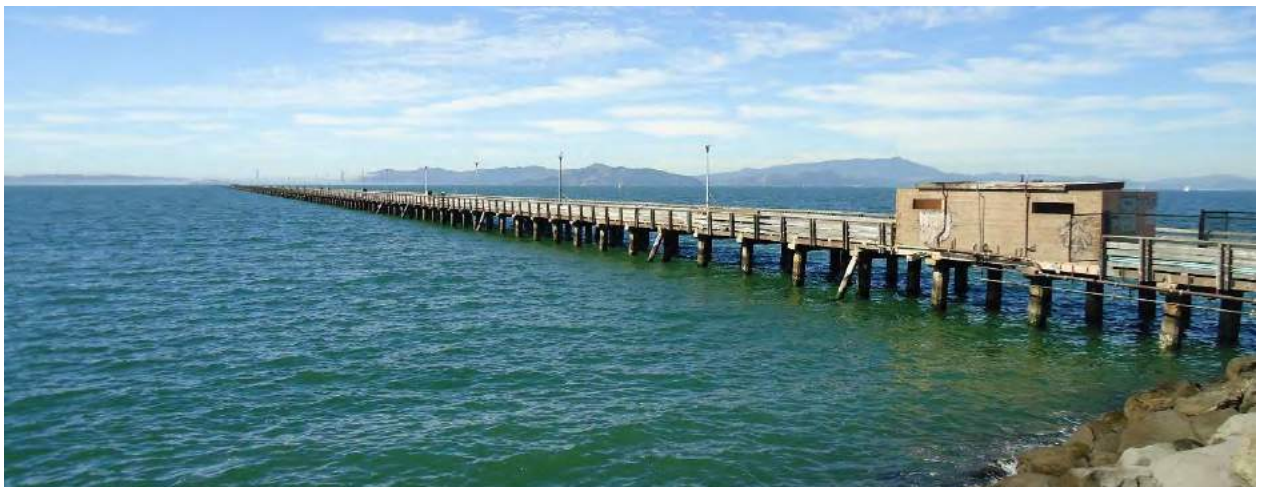
Photo 1-1: Berkeley Pier

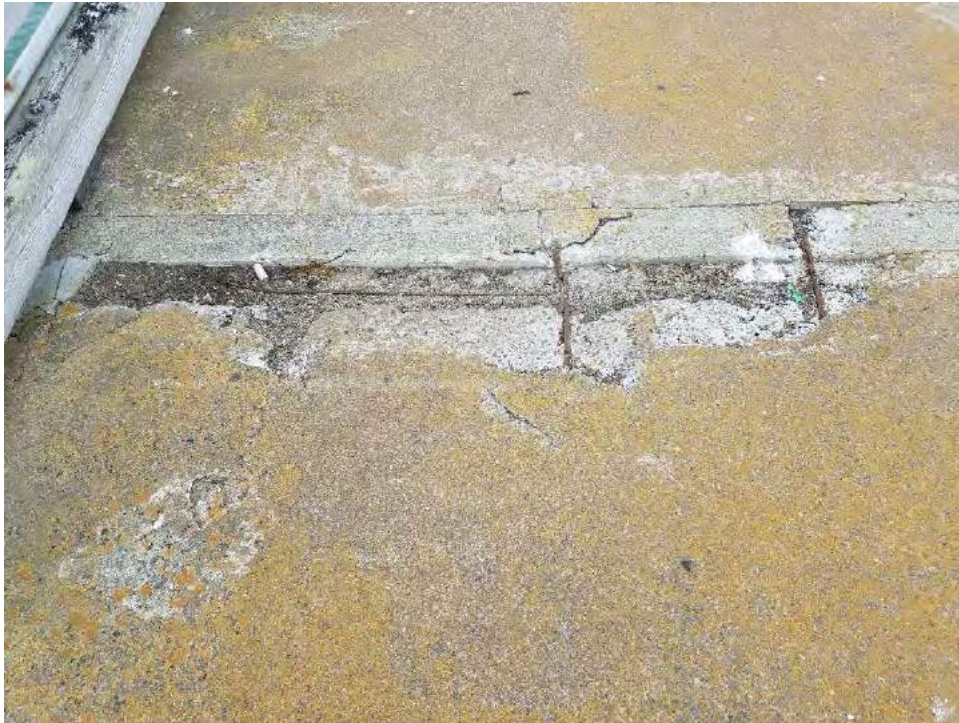
Photo 3-1: Open spall at Section 1 deck panel

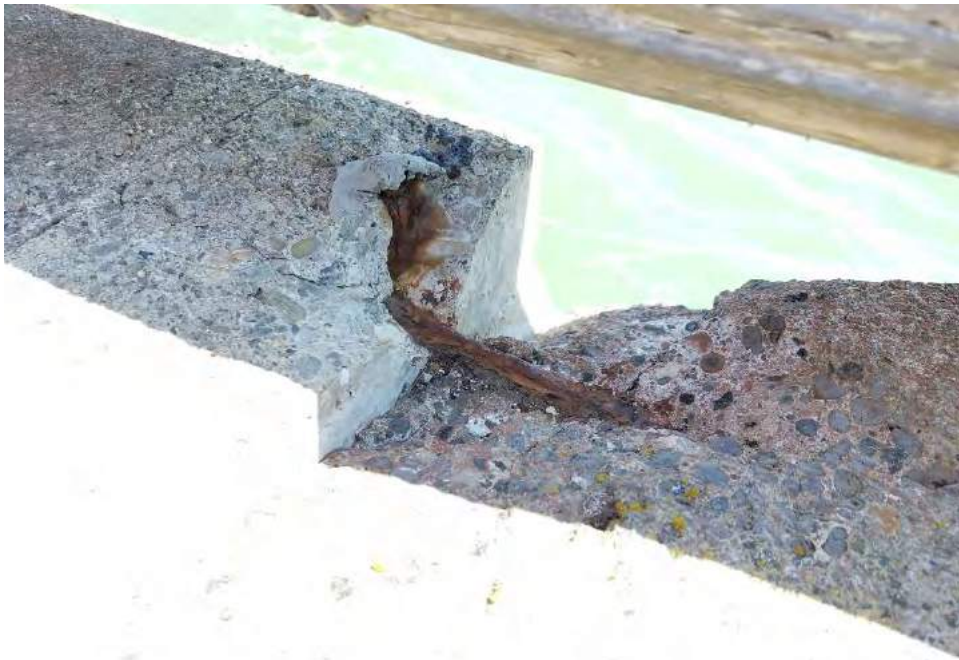
Photo 3-2: Open spall at pile bent with exposed longitudinal rebar

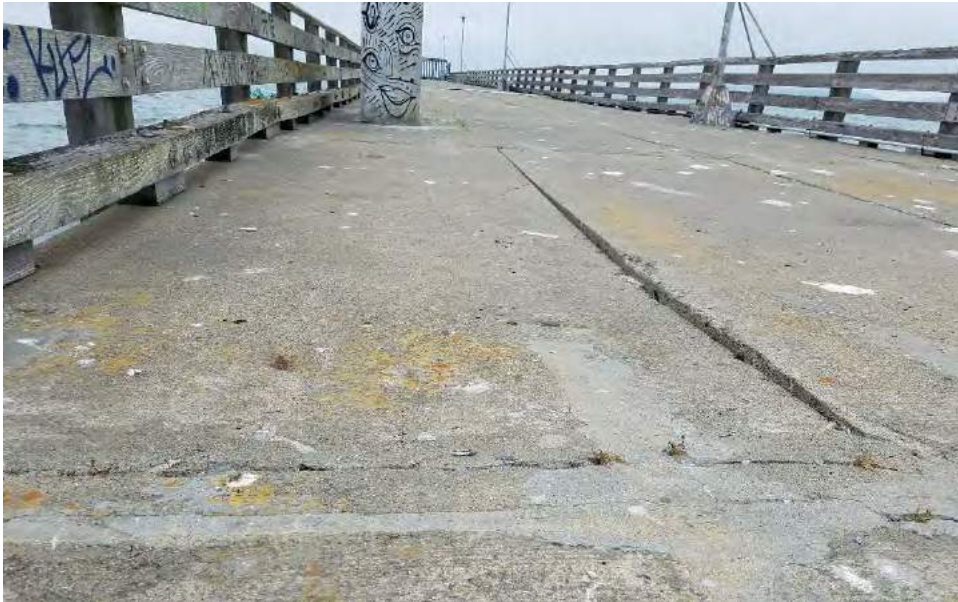
Photo 3-3: Severe Deflection at Section 2 Panel

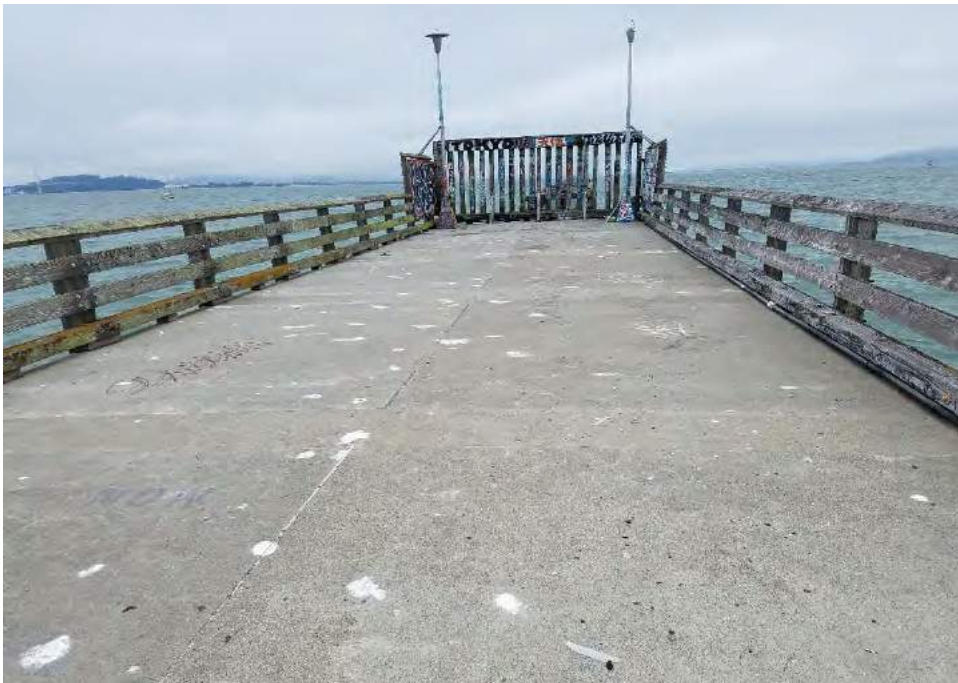
Photo 3-4: Typical Above Deck Condition of Section 3 Panels

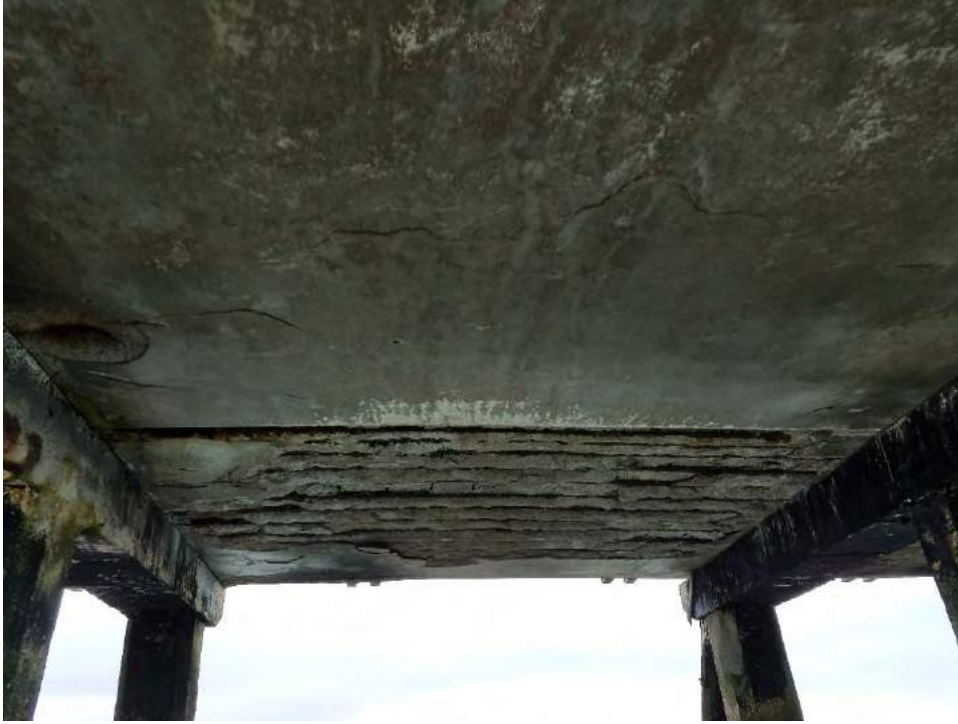
Photo 3-5: Typical Below Deck Condition of Section 1 Panels

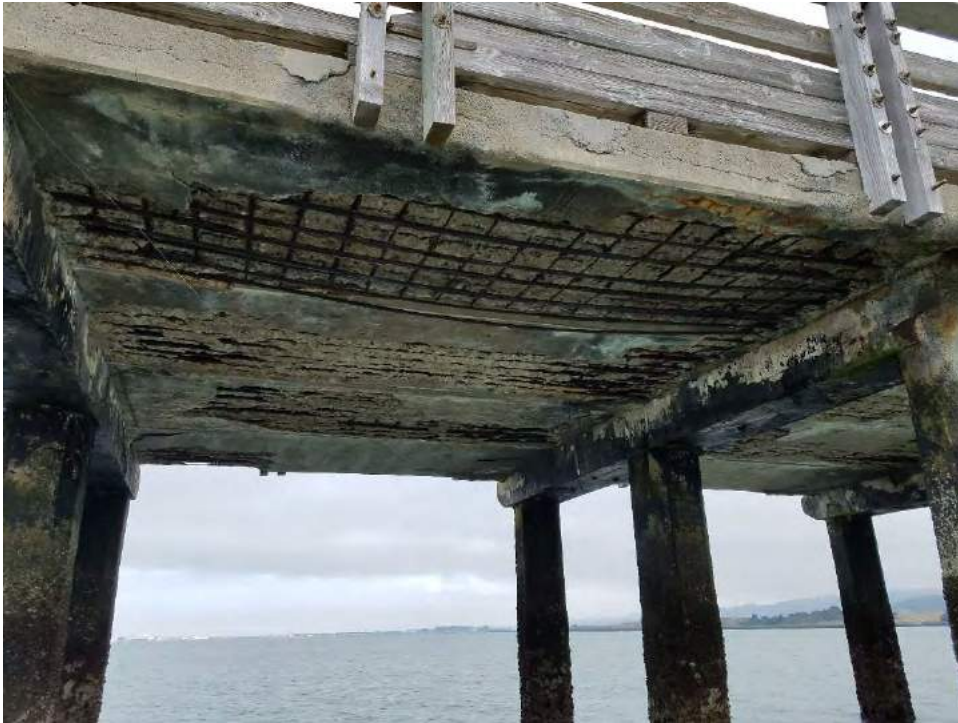
Photo 3-6: Typical Below Deck Condition of Section 2 Panels

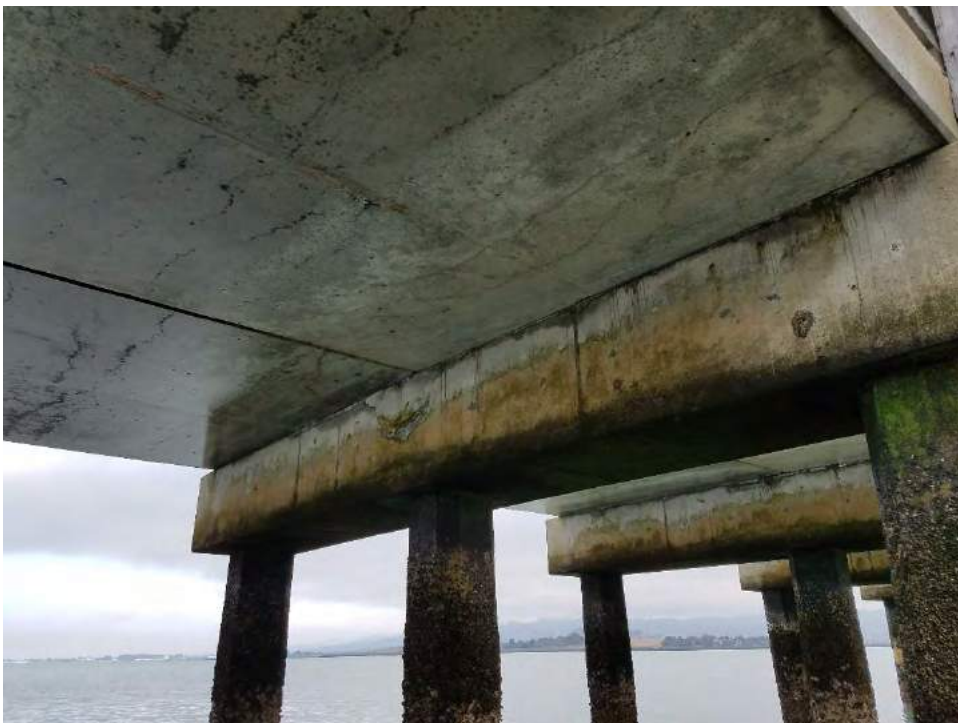
Photo 3-7: Typical Below Deck Condition of Section 3 Panels

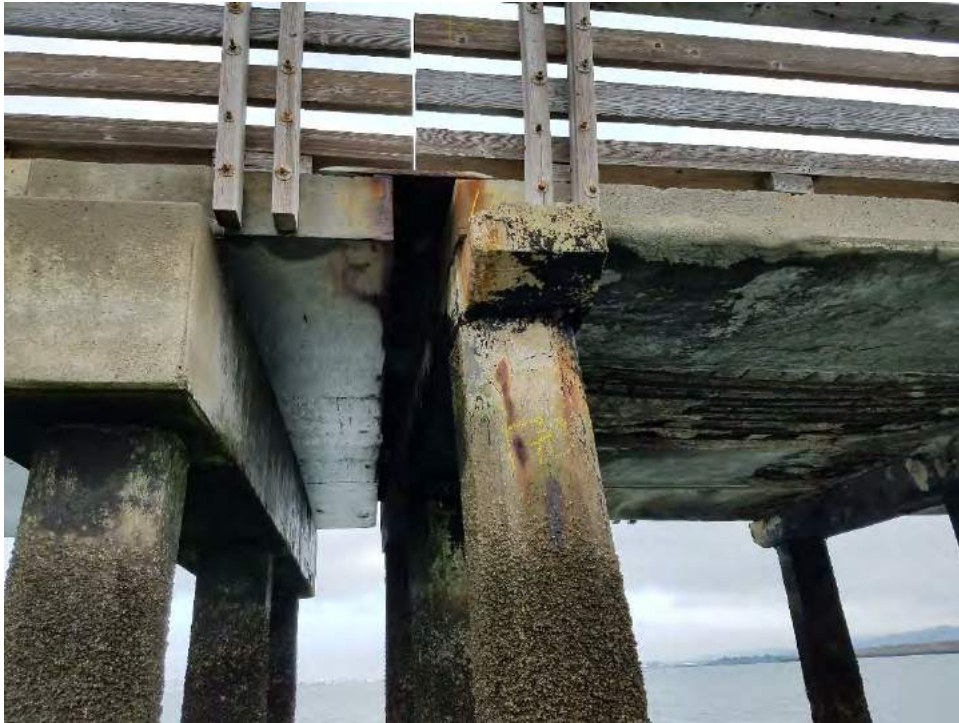
Photo 3-8: Comparison of Section 3 (left) and Section 2 (right)

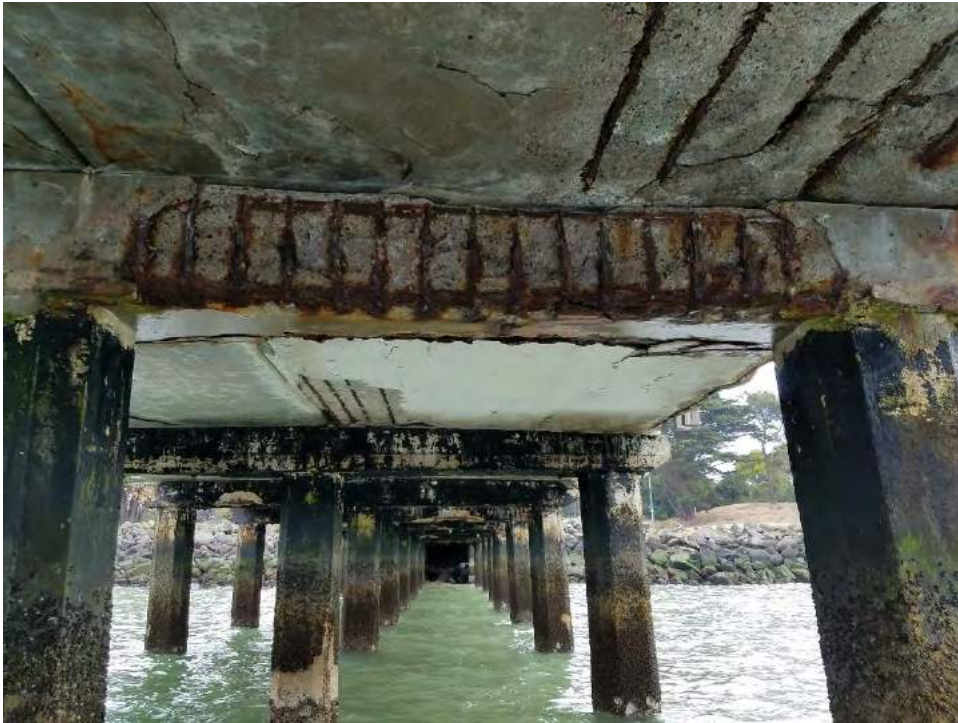
Photo 3-9: Example of Bent Cap with Open Spall in Section 1

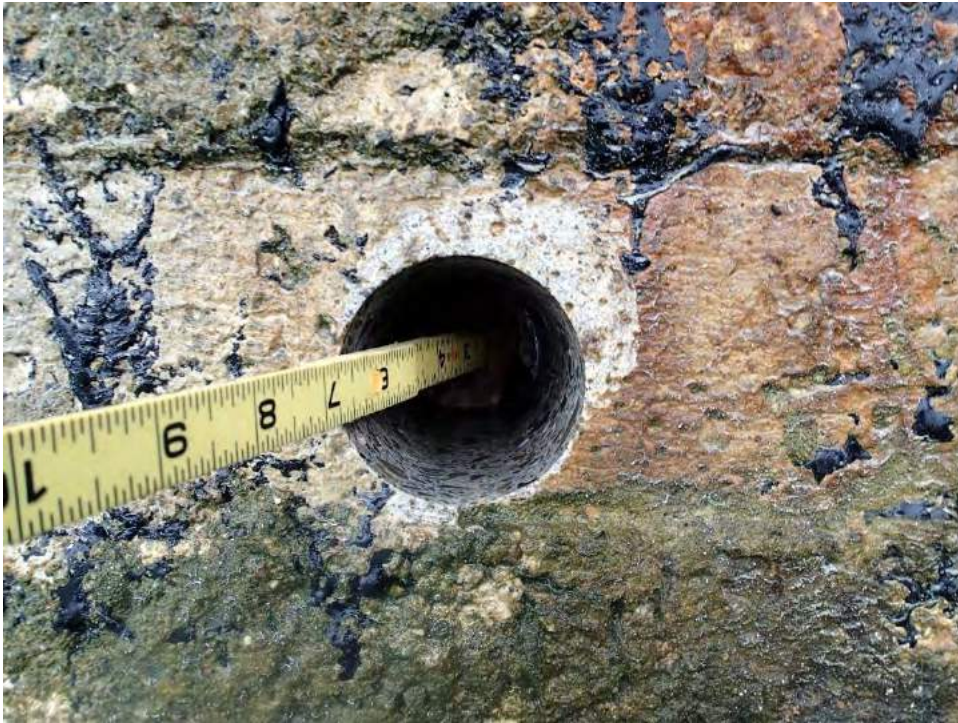
Photo 3-10: Core of concrete pile jacket

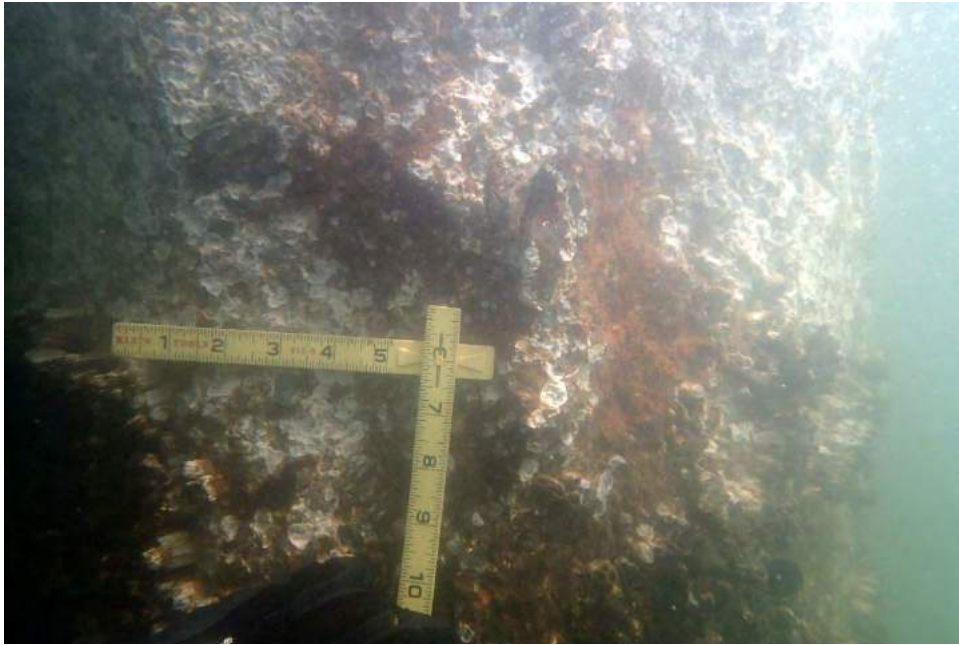
Photo 3-12: Underwater open spall on pile

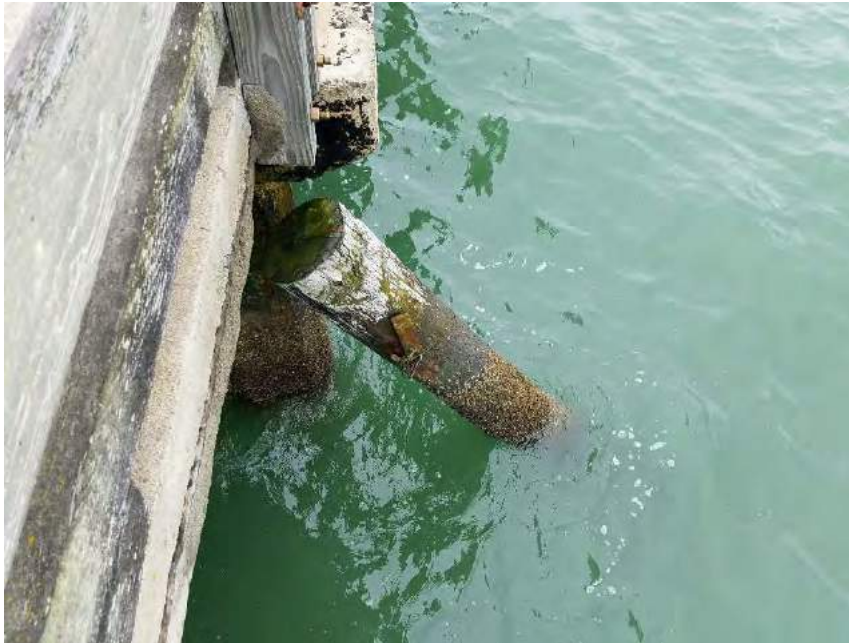
Photo 3-13: Timber Pile Disconnected from Bent Cap

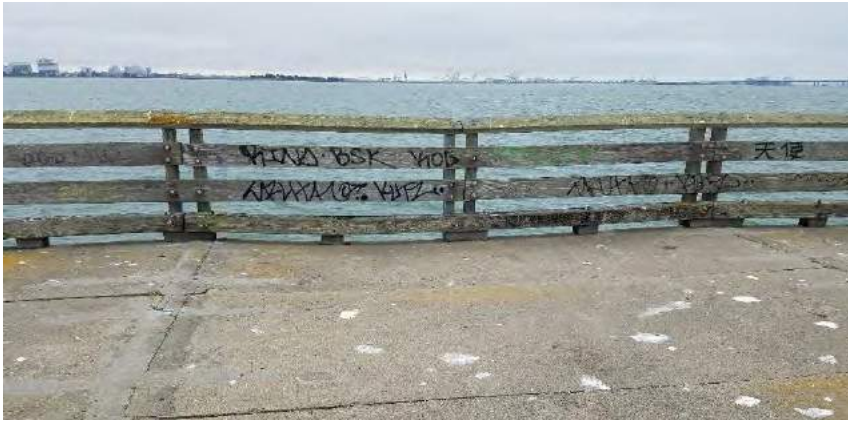
Photo 3-14: Deformed Guardrail Due to Concrete Deflection

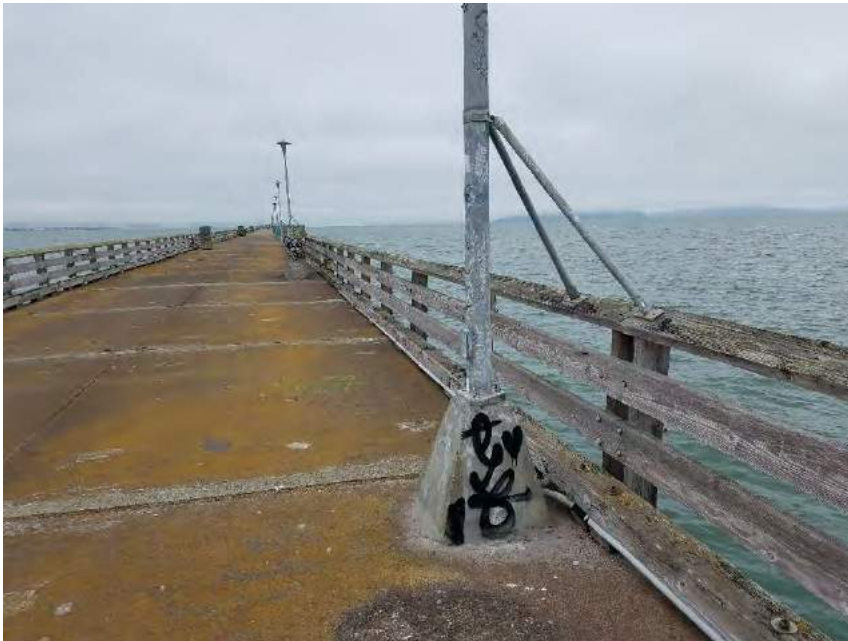
Photo 3-15: Typical Luminaire

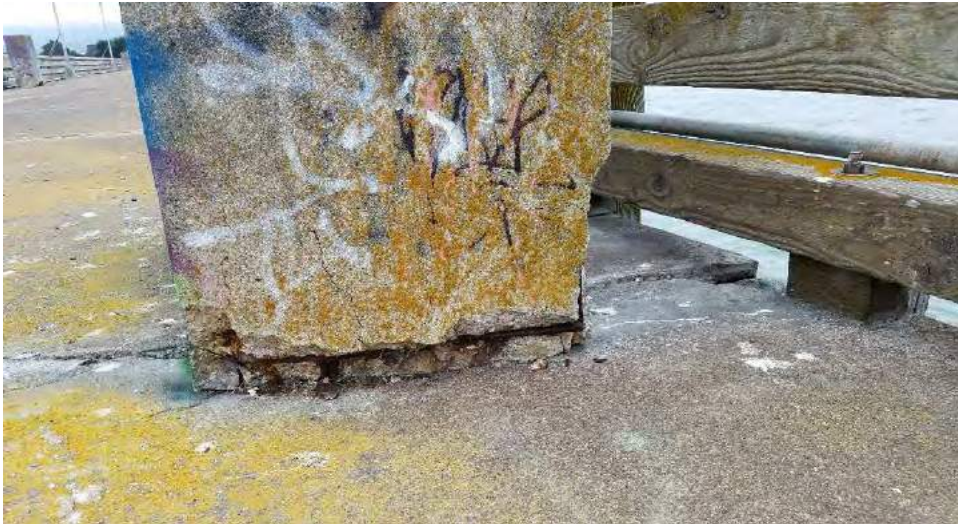
Photo 3-16: Typical condition of bench with concrete spalls

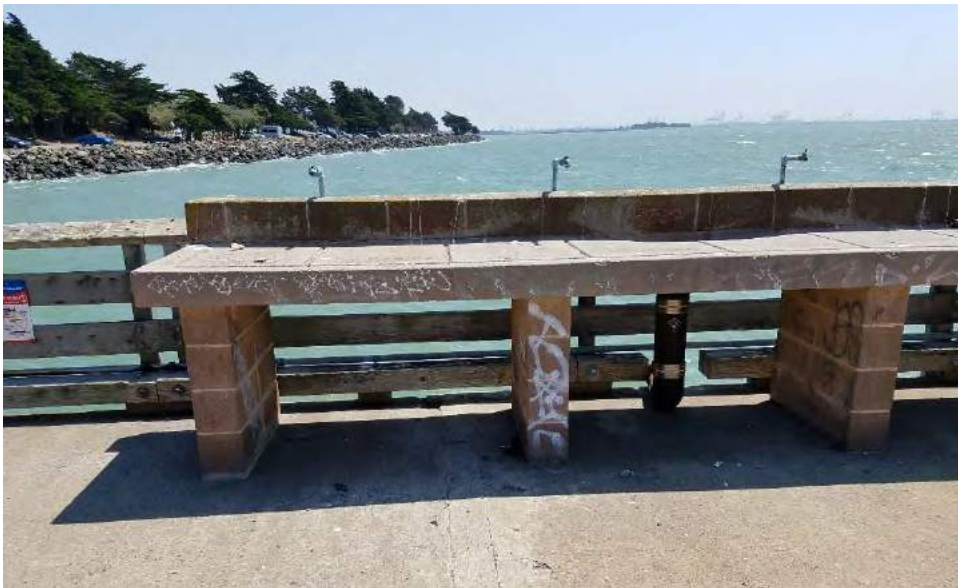
Photo 3-17: Fish Washing Station

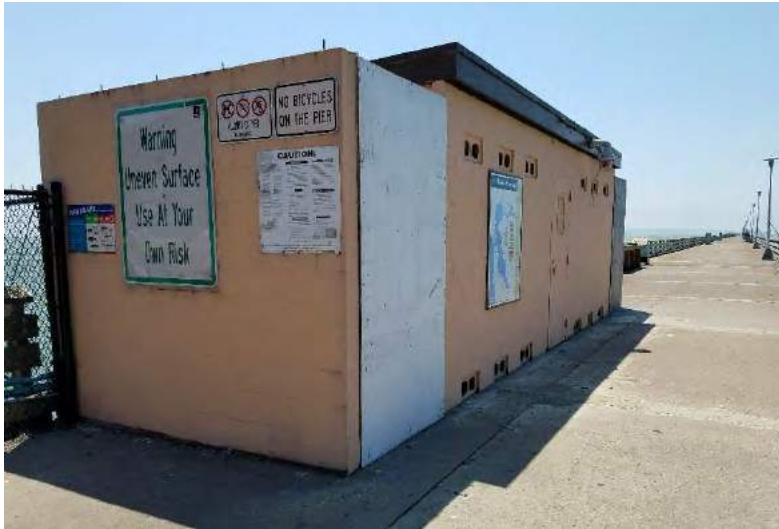
Photo 3-18: Restroom

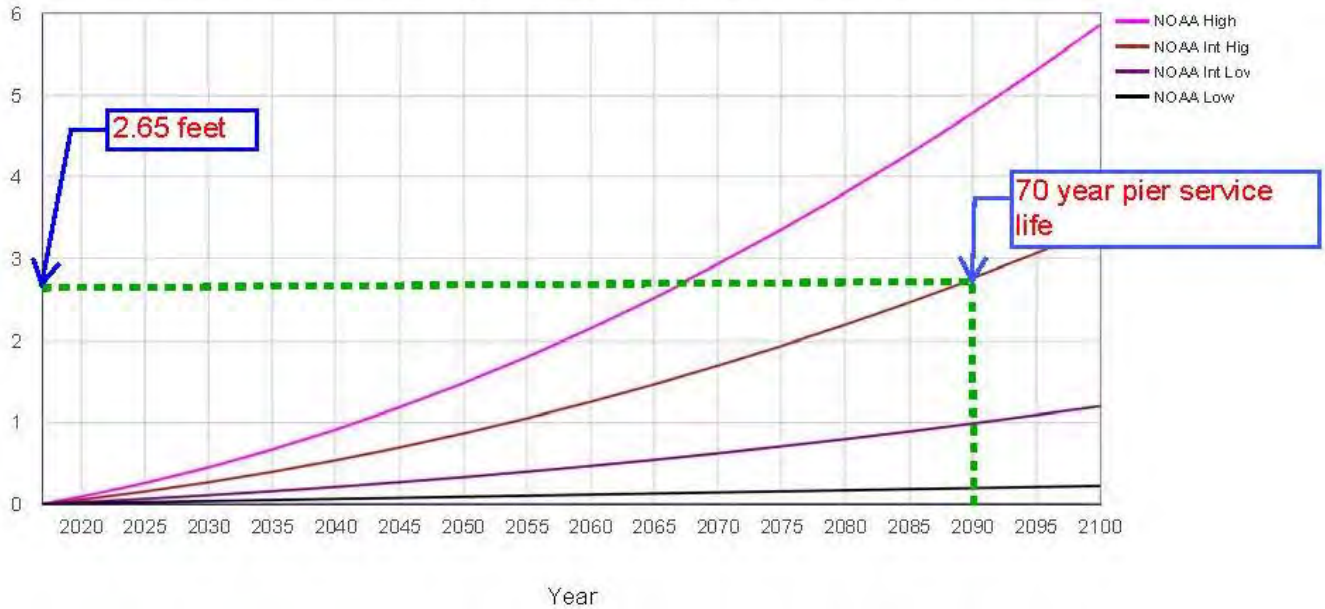
Figure 4-2: Relative Sea Level Change Projections

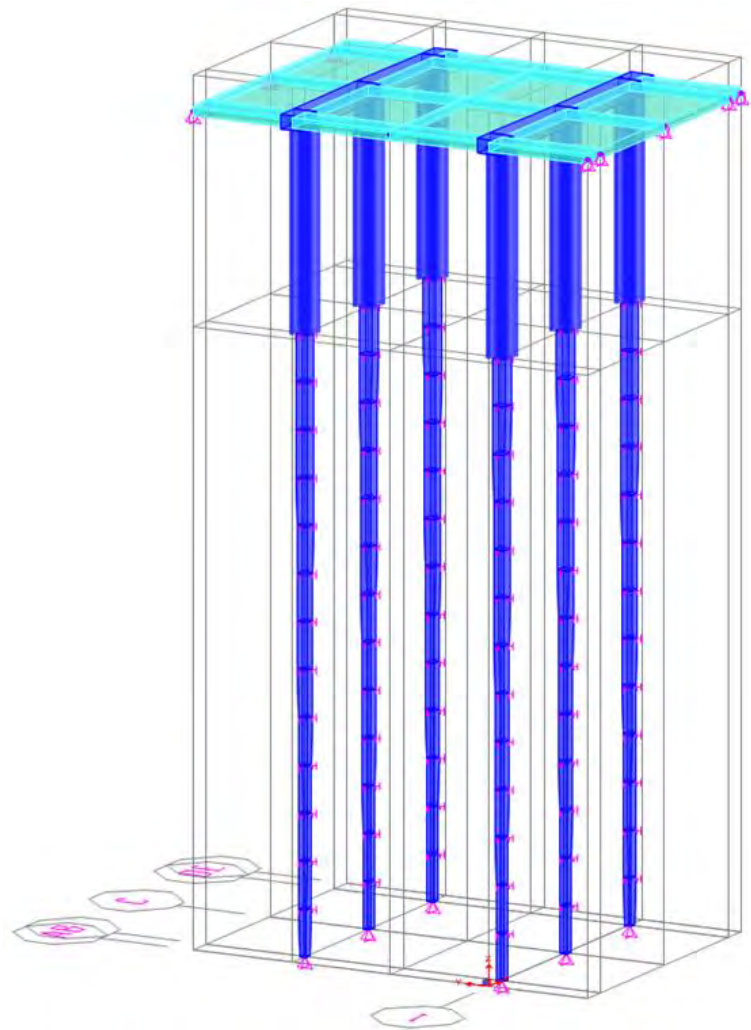
Figure 5-1: Existing Pier Configuration (Partial Section)

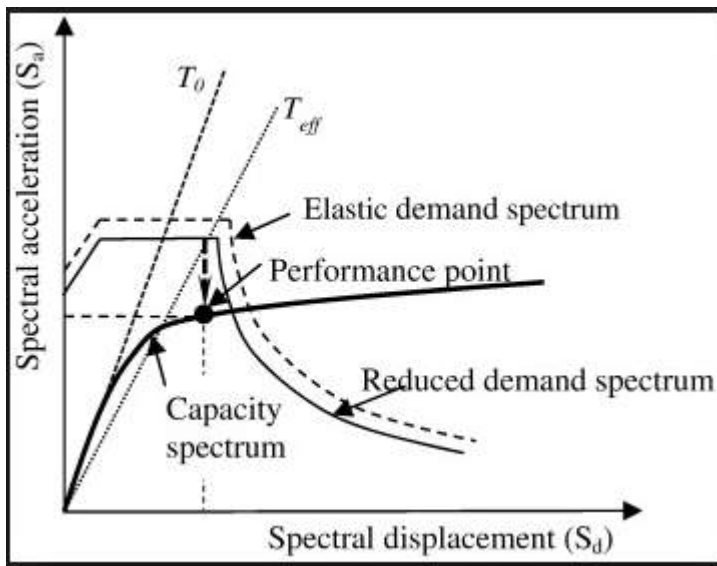
Figure 5-3: Typical Acceleration-Displacement Response Spectra (ADRS Spectra)

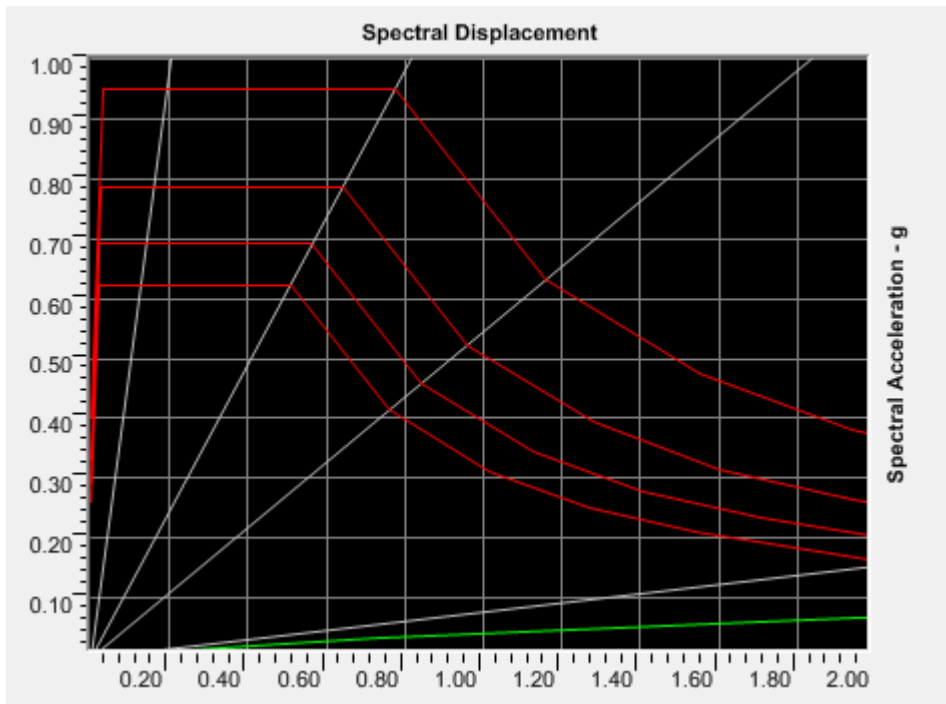
Figure 5-5: Acceleration Displacement Spectrum for Existing Timber Pile Condition

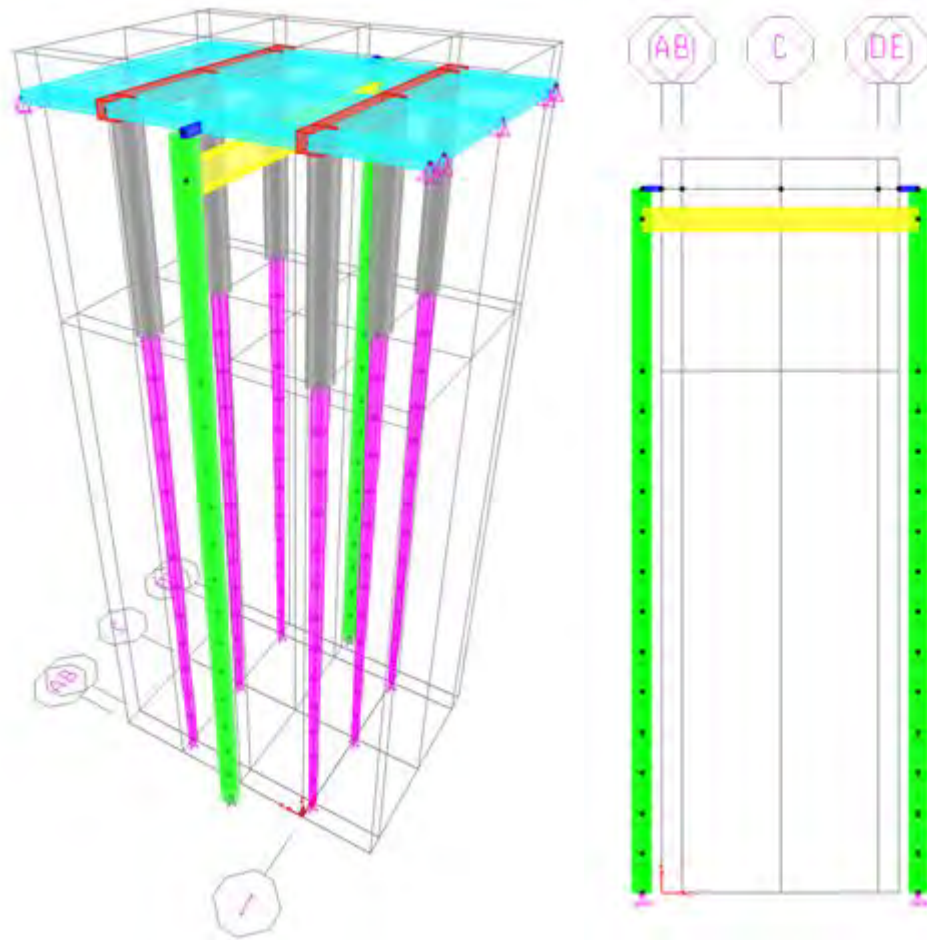
Figure 5-6: Typical Model View for Retrofit Model P4

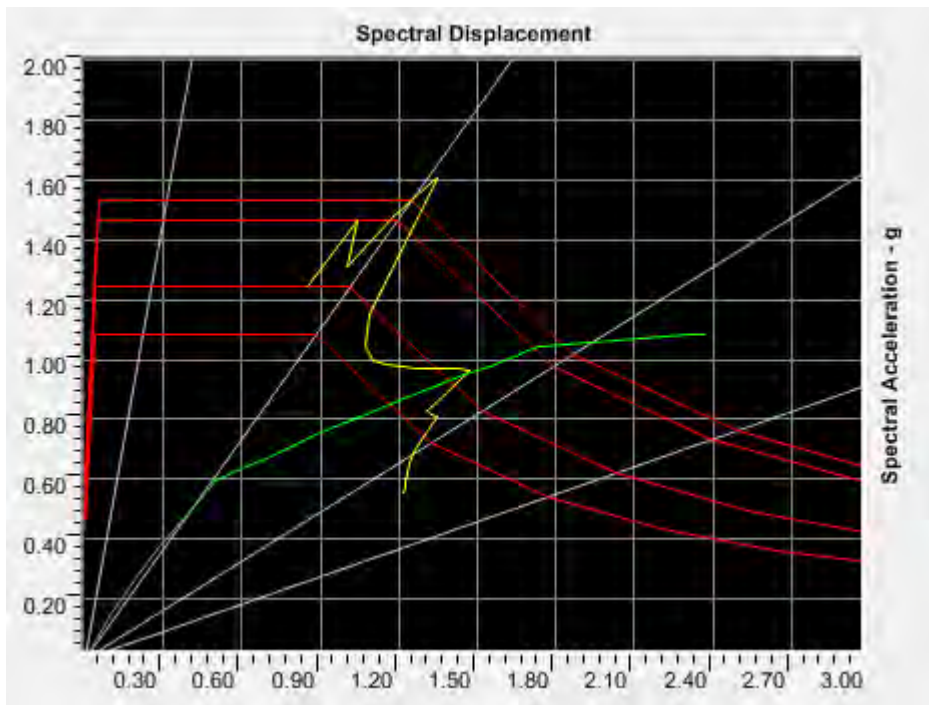
Figure 5-8: ADRS for P4 Retrofit Model

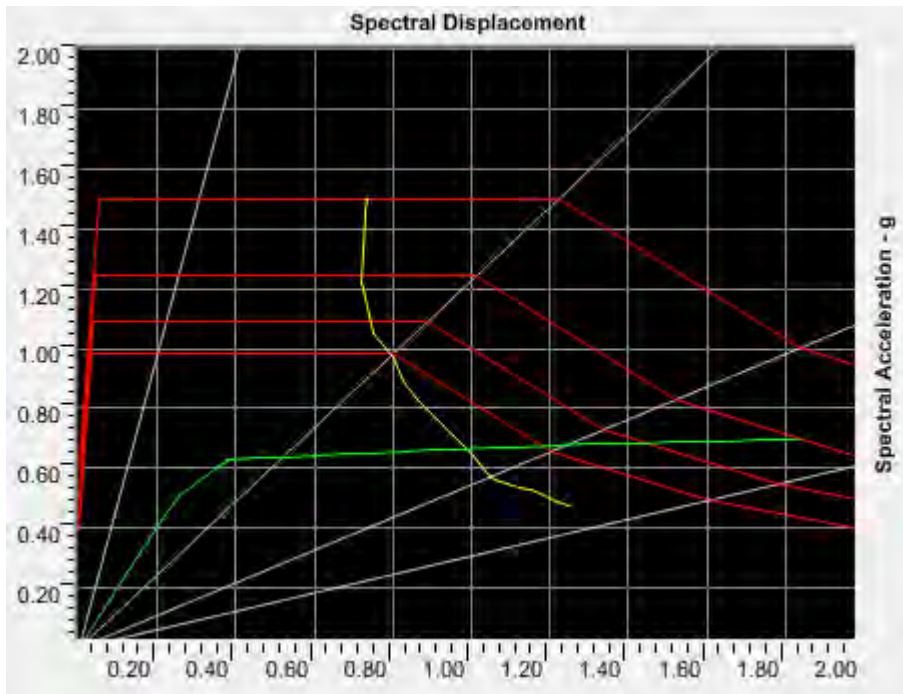
Figure 5-14: ADRS for P10 Model

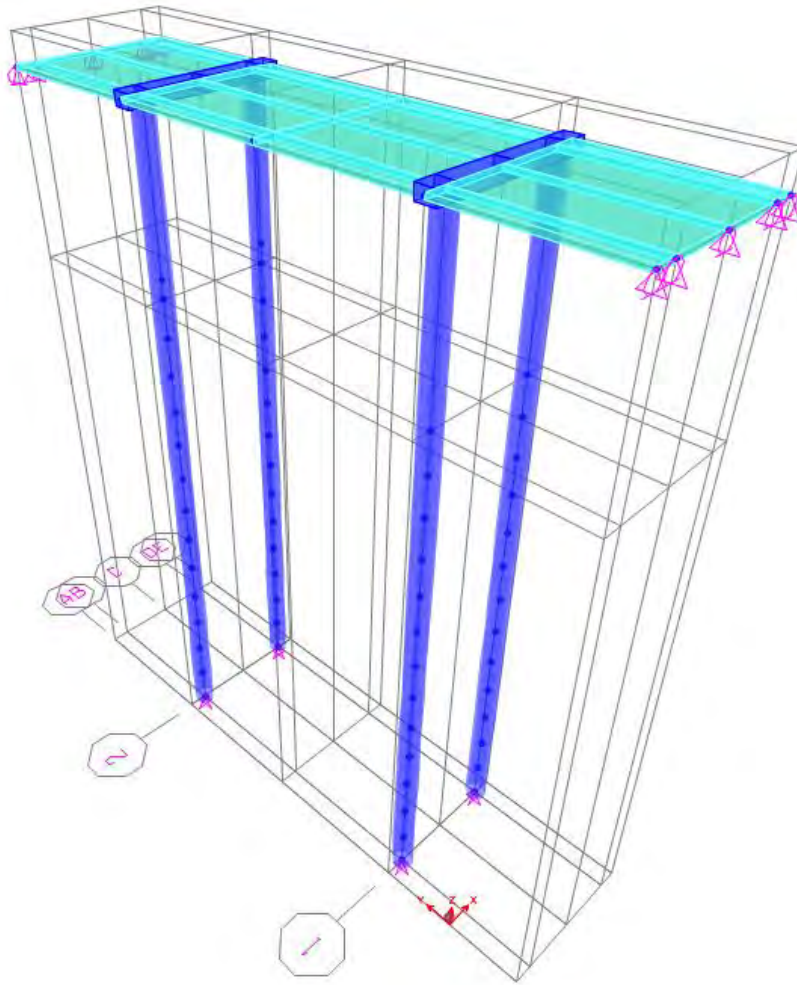
Figure 5-15: Typical Section of P10 Two Pile Bent Replacement Pier

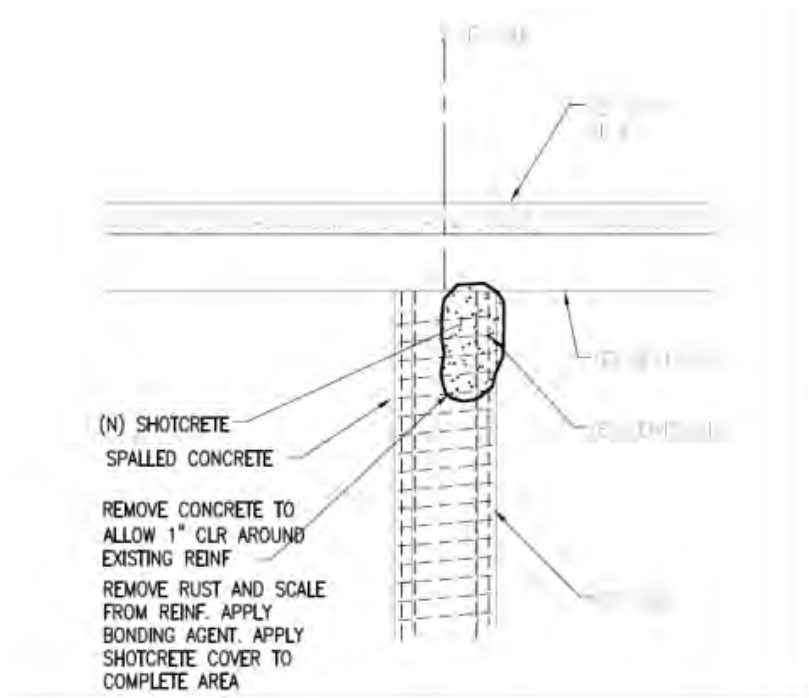
Figure 6-1: Pile Repair at Bent Cap

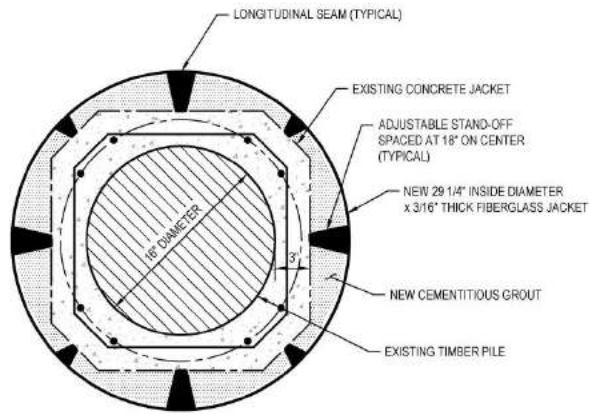
Figure 6-2: Fiberglass (FRP) Pile Jacket

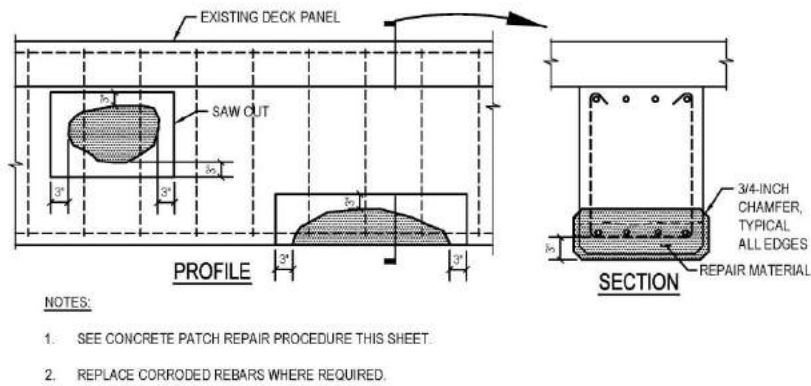
Figure 6-3: Typical Bent Cap Repair

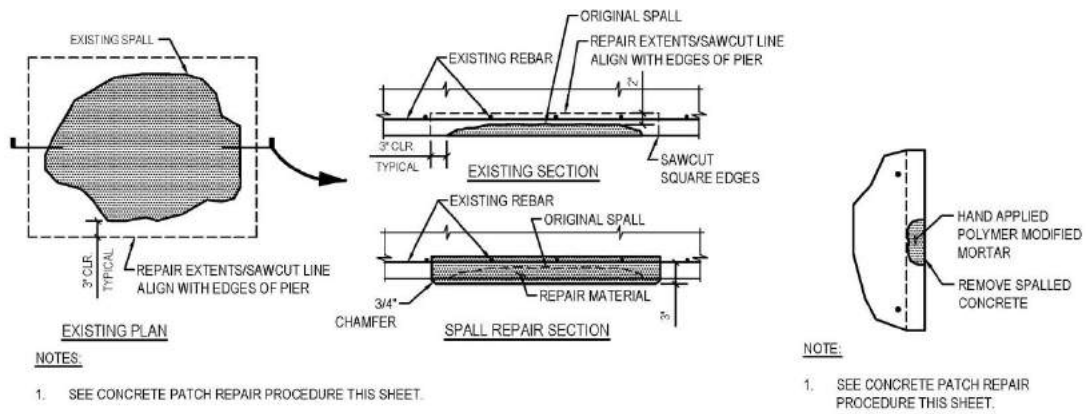
Figure 6-4: Deck Slab Repair

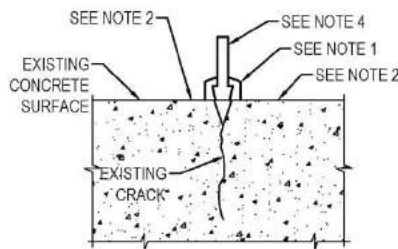
Figure 6-5: Typical Concrete Crack Repair

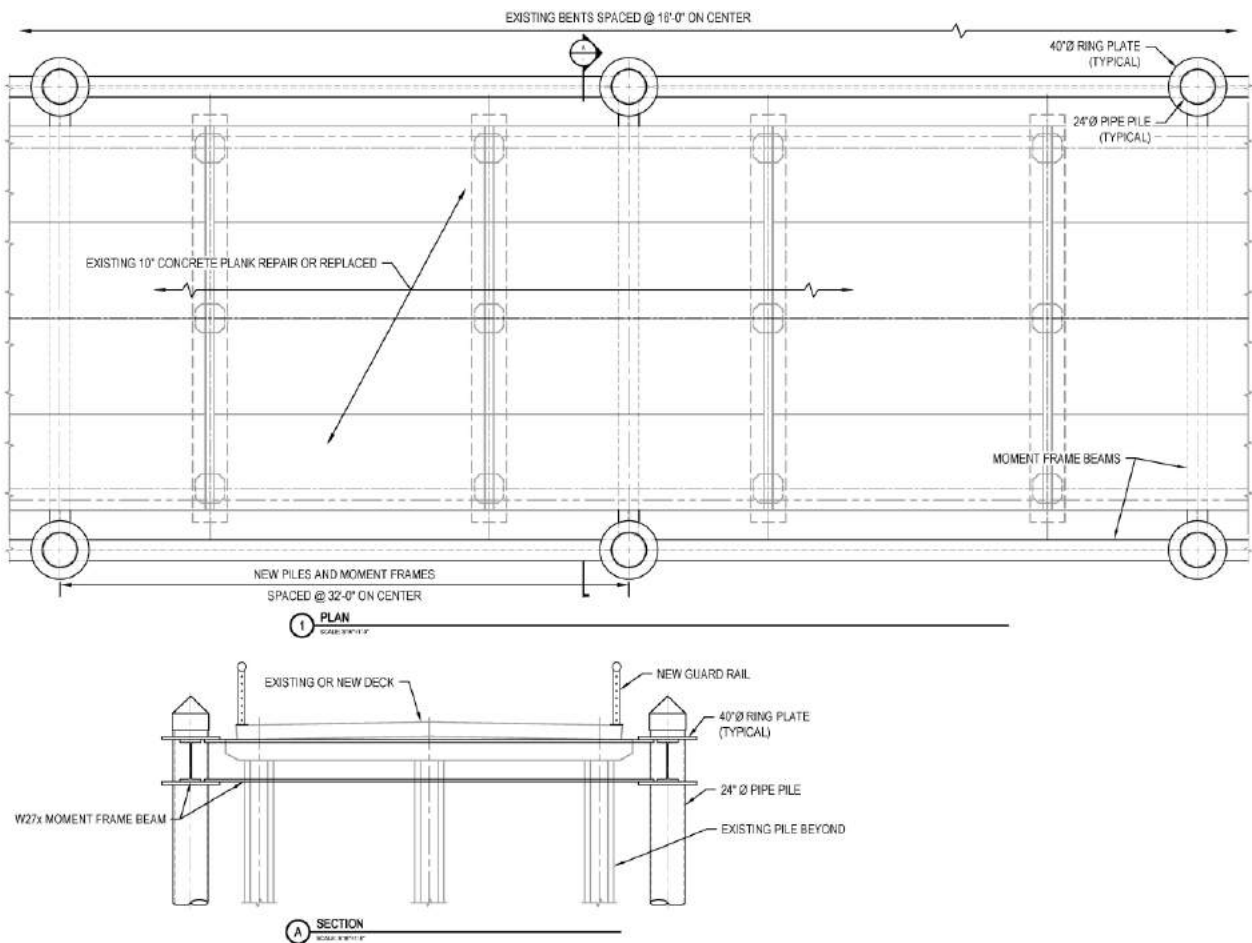
Figure 6-6: Pier Rehabilitation/Retrofit Alternative P4 – Concrete Repairs /Seismic Retrofit (add piles and moment frames)

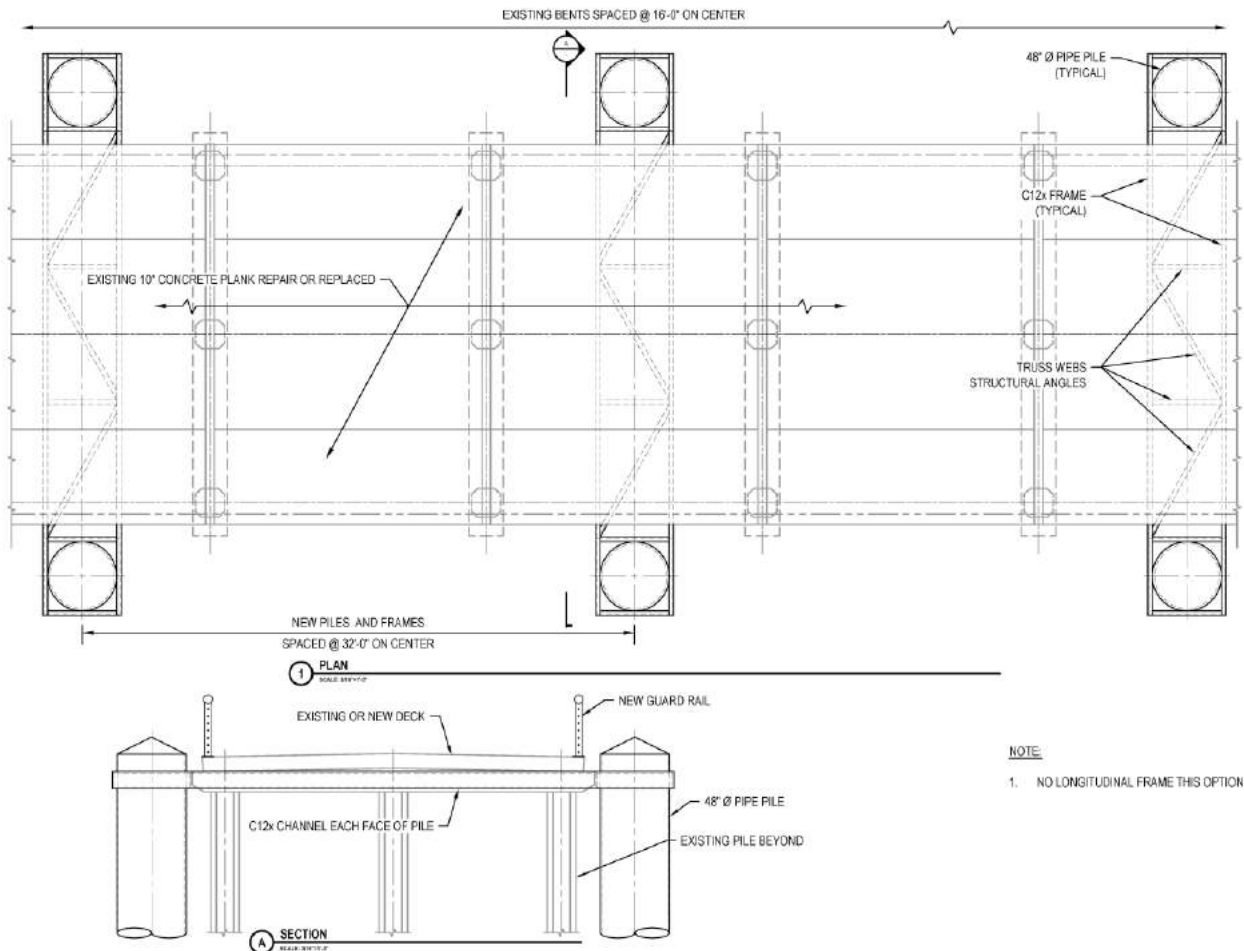
Figure 6-7: Pier Rehabilitation/Retrofit Alternative P5 – Concrete Repairs /Seismic Retrofit (add piles and pile bent frames)

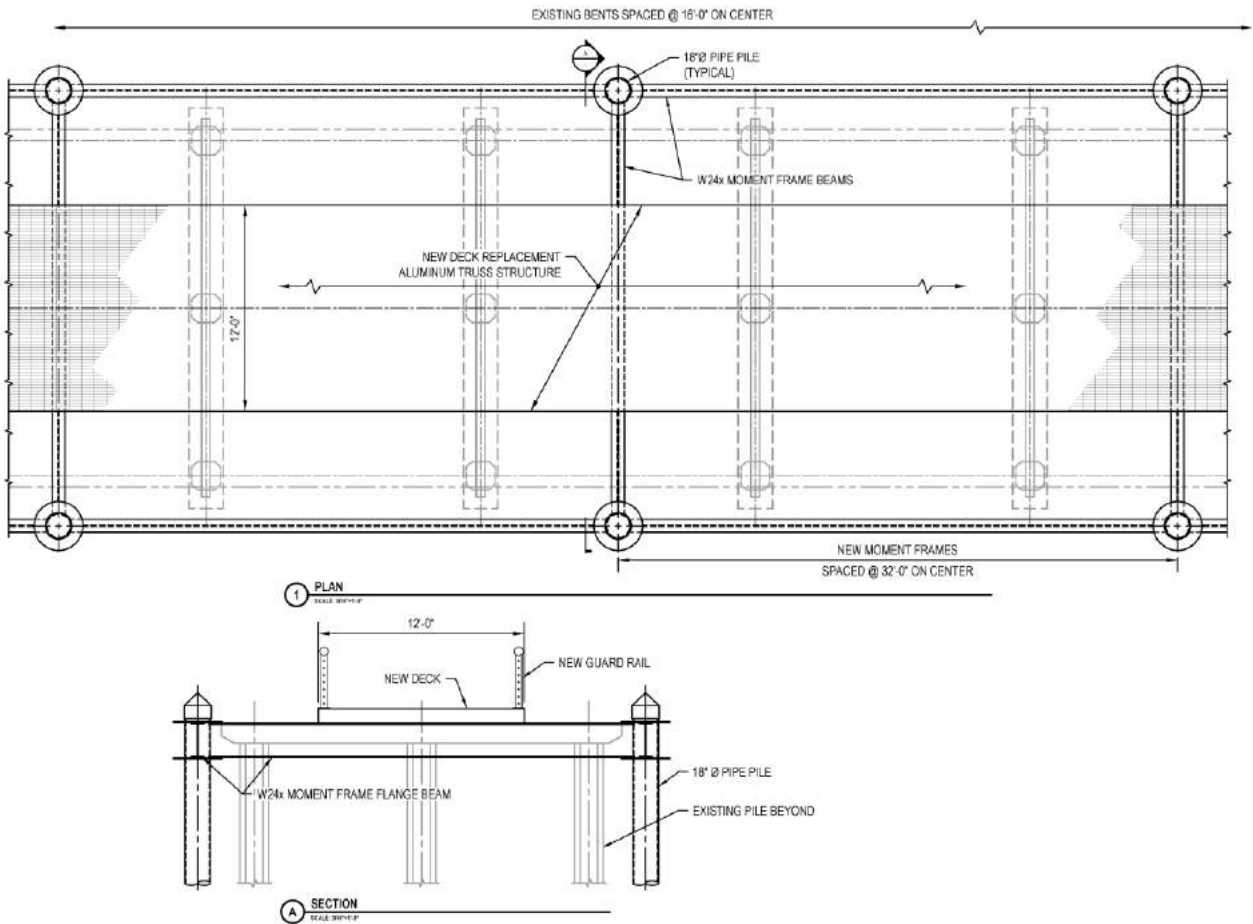
Figure 6-8: Pier Rehabilitation/Retrofit Alternative P6 – Concrete Repairs /Seismic Retrofit (add piles, moment frames and lightweight deck system)
