City of Berkeley
Berkeley Municipal Pier
DRAFT Structural Assessment Report

November 2017

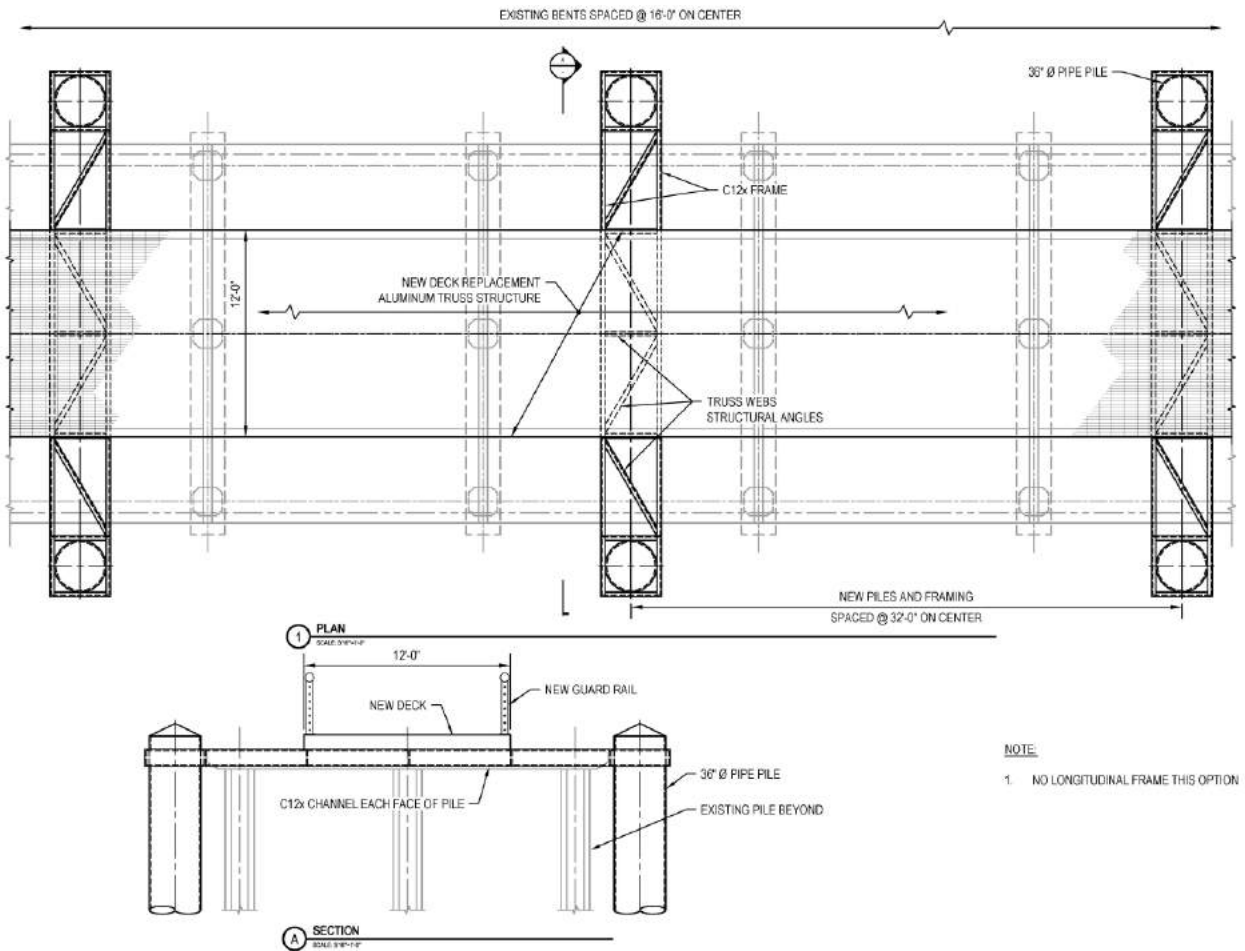
Figure 6-9: Pier Rehabilitation/Retrofit Alternative P7 – Concrete Repairs /Seismic Retrofit (add piles, pile bent trusses and lightweight deck system)

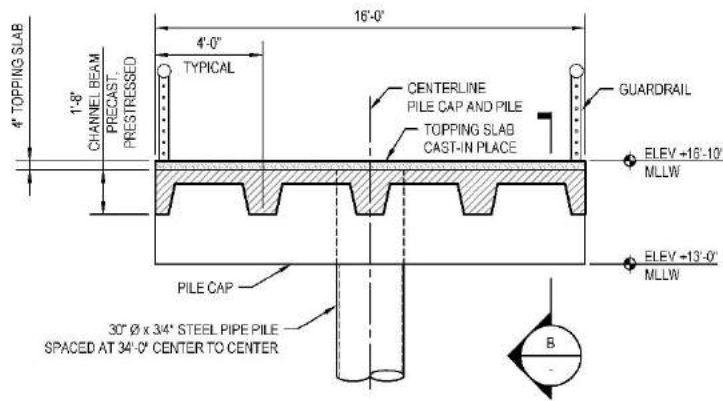
A SECTION - TRANSVERSE
SCALE: 1/4"=1'-0"

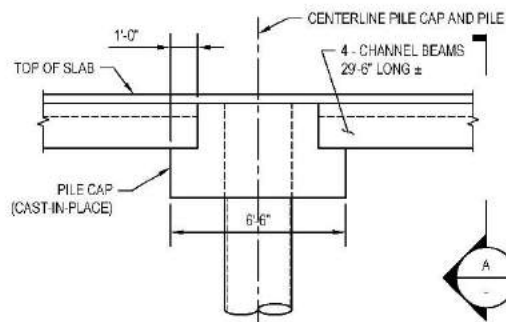
B SECTION - LONGITUDINAL
SCALE: 1/4"=1'-0"

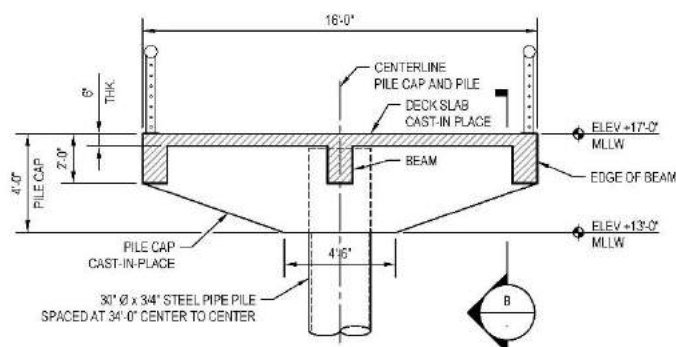
A SECTION - TRANSVERSE
SCALE: 1/4"=1'-0"

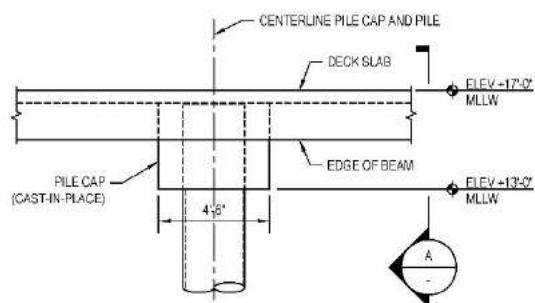
B SECTION - LONGITUDINAL
SCALE: 1/4"=1'-0"

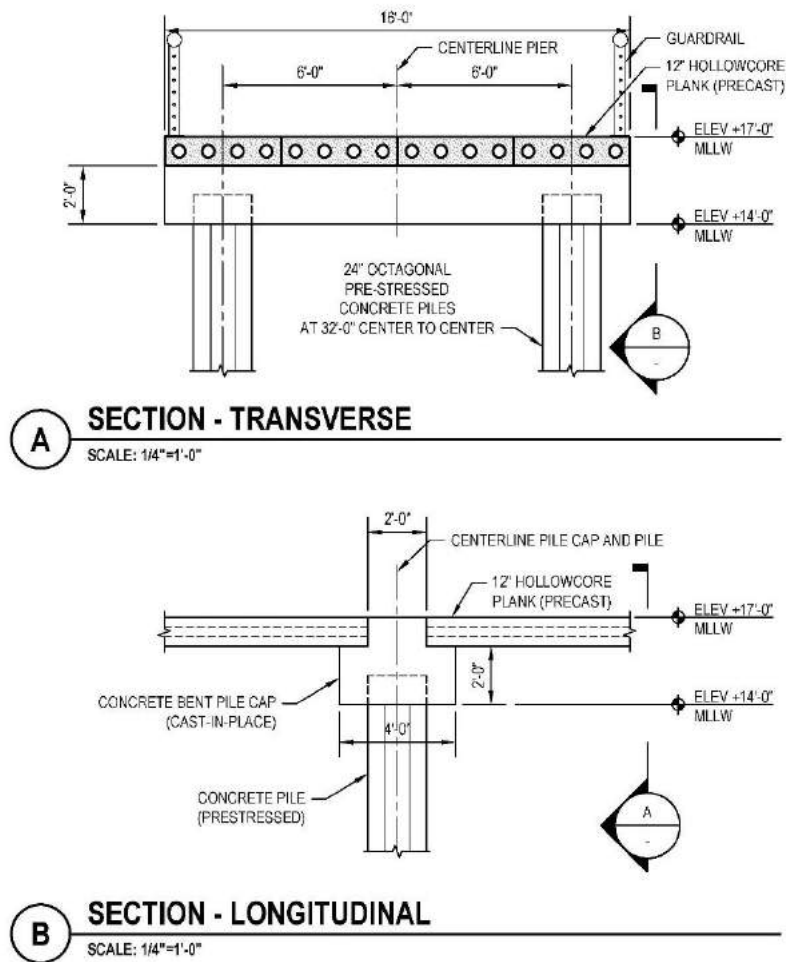
Figure 6-12: Pier Replacement Alternative P10 – Precast Concrete Construction

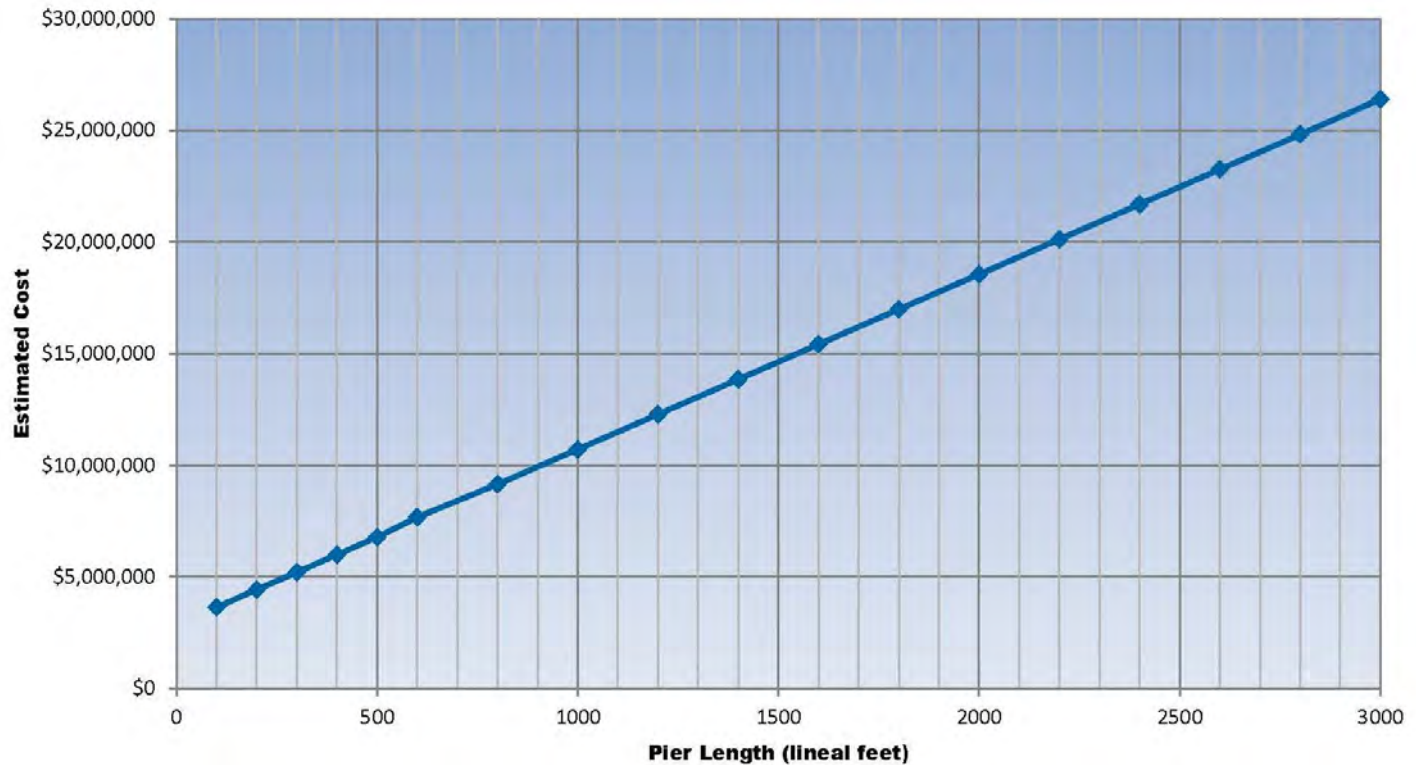
Figure 8-1: Replacement Pier Length versus Estimated Cost

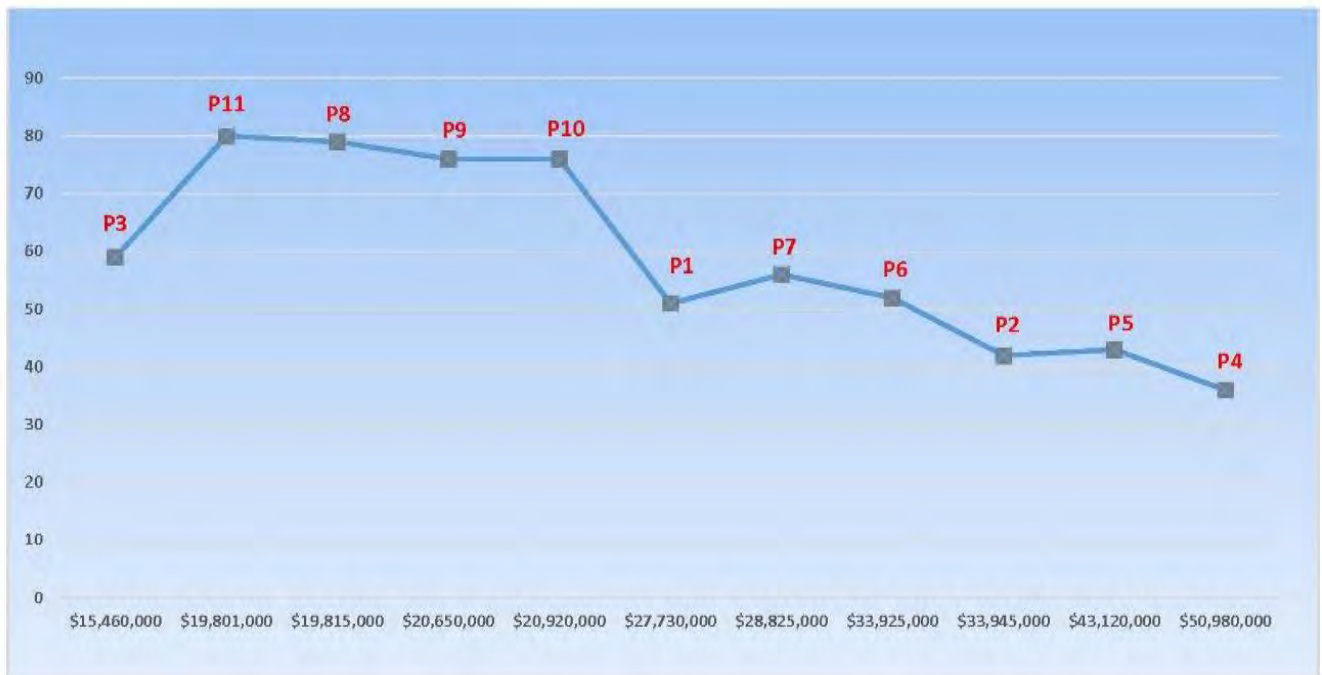
Figure 9-1: Alternative Rankings Graphic

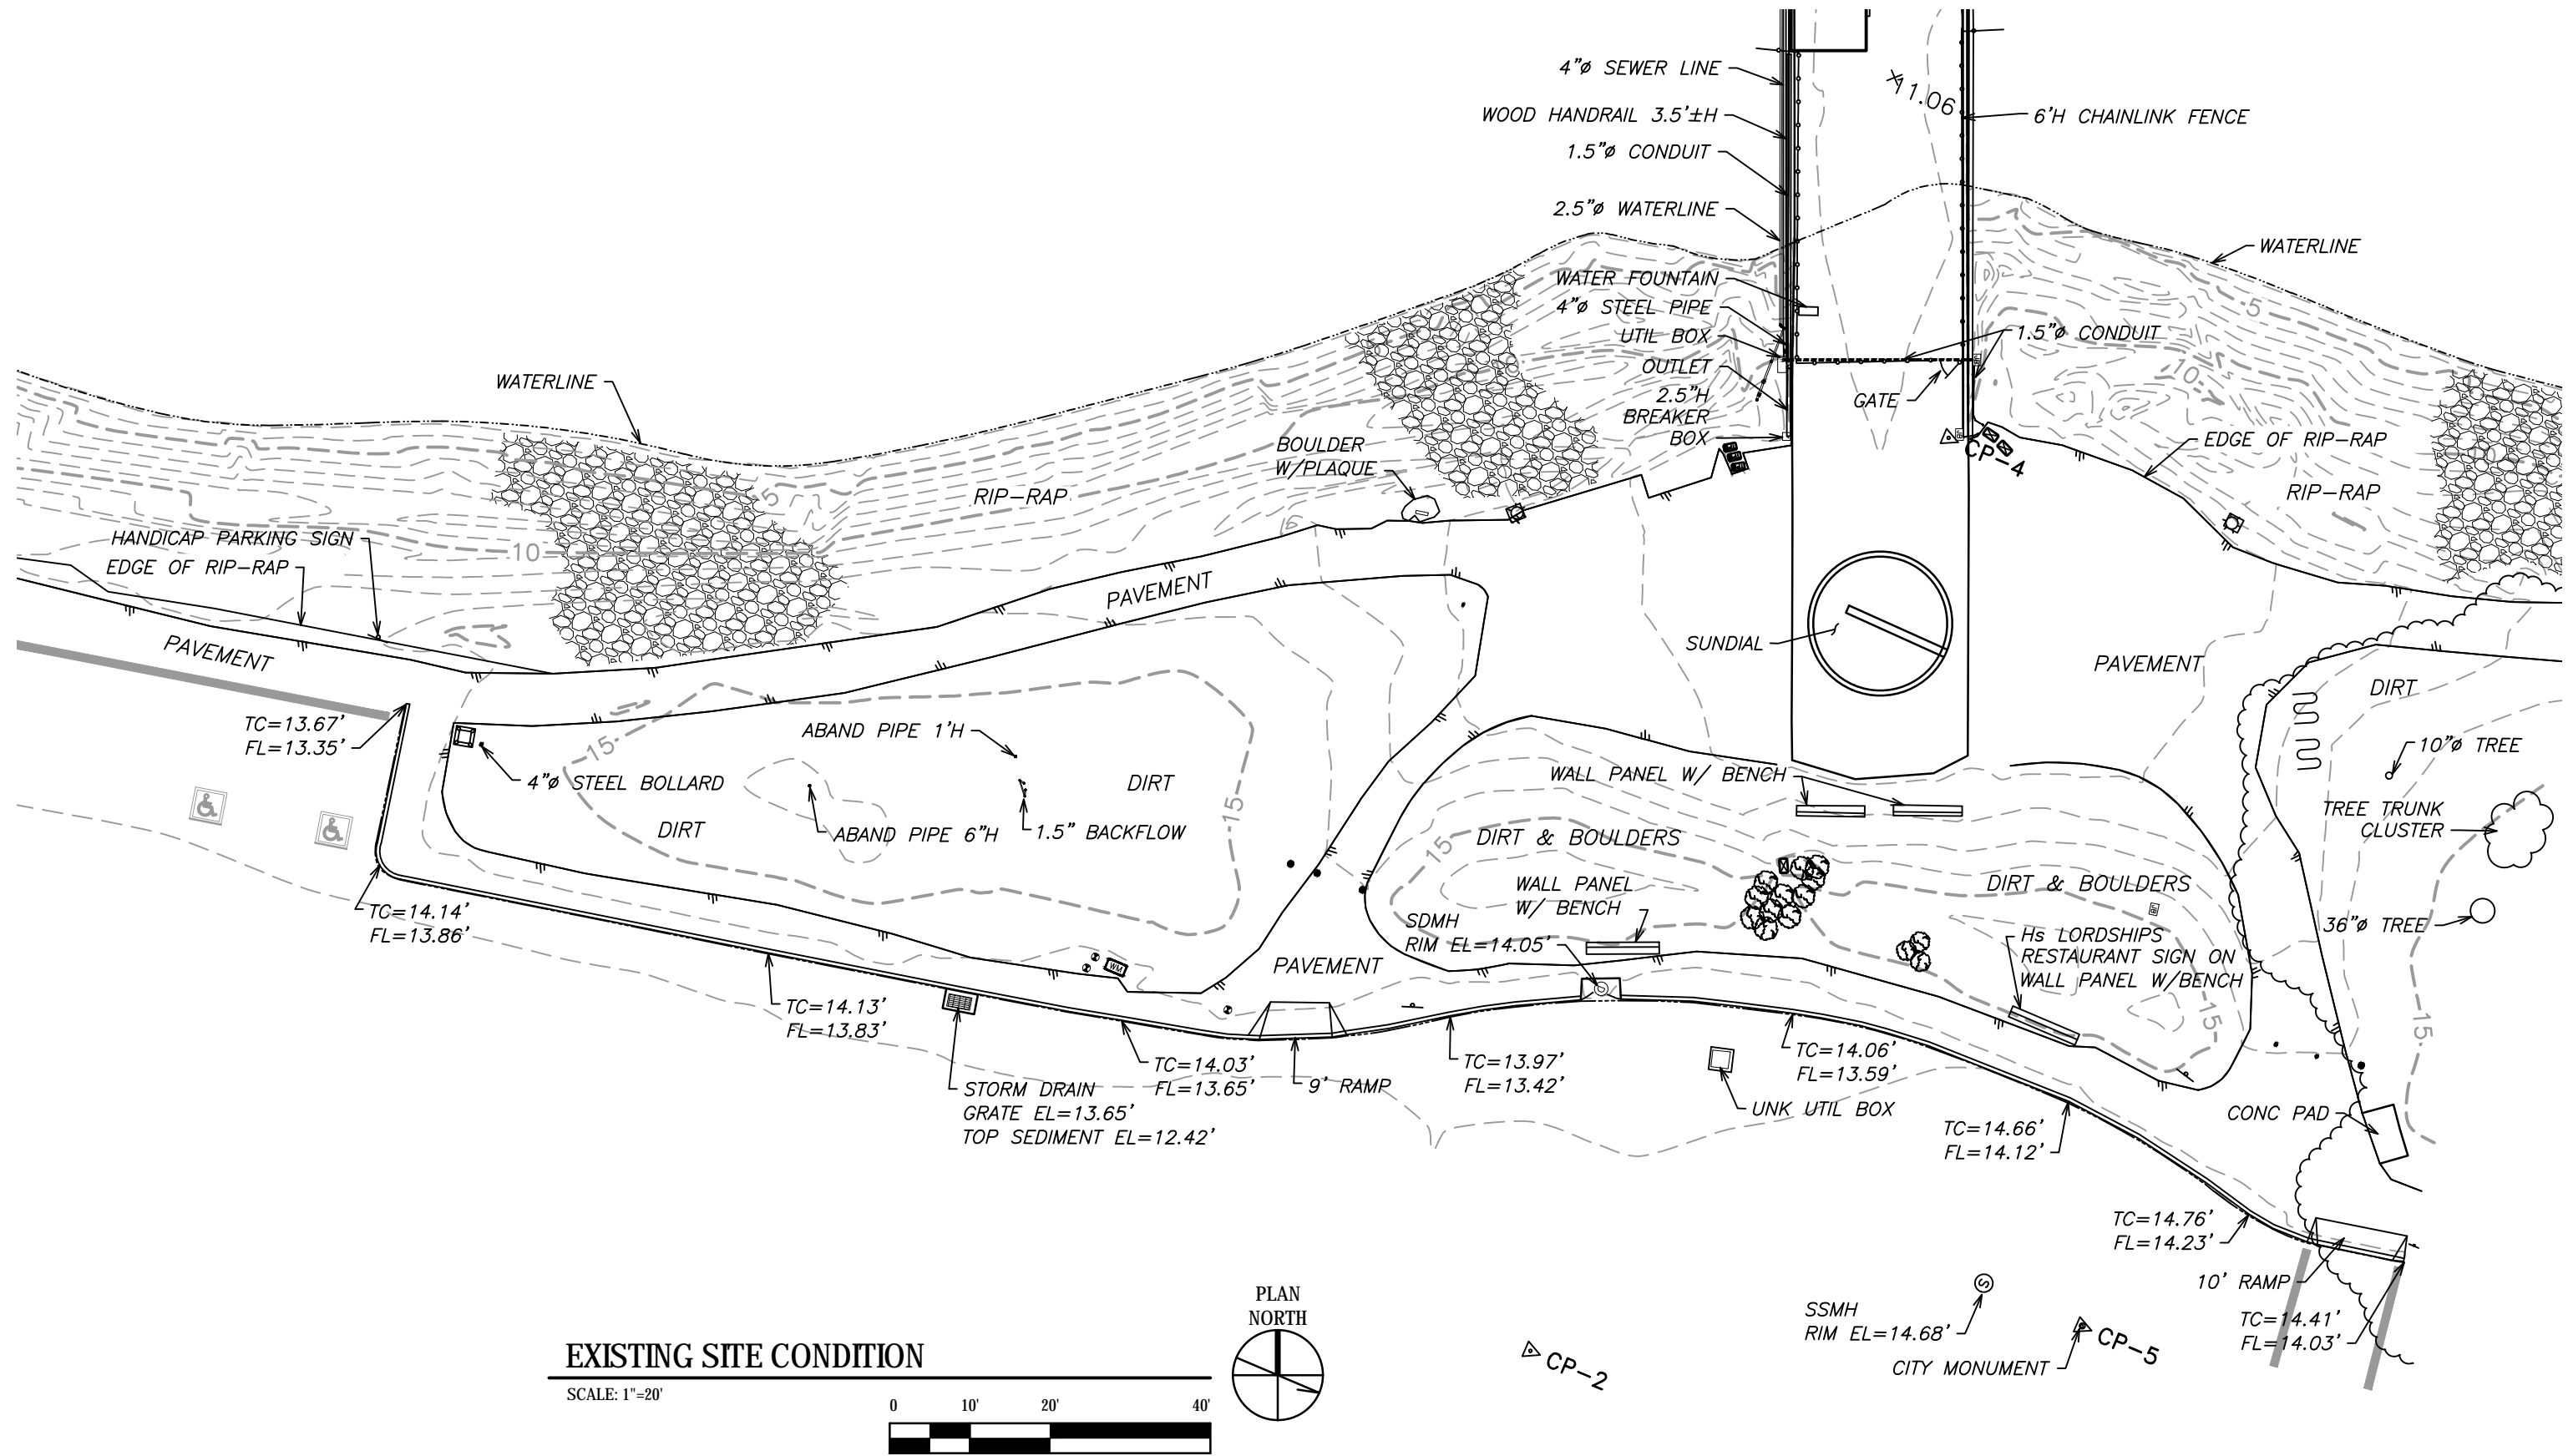
EXISTING SITE CONDITION

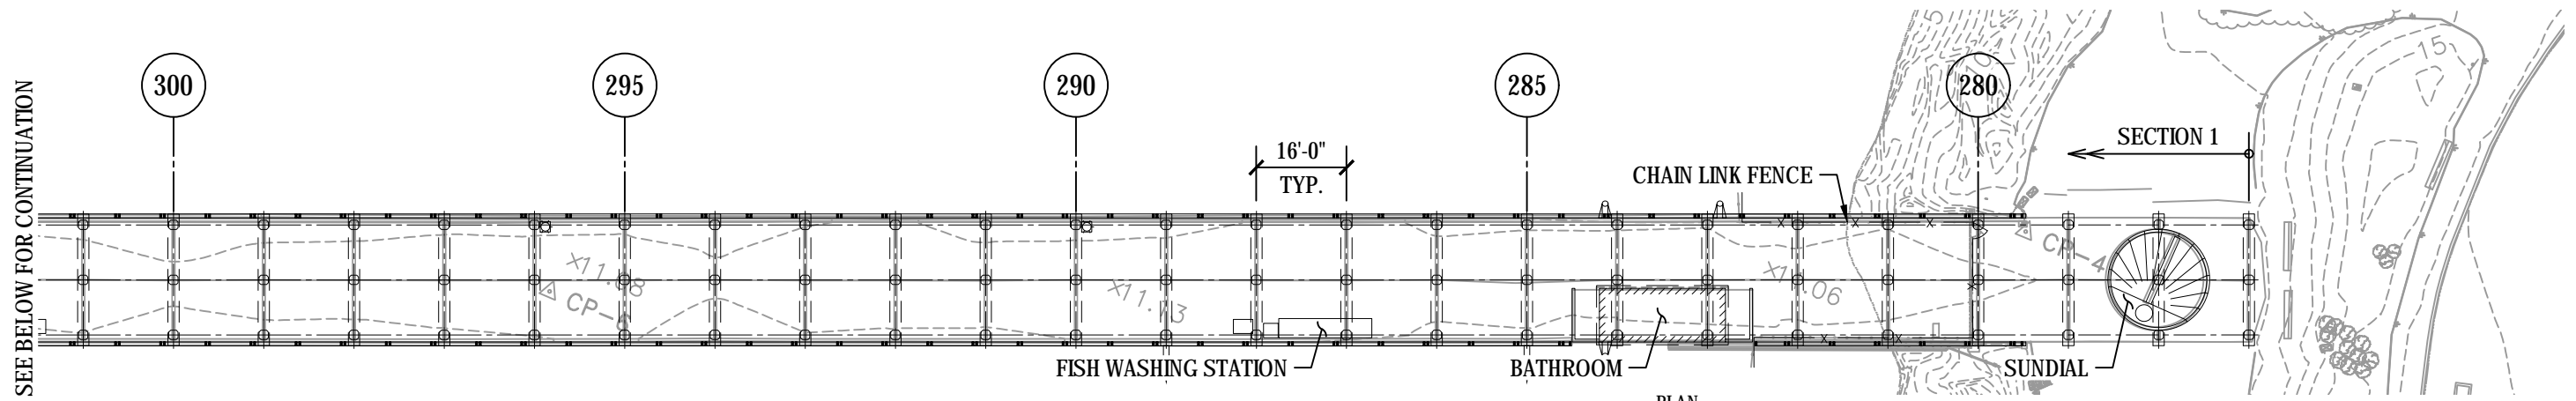
1 PARTIAL DECK PLAN
SCALE: 1"=30'

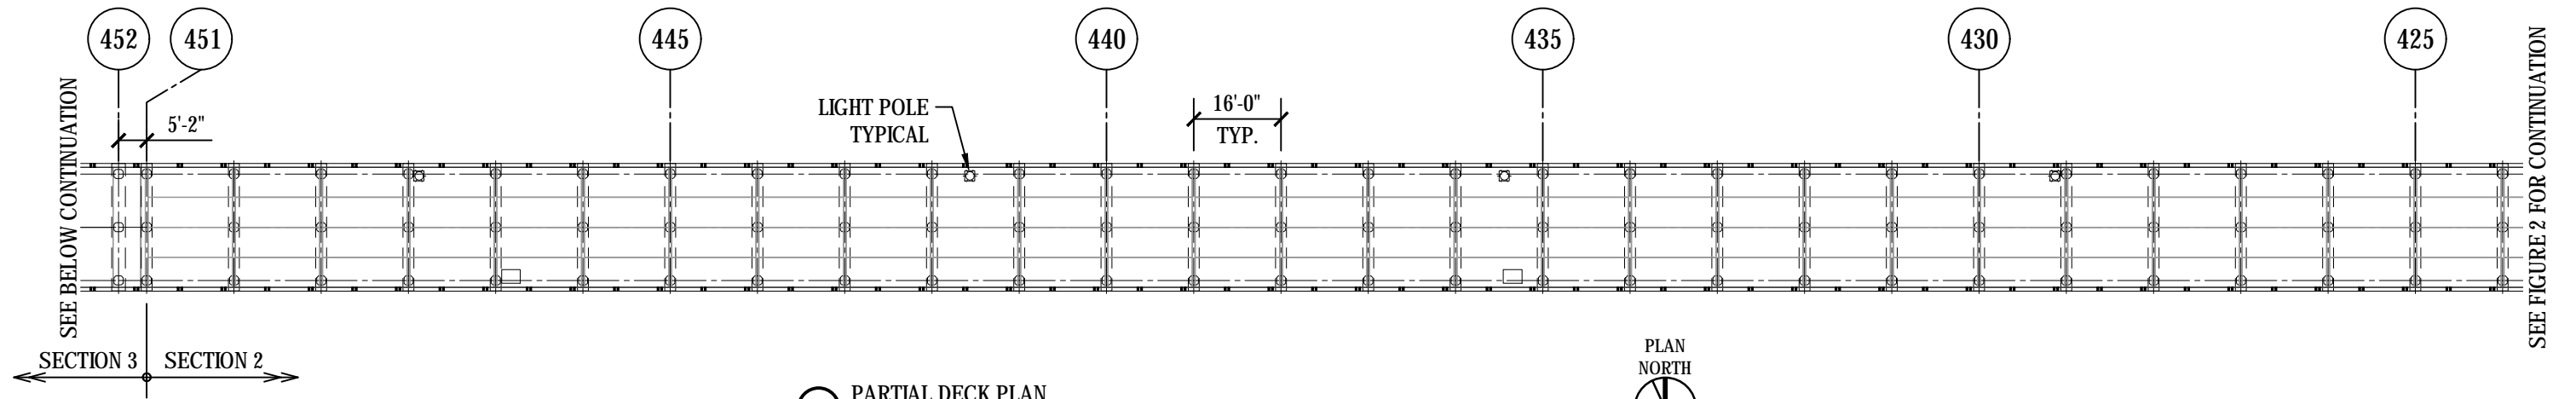
6 PARTIAL DECK PLAN
SCALE: 1"=30'

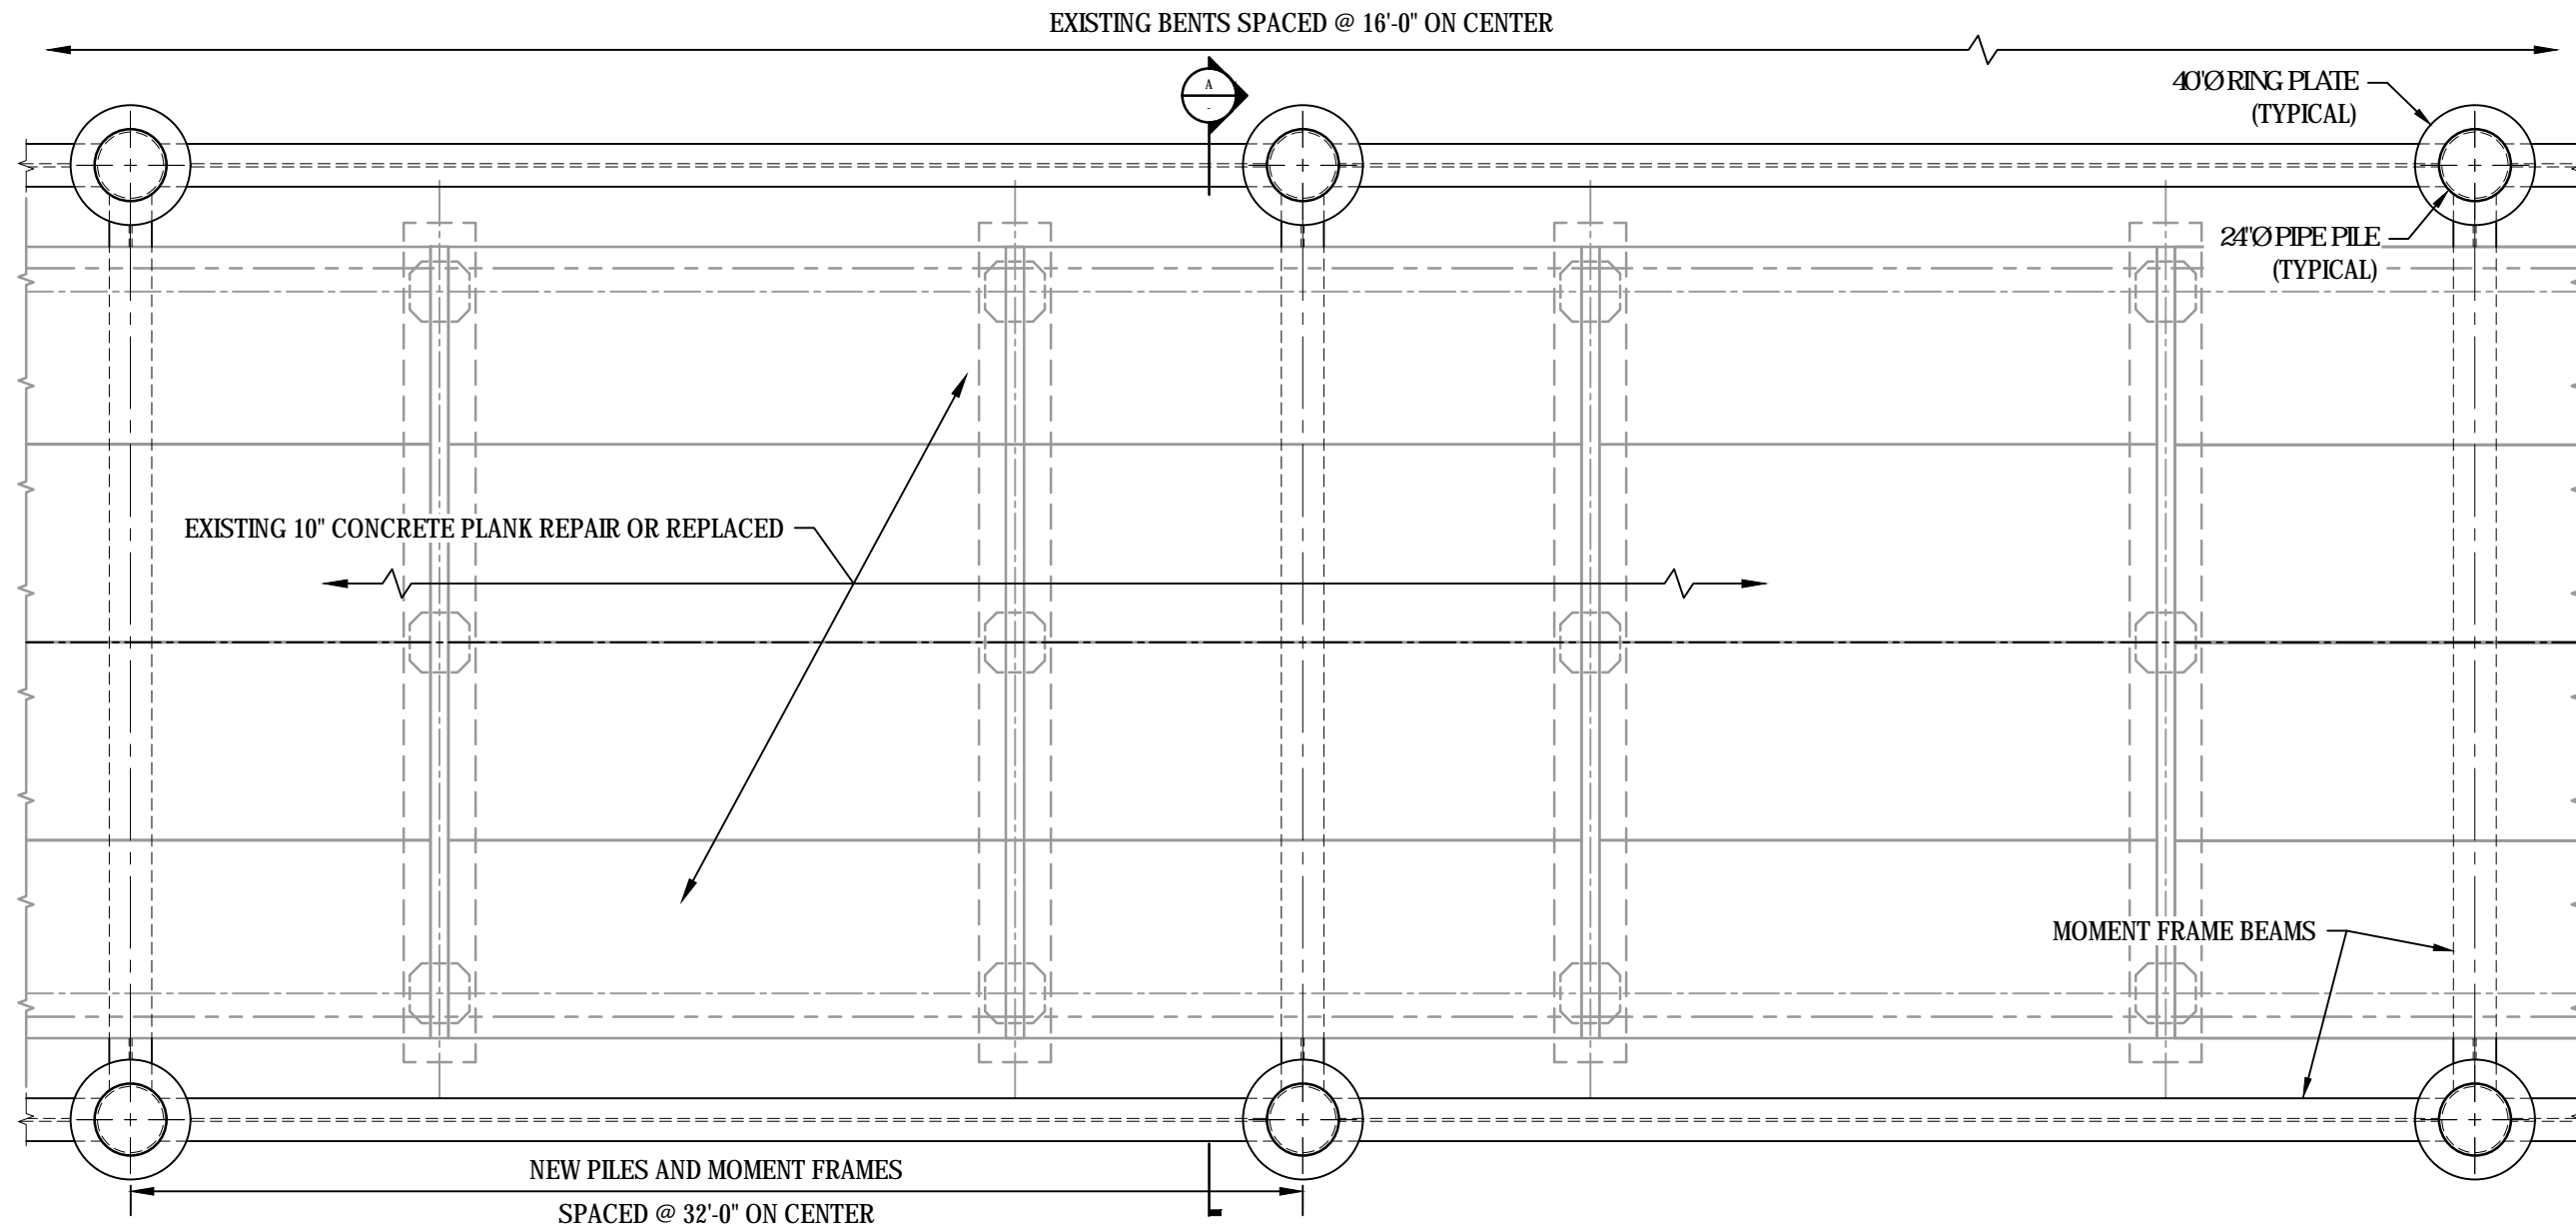
1 PLAN
SCALE: 3/16"=1'-0"

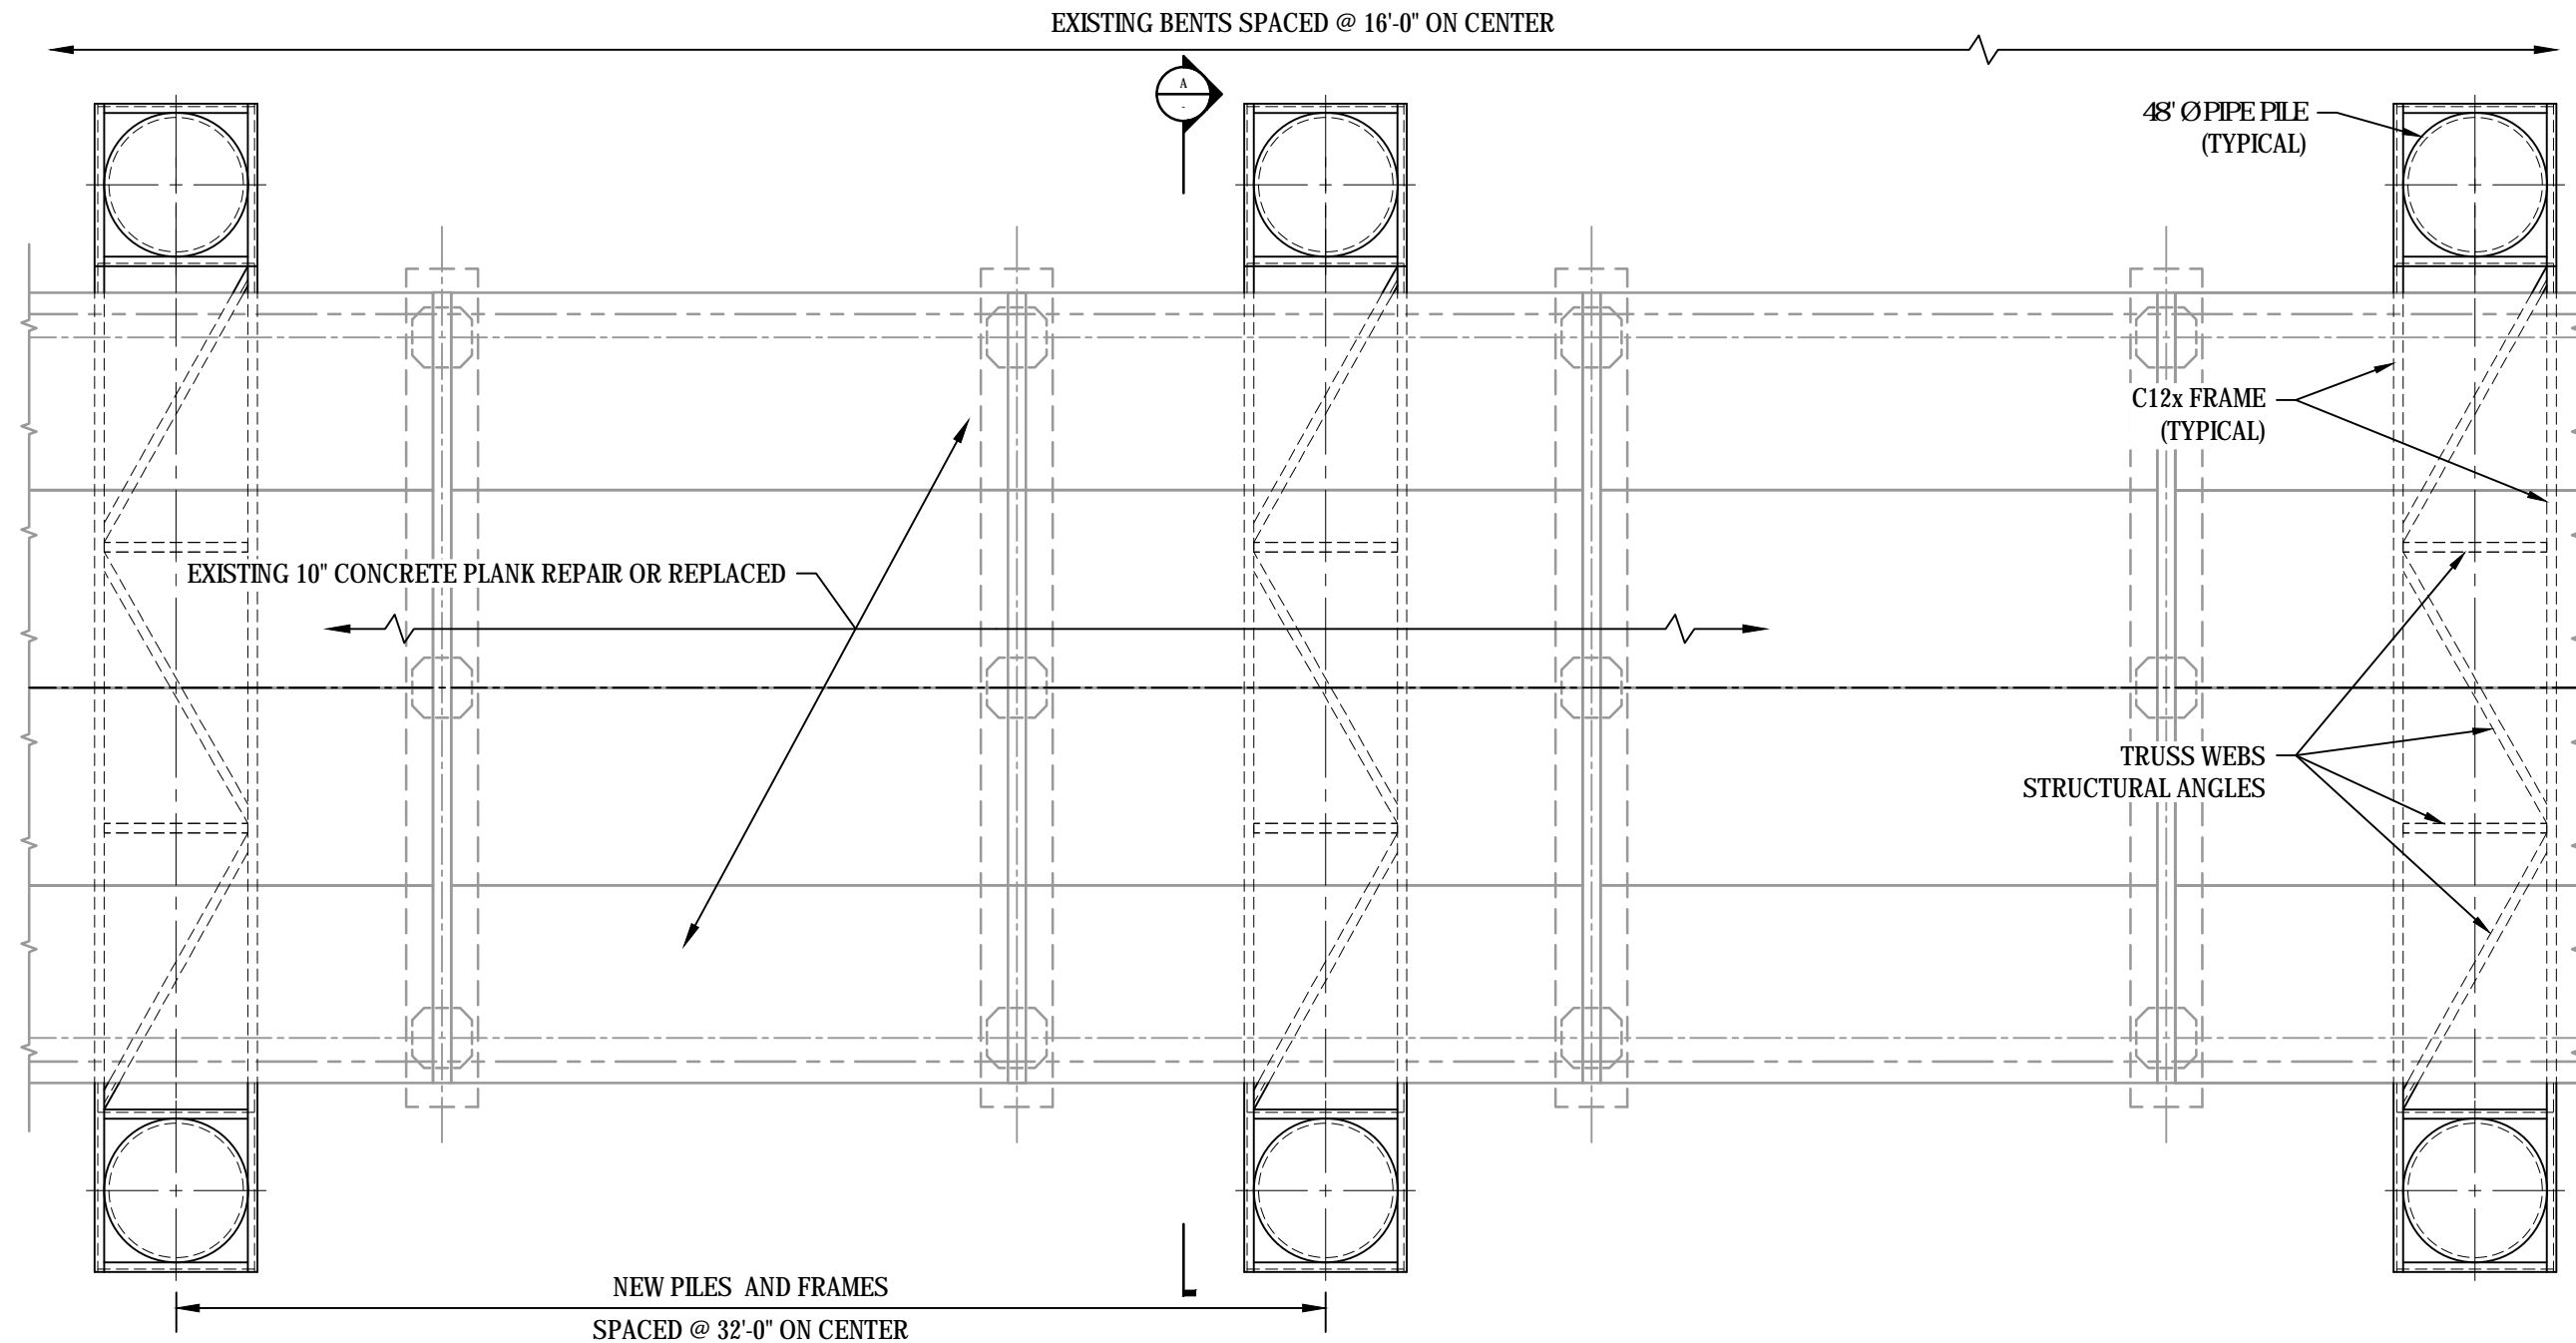
1 PLAN
SCALE: 3/16"=1'-0"

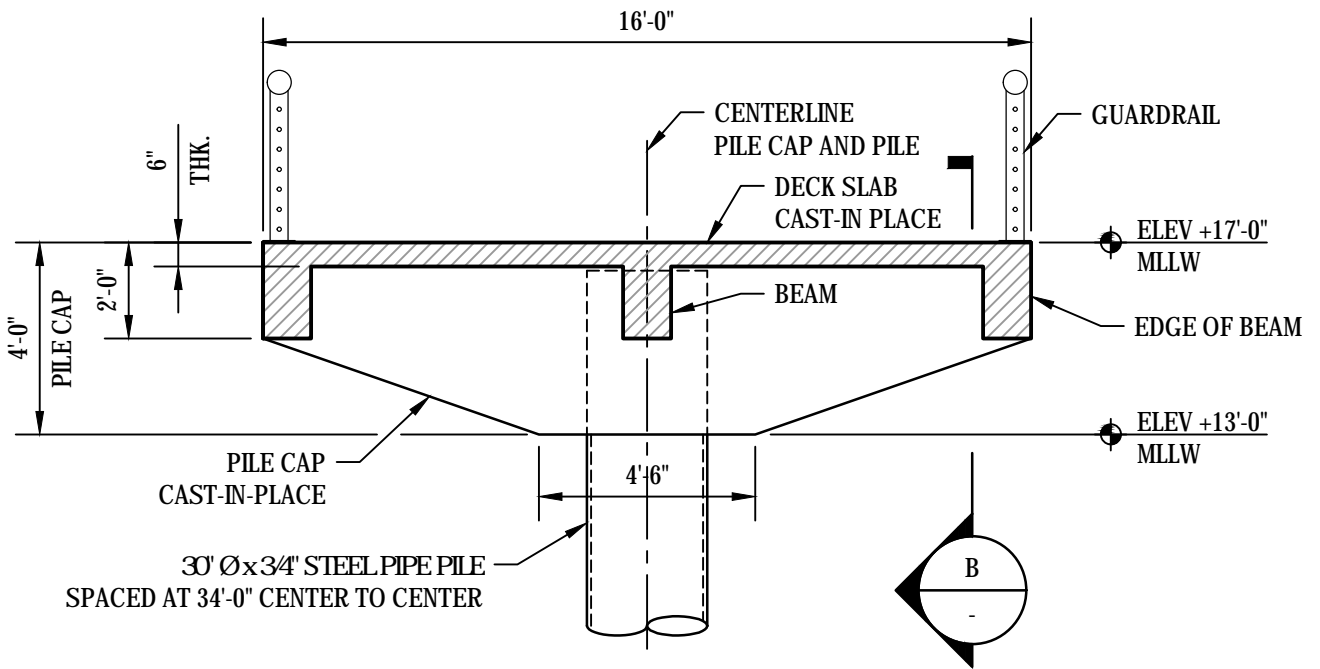
A SECTION - TRANSVERSE
SCALE: 1/4"=1'-0"

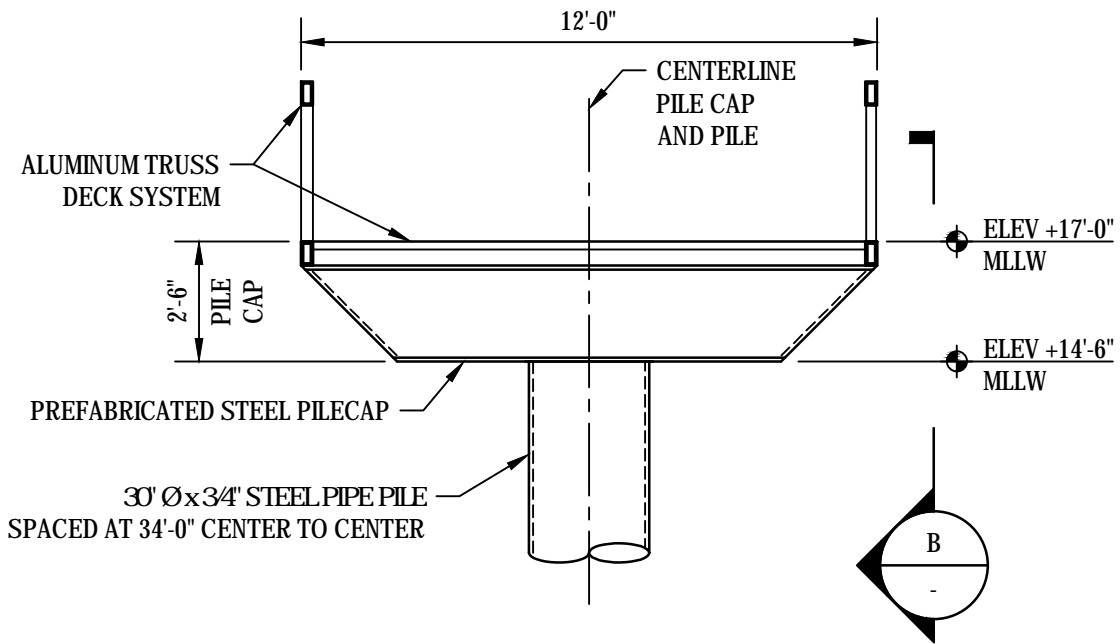
A SECTION - TRANSVERSE
SCALE: 1/4"=1'-0"

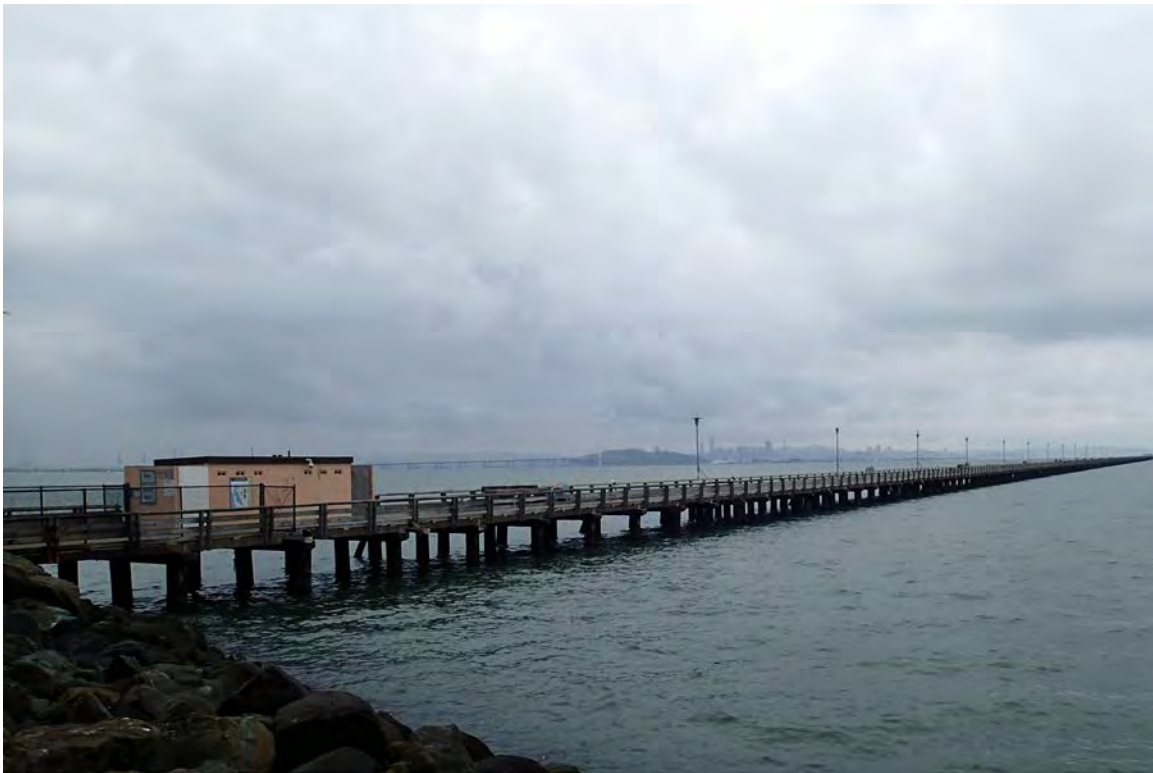
City of Berkeley, California Berkeley Municipal Pier Underwater Inspection Report

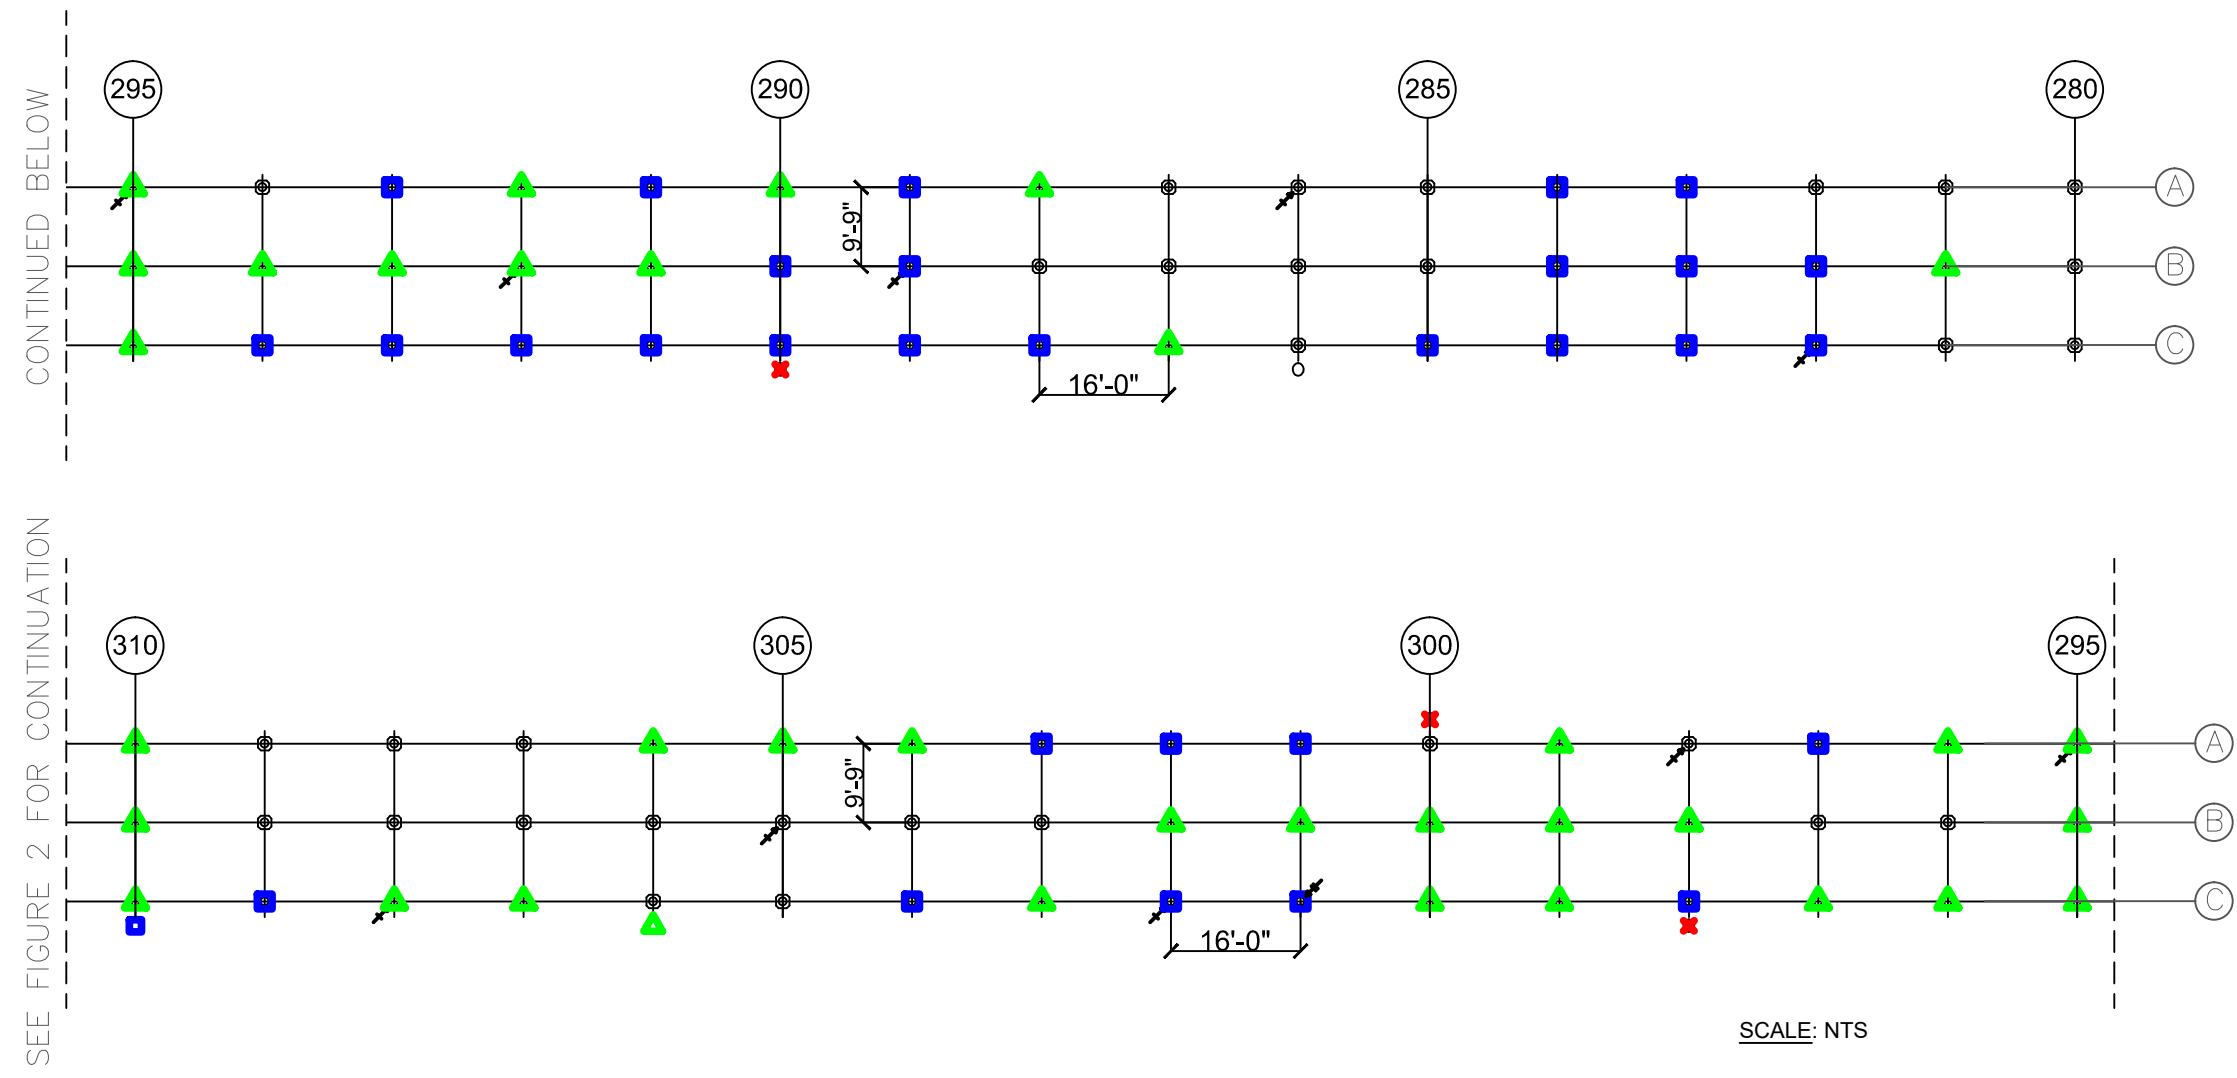
- LEGEND**
- PILE RATED MINOR OR NO DEFECT
 - △ PILE RATED MODERATE
 - PILE RATED MAJOR
 - ✗ PILE RATED SEVERE
 - ↗ LEVEL II INSPECTION LOCATION
 - ↘ LEVEL III INSPECTION LOCATION

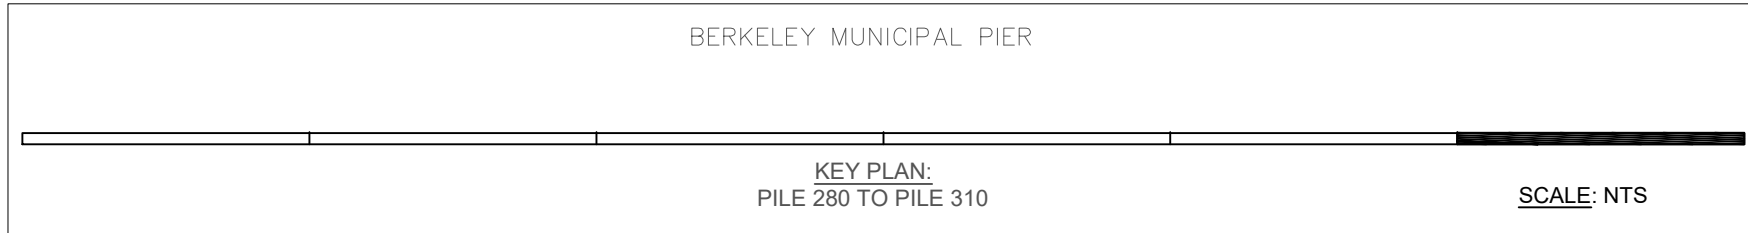
Sea Engineering, Inc.
 Santa Cruz, CA 95060
 PHONE 831.421.0871
 FAX 831.421.0875

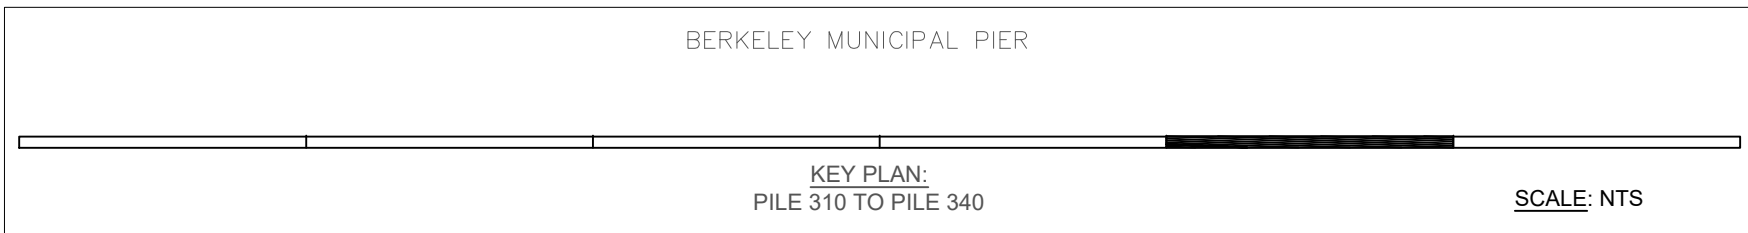
Sea Engineering, Inc.
 Santa Cruz, CA 95060
 PHONE 831.421.0871
 FAX 831.421.0875
