Park Description, Character-Defining Features & Conditions Matrix

Inventory of Features at Berkeley Civic Center Park

Berkeley Veterans Memorial Building

HISTORIC STRUCTURE REPORT | MARCH 2020

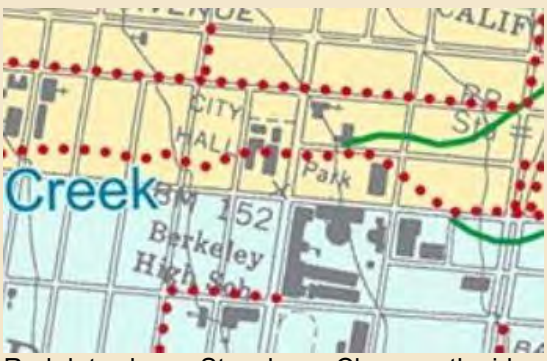
<i>Feature Key No.</i>	<i>Feature Name</i>	<i>Feature Description</i>
1 Natural Systems and Features		
1	Strawberry Creek running under Park	Culverted portion of Strawberry Creek runs along and under the north edge of the park
2 Topography		
2	Gentle Slope across the site from east to west	Slope runs generally east to west with the lowest portion of the park being in the southwest approximately 16-feet below the highest portion of the park at the northeast corner, approximately 550 feet away.

<p>Red dots shown Strawberry Ck on north side of "Park"</p>	
n/a	Good	Yes

- Review the condition of the Strawberry Creek culvert adjacent to the park
- Repair culvert as required to ensure continued stability
- Ensure proposed work for the park does not negatively impact the culverted creek
- Currently the park has good solar access on the south and west. Protect the park from overshadowing on these sides by buildings.

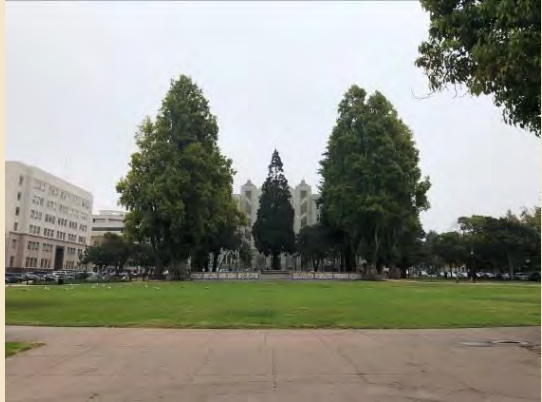
5	Four Primary Spaces within the Park	Laid out along the east-west centerline are the four primary spaces including the Giant Sequoia Terrace (foreground), Fountain Terrace, Circular Lawn, and the north-south oriented Western Esplanade.

<i>Date of Construction (Known or Estimated)</i>	<i>Condition</i>	<i>Character-Defining Feature</i>	<i>Representative Image(s)</i>
vest	1942	Fair to Good	Yes

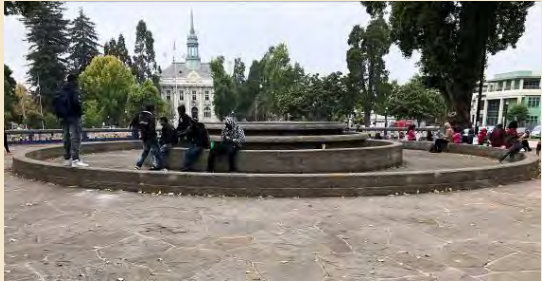
<i>Feature Key No.</i>	<i>Feature Name</i>	<i>Feature Description</i>
4 Constructed Water Features		
6	Central Fountain	<p>The cast-in-place concrete fountain measuring approximately 50-feet in diameter consists of an outer basin with board-form finished wall up to seat-wall height, this contains a broad reflecting pond as the base level of the fountain. Within the reflecting pond are three terrace levels, with the lower of the three being a visible horizontal board-form wall to approximately 10 feet high having a diameter of 25-feet. Both the two outer board-formed walls have broad flat tops. The two upper tiers have curved lips for water to cascade over. The floor of each tier is monolithic concrete. The top tier is sealed with plywood. The fountain does not currently function.</p>
7	Hatch lid to mechanical vault for Central Fountain	<p>Wood hatch lid to underground concrete vault once and possibly still containing fountain equipment. It is located to the northeast of the fountain terrace immediately outside the terrace perimeter wall.</p>

Date of Construction (Known or Estimated)	Condition	Character-Defining Feature	Representative Image(s)
of ed y 2- at s	1942	Concrete basins – Good Mechanical system – unknown assumed poor	Yes

The fountain is the dominant feature of the Fountain Terrace but has not functioned for decades. It is likely that there is a relationship between the size and number of poplar trees in the immediate vicinity and the fountain not functioning. Both the trees and the fountain are character-defining features but unfortunately the success of one may be related to the failure of the other.

The following alternatives for the fountain terrace composition address the relationship between the fountain and poplar trees and are consistent with the Secretary's standards: A) If the fountain basin is retained but it no longer has water in it, the poplars are recommended for retention; when it comes time to replant, consider using identical species. B) If the fountain is restored to its original working order with a play of water, the poplar roots are likely to continue to be a problem. When the poplar trees require replacing, consider a tree species with a similar a form and character to the poplars but which does not have water-seeking roots. Other design options may be considered for the fountain and Fountain Terrace and would require additional review and possibly mitigation.

- Retaining the essential form and function of the fountain with an inner fountain pool, two cascade pools and an outer reflecting pool, i.e. restoration, is recommended. In lieu of restoration, rehabilitation of the fountain is considered consistent with the Secretary of the Interior’s Standards for Rehabilitation. Alterations to the fountain that are additive to the original design and that do not destroy contributing features of the fountain are preferred. In this case, should the removal of alterations occurs in the future, the fountain’s integrity would not be damaged. Where rehabilitation is the selected treatment, a design that reflects the original in water level, movement, sound and reflective qualities is preferred. Introduction of new mechanical equipment may be done in a customized fashion so that the equipment fits the existing conditions of the fountain (Judy et al 1999 p.30)

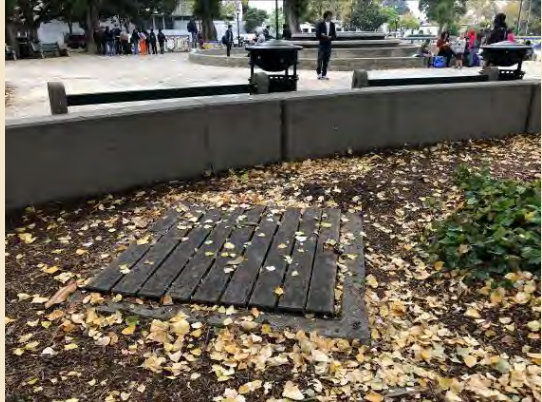
8	Side wall-fountains	<p>Remnants of two semi-circular bowl-shaped side fountains are located attached to the north and south perimeter wall defining the fountain terrace. Lying on the outward-facing side of the fountain terrace wall, the ground-level basin is paved with concrete at the north side with a bench mounted on top. On the south side there is a semicircular plywood panel covering the remains of the ground-level basin. The fountain terrace perimeter wall steps up marking the location of the site fountains. The fountains are believed to have never been put into operation. The walls of the two side wall-fountains were rebuilt when the Peace Wall was created starting in 1988 until the mid 1990s. The size and position of the walls is understood to be similar to originals.</p> <p>Historically, the two side wall-fountains each faced a roughly triangular lawn flanked by planting. These lawns were positioned to make the wall-fountains focal elements.</p>

ace	1942	Unknown	Yes

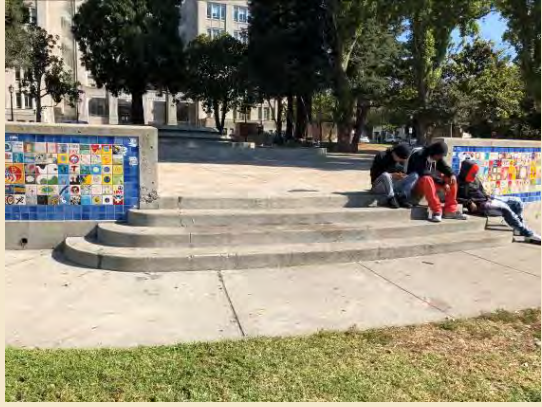
<i>Feature Key No.</i>	<i>Feature Name</i>	<i>Feature Description</i>
5 Circulation		
12	Stairs emanating from Fountain Terrace – west side	<p>Cast-in-place concrete stairs with radiused ends returning to the terrace perimeter wall on the west side of the terrace. Historically there was no opening in the wall in this location. Stairs were likely added when the Peace Wall was constructed.</p> <p>("Berkeley Voice" article dated October 24, 1984 shows a picture taken in 1978 without these stairs)</p>
13	Stairs emanating from Fountain Terrace – east side	<p>Cast-in-place concrete stairs on the east side of the terrace have a large-radius curve. According to the 1999 Report of the Summary of Historical Significance, these stairs originally had flagstone treads, now removed. At the ends of the stairs they step back and up with squared ends as they meet a stout plinth. The stairs and stout plinth is original to the park design.</p> <p>Historically stairs were also north and south of these large-radius curved stairs; these were replaced with sloped walks in 2006.</p>

Date of Construction (Known or Estimated)	Condition	Character-Defining Feature	Representative Image(s)
the se	After 1978	Good	No

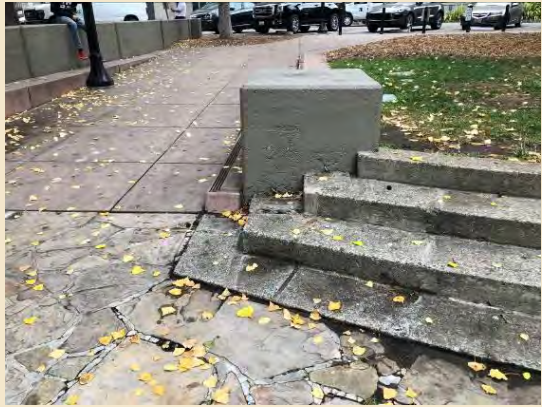
14	Concrete paving at Giant Sequoia Terrace	<p>Extending east from the Fountain Terrace concrete paving, installed in 2006, provides a pair of 15-foot wide paths, one on the north side the other on the south side of the giant sequoia planting bed. The two paths come together to the east of the giant sequoia with paving extending up to the asphalt-paved parking area. The slopes on these two side paths replaced stairs in order to offer an accessible route to the upper terrace around the giant sequoia.</p> <p>The concrete is pink in color; scoring is a square grid.</p>

ally	1942 / 2006	Good	Yes

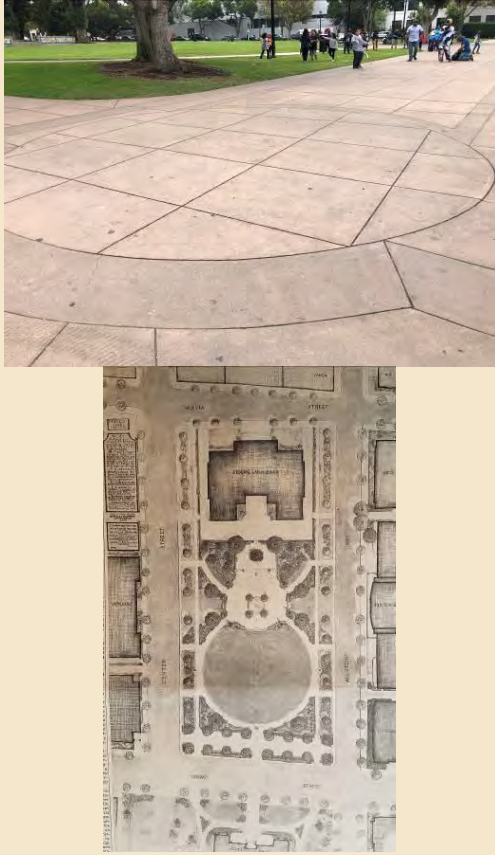
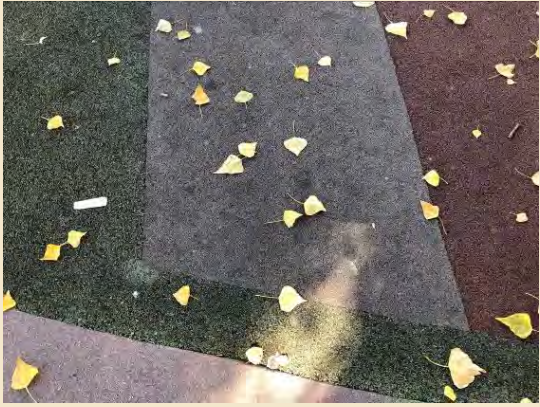
<i>Feature Key No.</i>	<i>Feature Name</i>	<i>Feature Description</i>
5 Circulation		
15	Esplanade at west end of Park	<p>A 25-foot wide esplanade made of pink-colored concrete, was installed in 2006, as part of the park improvements. Circular scoring patterns at the north and south ends, with a larger circle in the center of the esplanade respect the park's bilateral symmetry. The remainder of the scoring is a square grid.</p> <p>In 1940, this area was designed to provide an area of sheltered seating partially shaded and screened with high hedges (see representative images for 1940 concept plan). It remained that way until 1948 when the southern half was converted to a shuffle board court and in 1950 when the northern half of the esplanade was converted to a children's play area.</p>
16	Resilient Safety Surfacing in Playground	<p>A paving pattern of terracotta, grey and green surfaces of the play areas including the eastern area with a swing and the larger western play enclosure with climbing play elements. Both parts of the play area have had their resilient rubberized play surfacing patched with rubberized material that is black in color.</p>

Date of Construction (Known or Estimated)	Condition	Character-Defining Feature	Representative Image(s)
he le in ring d this	2006	Good	No

<p>The top image is a photograph of a large, paved plaza area with a grid pattern of light-colored concrete slabs. In the background, there are trees and people walking. The bottom image is an architectural site plan or map showing a similar grid layout with a central circular area and various labeled streets and buildings.</p>
ern	2006	Good	No

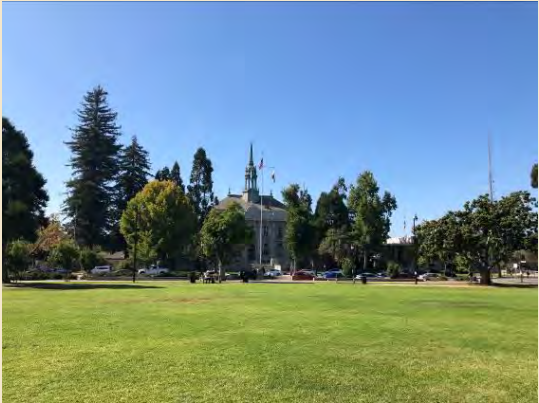
<i>Feature Key No.</i>	<i>Feature Name</i>	<i>Feature Description</i>
6 Vegetation		
18	Circular Lawn	<p>The large expanse of space at the western portion of the park measures approximately an acre and a third in area. Most of this is covered with lawn and being low it creates an opportunity for clear sight lines, a place for children to run and play, civic events, social gatherings, demonstrations and fairs.</p> <p>Historically it was used in this fashion for civic uses.</p>

Date of Construction (Known or Estimated)	Condition	Character-Defining Feature	Representative Image(s)
acre y for	1942	Good	Yes

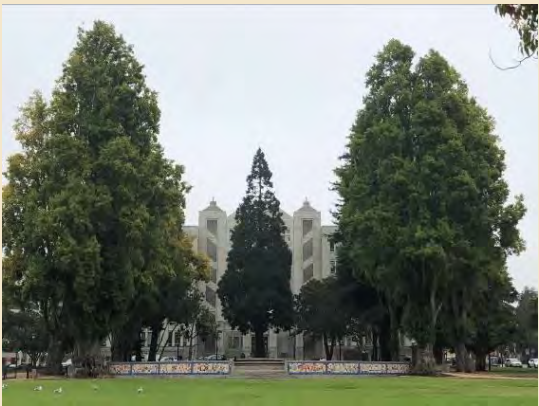
<i>Feature Key No.</i>	<i>Feature Name</i>	<i>Feature Description</i>
6 Vegetation		
19	Composition of Large Columnar Trees as Space Defining Elements at east end of Park	As a collection of trees placed in a manner to define a space, the Lombardy poplars (<i>Populus nigra</i> var. <i>Italica</i>) form two arcs of trees around the Fountain Terrace. A giant sequoia tree immediately to their east, lies on the center line between the arcs but not crowded so that its outline is evident. The composition is reinforced with an informal but substantial backdrop of tall coniferous trees including redwoods and Atlas cedars. Amongst the redwoods and poplars and reinforcing the density of the backdrop are evergreen American holly trees (<i>Ilex opaca</i>).
20	Giant Sequoia	The giant sequoia, as an individual tree with symmetrical pyramidal form and dark foliage color, performs the duty of an anchor of the centerline of the park. Some years it is decorated as a living Christmas tree for the City of Berkeley.. This is one of the species from the original plant list for the park.

<i>Date of Construction (Known or Estimated)</i>	<i>Condition</i>	<i>Character-Defining Feature</i>	<i>Representative Image(s)</i>
us s of ars,).	1942	Fair to Good	Yes

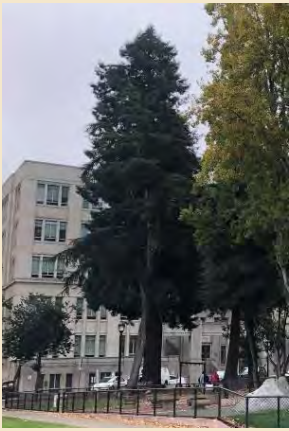
<i>Feature Key No.</i>	<i>Feature Name</i>	<i>Feature Description</i>
6 Vegetation		
22	Redwoods	Numerous redwoods (<i>Sequoia sempervirens</i>) contribute to the massive stand of tall, dark-foliaged conifers that provide the backdrop for the light-colored deciduous Lombardy poplar that ring the Fountain Terrace. They range in size from 5-inches DBH to 67-inch DBH. This is one of the species from the original plant list for the park.
23	Atlas Cedar	Two Atlas cedars (<i>Cedrus atlantica</i>) contribute their massive size to the evergreen backdrop behind the Lombardy poplars of which the redwoods comprise the bulk. They have 25-inch to 27-inch DBHs; one each anchors the northeast corner and the southeast corner of the evergreen mass. This is one of the species from the original plant list for the park.
24	American Holly	Five trees are located on each side of the centerline of the park in the mass of trees north and south of the terrace with the giant sequoia, for a total of ten trees. They measure four to six inches DBH. They are considered character-defining on account of their dark evergreen qualities and contribution to the mass of trees in this location.

<i>Date of Construction (Known or Estimated)</i>	<i>Condition</i>	<i>Character-Defining Feature</i>	<i>Representative Image(s)</i>
s	1942 and ongoing	Good	Yes

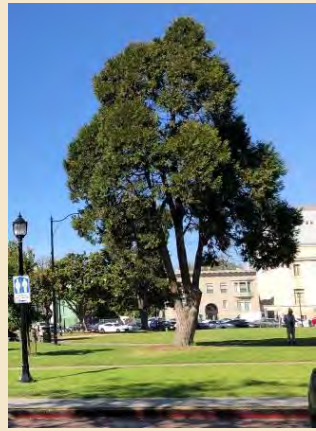
<i>Feature Key No.</i>	<i>Feature Name</i>	<i>Feature Description</i>
6 Vegetation		
25	Incense Cedar	Two incense cedar trees (<i>Calocedrus decurrens</i>) remain in the park at its west end. Both have experienced health or pruning setbacks. They measure 28" and 29" DBH. This is one of the species from the original plant list for the park.
26	Camphor Trees	Four camphor trees (<i>Cinnamomum camphora</i>) remain in the park located roughly at the four corners of the park. The smallest is 14-inches diameter at breast height (DBH), the largest 31-inches DBH. Most are failing, some have significant dieback. These were an original species to the park and were more numerous in the park in the past.
27	Southern Magnolia	Southern magnolias (<i>Magnolia grandiflora</i>) are both within the park and in front (east) of the 2180 Milvia Street building. Over the recent decades, they appear to have been used as a replacement planting for other species that have failed, including camphor trees.

Date of Construction (Known or Estimated)	Condition	Character-Defining Feature	Representative Image(s)
ave	1942	Fair	Yes

- Develop a vegetation management plan prior to removal of any trees. Include recommendations for tailored arboricultural treatment of the giant sequoia, for other historic and non-historic trees and stormwater management in the plan
- Protection of the giant sequoia is preferred. Obtain an independent arborist's recommendations to inform care and maintenance of this tree significant specimen tree. The arborist is to be a licensed arborist certified by the American Society of Consulting Arborists
- Retain the balance of the east end of the park being canopied; versus the generally open quality of the west end. Avoid adding new forested areas in open areas
- Provide for multiple new generations of trees within the park by staggering planting dates and/or providing for tree species with medium and long life expectancies

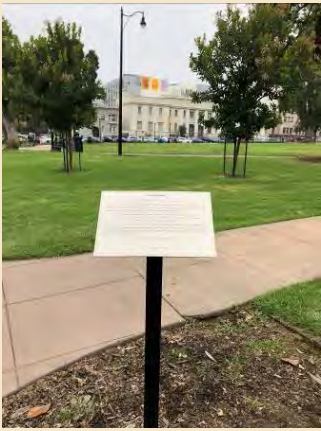
<i>Feature Key No.</i>	<i>Feature Name</i>	<i>Feature Description</i>
6 Vegetation		
28	Memorial Strawberry Trees	Two strawberry trees (<i>Arbutus unedo</i> 'Marina') are located at the southwest corner of the park along with a plaque identifying that the trees were planted in memory of the loss of life of young Americans and Irish visitors in a balcony collapse in 2015.
29	Hedge – Indian Hawthorn	Indian Hawthorn (<i>Rhaphiolepis indica</i>) forms an informal hedge along the frontage of Martin Luther King Jr. Way lies between the sidewalk and Western Esplanade. The southern half of the frontage is robustly covered in the shrub while the northern half has few or stunted shrubs and is largely covered with wood mulch. In the original 1940 design, tall hedges were located in this position to provide a screen for Grove Street Esplanade.
30	Hedge – Privot	An 8 to 10-foot high shrubbery of privot (<i>Ligustrum lucidum</i>) envelopes the porta-potty at the south-west corner of the park.

<i>Date of Construction (Known or Estimated)</i>	<i>Condition</i>	<i>Character-Defining Feature</i>	<i>Representative Image(s)</i>
ark	2018	Good	No

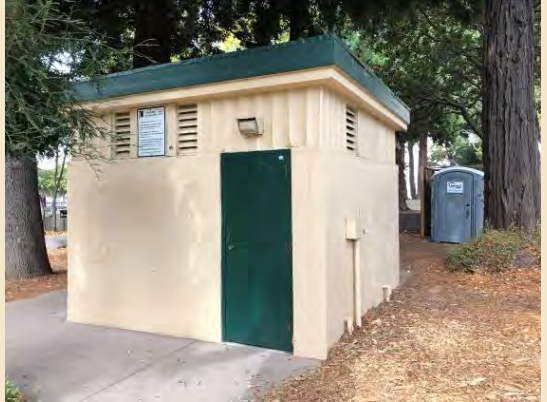
<i>Feature Key No.</i>	<i>Feature Name</i>	<i>Feature Description</i>
7 Buildings & Structures		
31	Concrete Utility Room, former Restroom	<p>Located in the south-east corner of the park in the grove of evergreen trees there is a concrete former-restroom building with a footprint of approximately 12-feet by 12-feet. The walls are horizontal board-form concrete with a two-foot high band below the eave-line of vertically scalloped concrete. Each side has inset louvers, the door faces south. The flat roof and doors are painted dark green while the rest of the structure is painted a buttery cream color. A 1941 photo of the park during construction shows this southern restroom structure with a six-foot high privacy baffle wall on the south side protecting the bathroom door.</p>
32	Wood Fencing	<p>Eight-foot high wood slat fencing screens and encloses the two porta potties in the park, one near the southwest corner of the park, the other at the southeast corner. The fencing is constructed of 1x4 fir slats with 1-inch gaps between the boards. The fencing is located on three sides of the plastic porta-potties.</p>

<i>Date of Construction (Known or Estimated)</i>	<i>Condition</i>	<i>Character-Defining Feature</i>	<i>Representative Image(s)</i>
ete or a	1941	Fair to Good	Yes

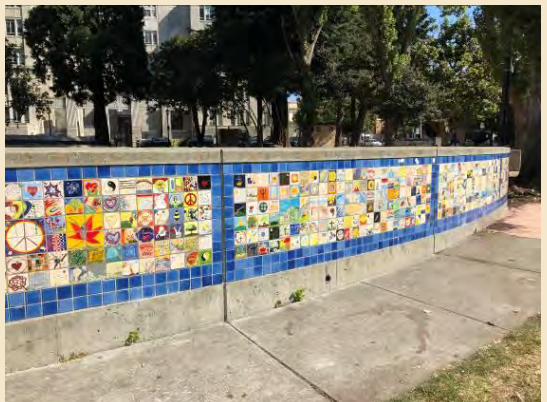
33	Peace Wall Sculpture	<p>Historically there was a perimeter wall surrounding the Fountain Terrace comprised of five sections. The first west of the fountain without a stair opening in the middle; the second on south side of the fountain and the third on the north side of the fountain; the fourth and fifth sections to the northeast and southeast of the fountain respectively. According to the Landmark Application, the north and south walls were rebuilt in 1988 and 1989 but are of approximately similar proportions as the original wall. The significant change in the rebuilding of the walls appears to have been creation of a new opening on the centerline of the park in the large wall facing west. The original wall exhibited a visible horizontal board form finish.</p> <p>The perimeter wall defines the edge of the terrace and has a mosaic of individually decorated tiles on both vertical faces on all wall segments surrounding the fountain except the fourth and fifth segments described above, i.e. the two eastern walls nearest the giant sequoia. Referred to as the Peace Wall Sculpture, the tile surfacing was designated in the Landmark Report as having importance in its own right, to the City.</p>

the ng n ed and rred s	1988 until the mid-1990s	Good	<p>Most of the present wall is not original but occupies the same location as the original wall.</p> <p>Presence of a wall around the Fountain Terrace is character-defining</p>

- The Peace Wall, including construction of a new wall which recalls the original perimeter wall of the fountain terrace, but replaces the original Deco board-form concrete surface, with individually decorated tiles painted by citizens and social groups. The new wall has an opening facing the lawn to the west unlike the original. In the landmark report, this feature has been identified as being important to the City of Berkeley

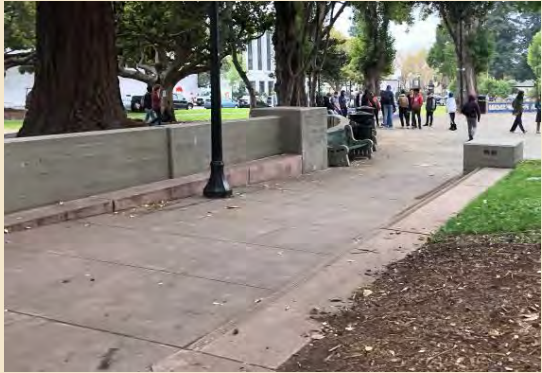
<i>Feature Key No.</i>	<i>Feature Name</i>	<i>Feature Description</i>
7 Buildings & Structures		
34	Concrete Walls North and south of the Giant Sequoia terrace	Two pairs of concrete piers define the thresholds of the two paths that lead east from the Fountain Terrace. These and the horizontal board-form wall are original to the park. The walls currently painted olive green were originally unpainted concrete.
35	Concrete Stairs at Entry to 2180 Milvia Street Building	Stairs, which appear to be original to the building located at 2180 Milvia Street, are concrete with white-painted nose markings. Handrails at the sides are galvanized pipe rail attached to the side walls; they appear to be a later addition. Two sets of handrails mid-stair have square hollow section posts and flat handrails and appear to be contemporaneous with the stairs.
36	Concrete Ramp at Entry to 2180 Milvia Street Building	On the north side of the stairs a concrete switchback ramp has been added, for a total ramp length of 120lf. Galvanized pipe rails are integrated to the guardrail except where there is a concrete sidewall, where the handrail is wall-mounted. The guard rail is galvanized steel with vertical pickets and a double horizontal rail at the top. This was part of the rehabilitation work completed by ELS Architecture in 2000.

Date of Construction (Known or Estimated)	Condition	Character-Defining Feature	Representative Image(s)
alls	1942	Good	Yes

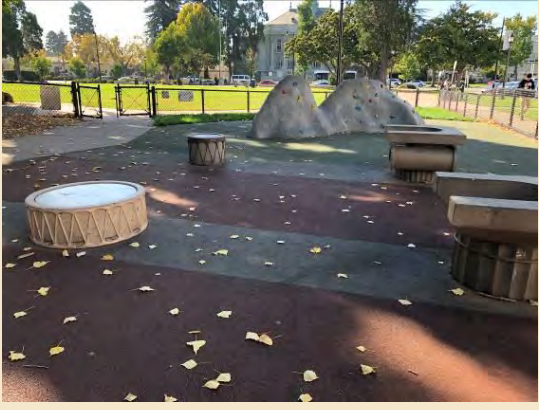
<i>Feature Key No.</i>	<i>Feature Name</i>	<i>Feature Description</i>
7 Buildings & Structures		
40	Western part of Children's Play Area	A children's play area for tots and young children is located between the Fountain Terrace Center Street. Surfacing under play elements is resilient safety surfacing. Play elements include a climbing boulder with handholds, three concrete 'drums', four concrete column capitols (ionic, doric, Corinthian and Tuscan) with carved out seats, and a grinding rock climber. Where not covered with safety surfacing, the surface of the ground is either grass where there are trees, mulch. A bench sits over the location of one of the side wall-fountain described above. A concrete path leads from the eastern-most to the western-most set of gates within the fenced area.
41	Eastern part of Children's Play Area	A swing set with two swings for young children is comprised of two tubular steel posts and cross member. Two sling swings are positioned in a generous area of resilient safety surfacing.

<i>Date of Construction (Known or Estimated)</i>	<i>Condition</i>	<i>Character-Defining Feature</i>	<i>Representative Image(s)</i>
and or is	2006	Good	No

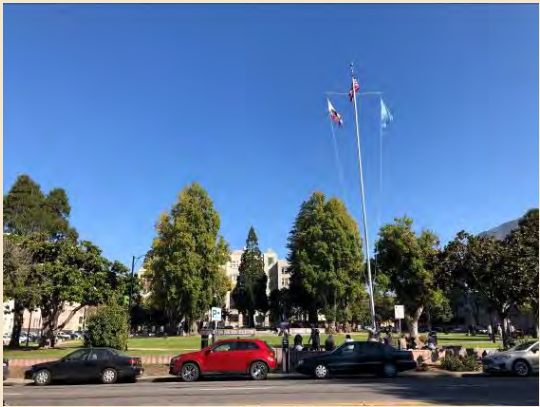
<i>Feature Key No.</i>	<i>Feature Name</i>	<i>Feature Description</i>
8 Views & Vistas		
42	Centerline View	<p>The view from either east or west along the centerline is a view down the primary organizing element of the park. The bilateral symmetry is reinforced by the presence of sizable vertical elements within the park, most notably the large trees at the east end. Most park elements relate to or are organized around this line. The centerline, however, does not align with either the paths or cupola at Old City Hall which initially appear to, but in fact do not, lie on this line.</p>
43	View across the Fountain Terrace	<p>The fountain and it's terrace has been a key location in the park since the original 1940 design. Because it is circular with the fountain at it's center-point, views across the terrace from a range of different positions in the eastern half of the park.</p>

<i>Date of Construction (Known or Estimated)</i>	<i>Condition</i>	<i>Character-Defining Feature</i>	<i>Representative Image(s)</i>
g er e.	1942	Fair to Good	Yes

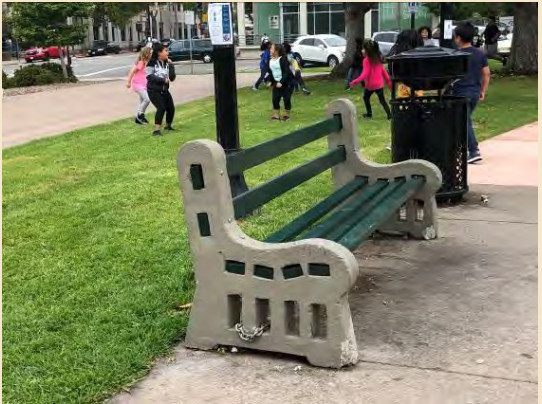
<i>Feature Key No.</i>	<i>Feature Name</i>	<i>Feature Description</i>
9 Small-Scale Features		
44	Flagpole	<p>This was one of the first features in the park.</p> <p>The flagpole is located on the centerline of the park at its west end, relocated to this position in 2006. Its base is a substantial three-tiered, four-sided base with vertical board-form finish. A cross arm allows for presentation of multiple flags. The flagpole is topped with a gold sphere.</p> <p>The original location of the flagpole was axial with Old City Hall because the design for the park with its new axis did not yet exist.</p> <p>In 2006 the flagpole and its original base were relocated from immediately within the circular path around the lawn to a position centered on the west side of the Western Esplanade. The flagpole has a galvanized painted finish.</p>
45	Concrete and Slat Bench	<p>Concrete and wood slat benches are original to the park. They are made up of pre-cast concrete ends that serve as bench-supports with low arms. Six, painted 2x4 wood slats fit in between the precast ends. In many places individual benches are situated in close proximity to a trash receptacle and sometimes a light pole.</p> <p>Historical accounts of the opening and early civic events in the park note that there were 60 permanent concrete benches and a further 100 wood benches within the park. Today there are eight concrete and slat benches in the park.</p>

<i>Date of Construction (Known or Estimated)</i>	<i>Condition</i>	<i>Character-Defining Feature</i>	<i>Representative Image(s)</i>
<p>n in A ere.</p> <p>ar e</p>	<p>1942 Relocated in 2006</p>	<p>Fair to Good</p>	<p>Yes</p>	 
<p>nto sh) are</p>	<p>1942 and possibly later</p>	<p>Good</p>	<p>Yes</p>

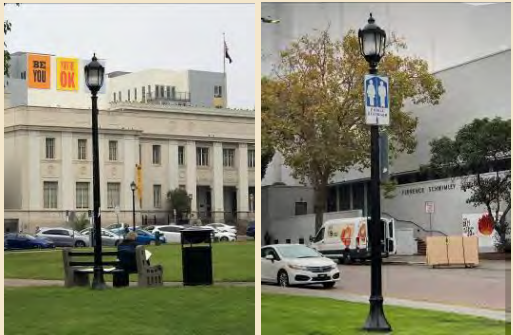
46	Light Fixture: fluted pole, flared base	<p>The tapered, fluted steel poles have flared bases and a contemporary acorn-style fixture. The pole and acorn fixture appear to be contemporary and measure approximately 12 to 14-feet tall. Finish is black powder coat. This is the predominant fixture style in the park.</p>

<p>both t</p>	<p>2006 or later</p>	<p>Good</p>	<p>No</p>

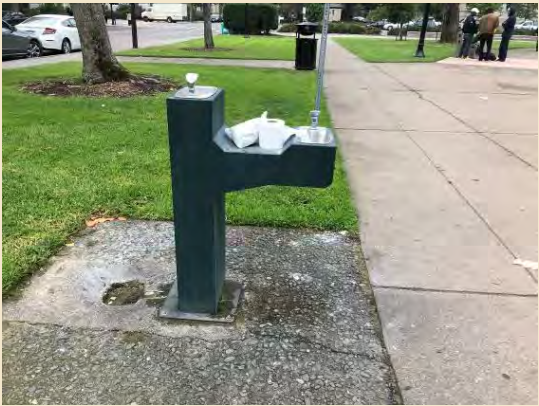
<i>Feature Key No.</i>	<i>Feature Name</i>	<i>Feature Description</i>
9 Small-Scale Features		
47	Light Fixture: pole with arm and hanging acorn fixture	<p>With a tapered steel pole without fluting, this fixture has a decorative steel arm with bracket and hanging acorn fixture. It is approximately 18-feet tall. This fixture is original to the park can be seen in photos of the park from the 1950s. A few are mixed in with the fluted-pole flared-base light fixture style of the park above.</p> <p>Historical accounts note that all overhead wires were undergrounded as part of the implementation of the park project. This ensures a clear uncluttered view of Old City Hall and adjacent buildings.</p>
48	Light Fixture: street light with cobra arm and banner	<p>Tapered fluted steel pole with decorated arm and contemporary cobra head. Banners are attached to many, though not all poles of this style. Height is approximately 22-feet.</p>

49	Drinking Fountain	<p>Contemporary steel drinking fountain with spigots for people with all abilities positioned on concrete pad. The bowl is stainless steel and stout steel support is green powder-coated. Historical accounts indicate that drinking fountains were part of the original design for the park.</p>

Date of Construction (Known or Estimated)	Condition	Character-Defining Feature	Representative Image(s)
t and nd	1942	Good	Yes	 
	No known	Good	No	 
a ark.	2006 or more recently	Good	No

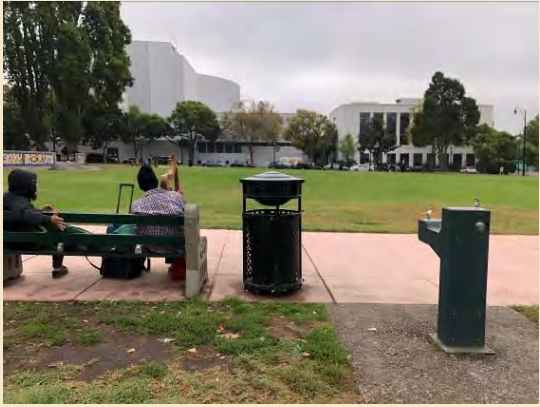
<i>Feature Key No.</i>	<i>Feature Name</i>	<i>Feature Description</i>
9 Small-Scale Features		
50	Trash Receptacle	Contemporary steel trash receptacle with lid for recyclables. Finish is black powder-coated.
51	Bicycle Rack	Wave rack made of galvanize tubular steel, mounted on a concrete pad, located on the southeast side of the 2180 Milvia Building entry stairs.
52	Peace Marker	A marker that is part of a world-wide movement to promote peace, the Peace Pole Project endeavors to inspire and foster peace wherever the pole is mounted. It is a hollow square pole with white finish, and end cap. Lettering is helvetica black.

<i>Date of Construction (Known or Estimated)</i>	<i>Condition</i>	<i>Character-Defining Feature</i>		<i>Representative Image(s)</i>
2006 or more recently	Good	No

2006 or more recently	Good	No		 
steel	~1999 or later	Good	No

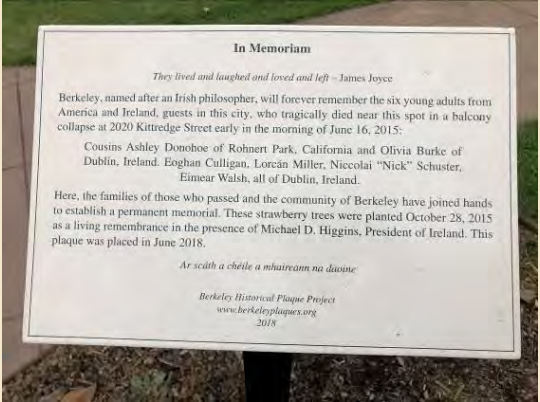
<i>Feature Key No.</i>	<i>Feature Name</i>	<i>Feature Description</i>
9 Small-Scale Features		
53	Memorial Plaque	This post-mounted memorial plaque honors those whose lives were lost as a result of the 2 balcony collapse, particularly noting the Irish young adults in the number lost. Together with the plaque 2 strawberry trees were planted nearby.
54	Peace Wall Plaque	This wall-mounted plaque recognizes the organizers and participants in the creation of the handmade tiles that surface the wall that forms the perimeter of the Fountain Terrace.
55	Peace Wall Memorial Plaque	This ground-mounted bronze plaque is in memory of Martin Luther King, Jr and the wall of peace. It was donated by the United Black Churches of Berkeley.

Date of Construction (Known or Estimated)	Condition	Character-Defining Feature	Representative Image(s)
2015	2018	Good	No

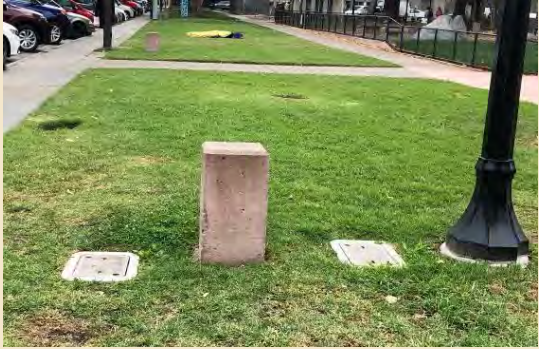
<i>Feature Key No.</i>	<i>Feature Name</i>	<i>Feature Description</i>
9 Small-Scale Features		
56	Concrete Bollard	Square concrete bollards, cast-in-place of pink colored concrete. These are located along the frontage of Center Street
57	Steel Removable Bollards	Seven steel bollards, located six-feet on-center, of four-inch diameter tubular steel with a domed cap. All are removable with their housing being an in-ground sleeve set with its rim four-inches above grade. This work was completed by the Department of Parks, Recreation and Waterfront in 2006
58	Portable Toilet	Two temporary, plastic portable toilets are located in the park. The first is in the southwest corner of the park the second is in the southeast corner in the grove of evergreen trees. Both have fence screening. The porta-potty at the southwest corner also has a hand cleaning station. Both are heavily used by those who frequent the park.

Date of Construction (Known or Estimated)	Condition	Character-Defining Feature	Representative Image(s)
he	After 2006	Good	No

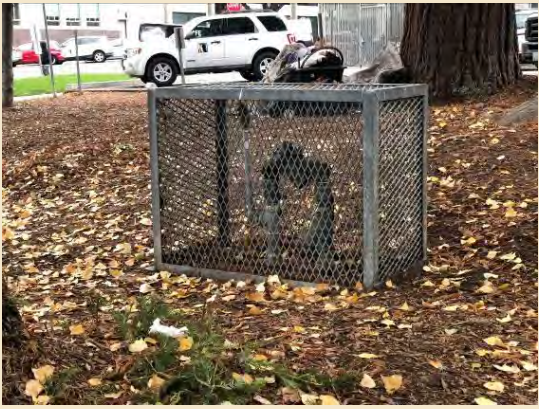
<i>Feature Key No.</i>	<i>Feature Name</i>	<i>Feature Description</i>
9 Small-Scale Features		
59	Parking Meter	Automated, solar powered parking meter boxes are located at the back of sidewalk. These steel devices standing approximately six-feet tall.
60	Backflow Preventer	Irrigation back flow preventer in a cage set amongst the redwoods at the east end of the park.
61	Wood Edging at Giant Sequoia	Wood edging defines the edge of the bed in which the giant sequoia sits.

Date of Construction (Known or Estimated)	Condition	Character-Defining Feature	Representative Image(s)
are	Not known	Good	No	 
ark.	Not known	Good	No
