Sports Turf Solutions

Re: Impact Test Results – ASFU Gilman Street Fields

On September 24th I conducted impact attenuation tests on the two synthetic turf soccer fields at ASFU's Gilman Street complex in Berkeley, CA. The tests were conducted in accordance with ASTM test method F355-A and test specification F1936-10. Section 8.3 of test specification F1936-10 was used to select test point locations. Detailed test results are attached.

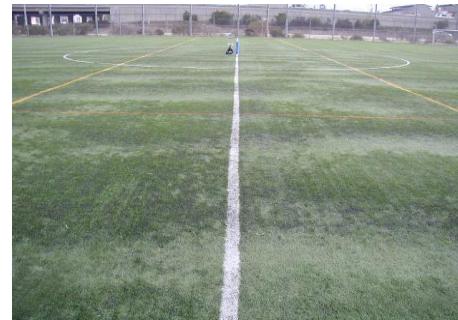
Field Layout: Soccer and lacrosse
 Surface Type: Infilled synthetic turf
 Manufacturer: FieldTurf USA
 Date Installed: August, 2008
 Condition: Mostly clean; dry
 Orientation: End A is NNW

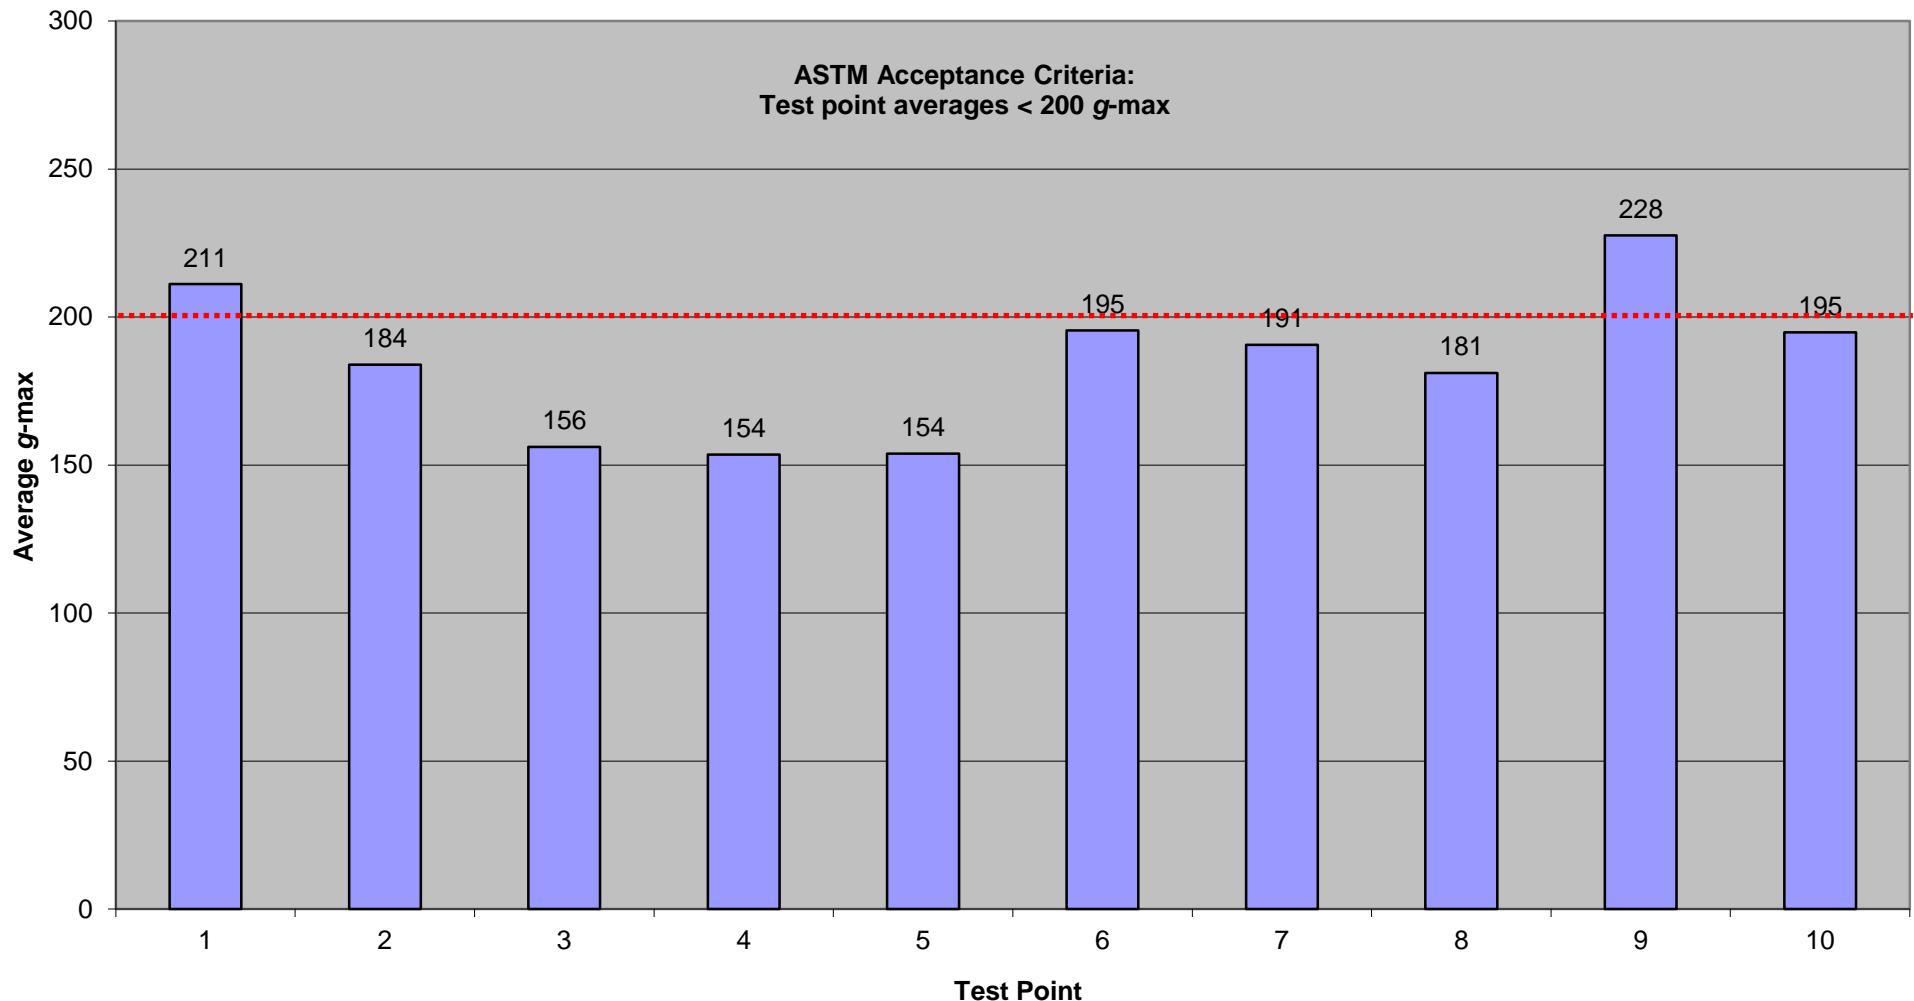
ASFU - Gilman Street Fields - North Field
Average g-max Levels

The test results reported herein reflect the performance of the points tested, at the time of testing and at the temperatures reported. As recorded in the attached results, **test points #1 and #9 on the north field, and test points #1, #7, and #9 on the south field, failed to meet ASTM's requirement of <200 average g-max**, when tested in accordance with the above listed method and specification. (It should be noted that these results do not imply that an impact-related injury cannot occur if the surface systems comply with ASTM's g-max requirement.)

Highest average reading	228
Lowest average reading	154
Average of the averages	185

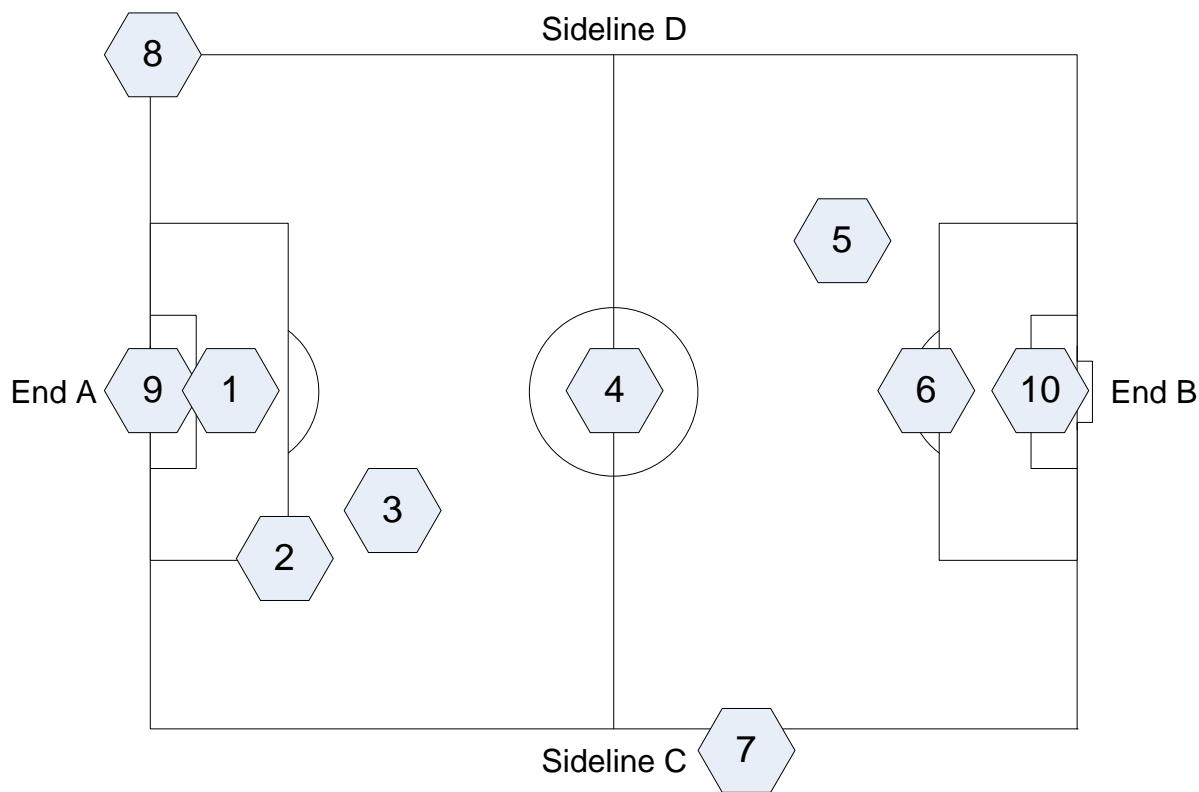
Test Point Reference Guide

- Point 1 – Penalty kick line, end A, center of field
- Point 2 – Corner of penalty box between end A and mid-field line, closest to sideline C
- Point 3 - 75' from mid-field line to end A, 40' from center of field to sideline C
- Point 4 – Mid-field line, center of field
- Point 5 – 75' from mid-field line to end B, 63' from center of field to sideline D
- Point 6 – Half way from restraining arc to edge of penalty box at end B, center of field
- Point 7 – 50' from mid-field line to end B, 5' outside sideline C
- Point 8 – Corner of the field at end A and sideline D
- Point 9 – 3' from goal line to mid-field line, end A, center of field
- Point 10 – 15' from goal line to mid-field line, end B, center of field

Note: Not to scale. Lacrosse lines and smaller soccer fields not shown.

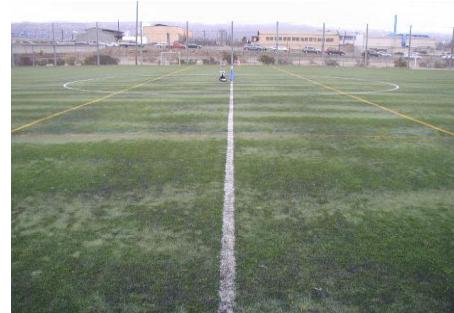
Field Layout: Soccer and lacrosse
 Surface Type: Infilled synthetic turf
 Manufacturer: FieldTurf USA
 Date Installed: August, 2008
 Condition: Mostly clean; dry
 Orientation: End A is NNW

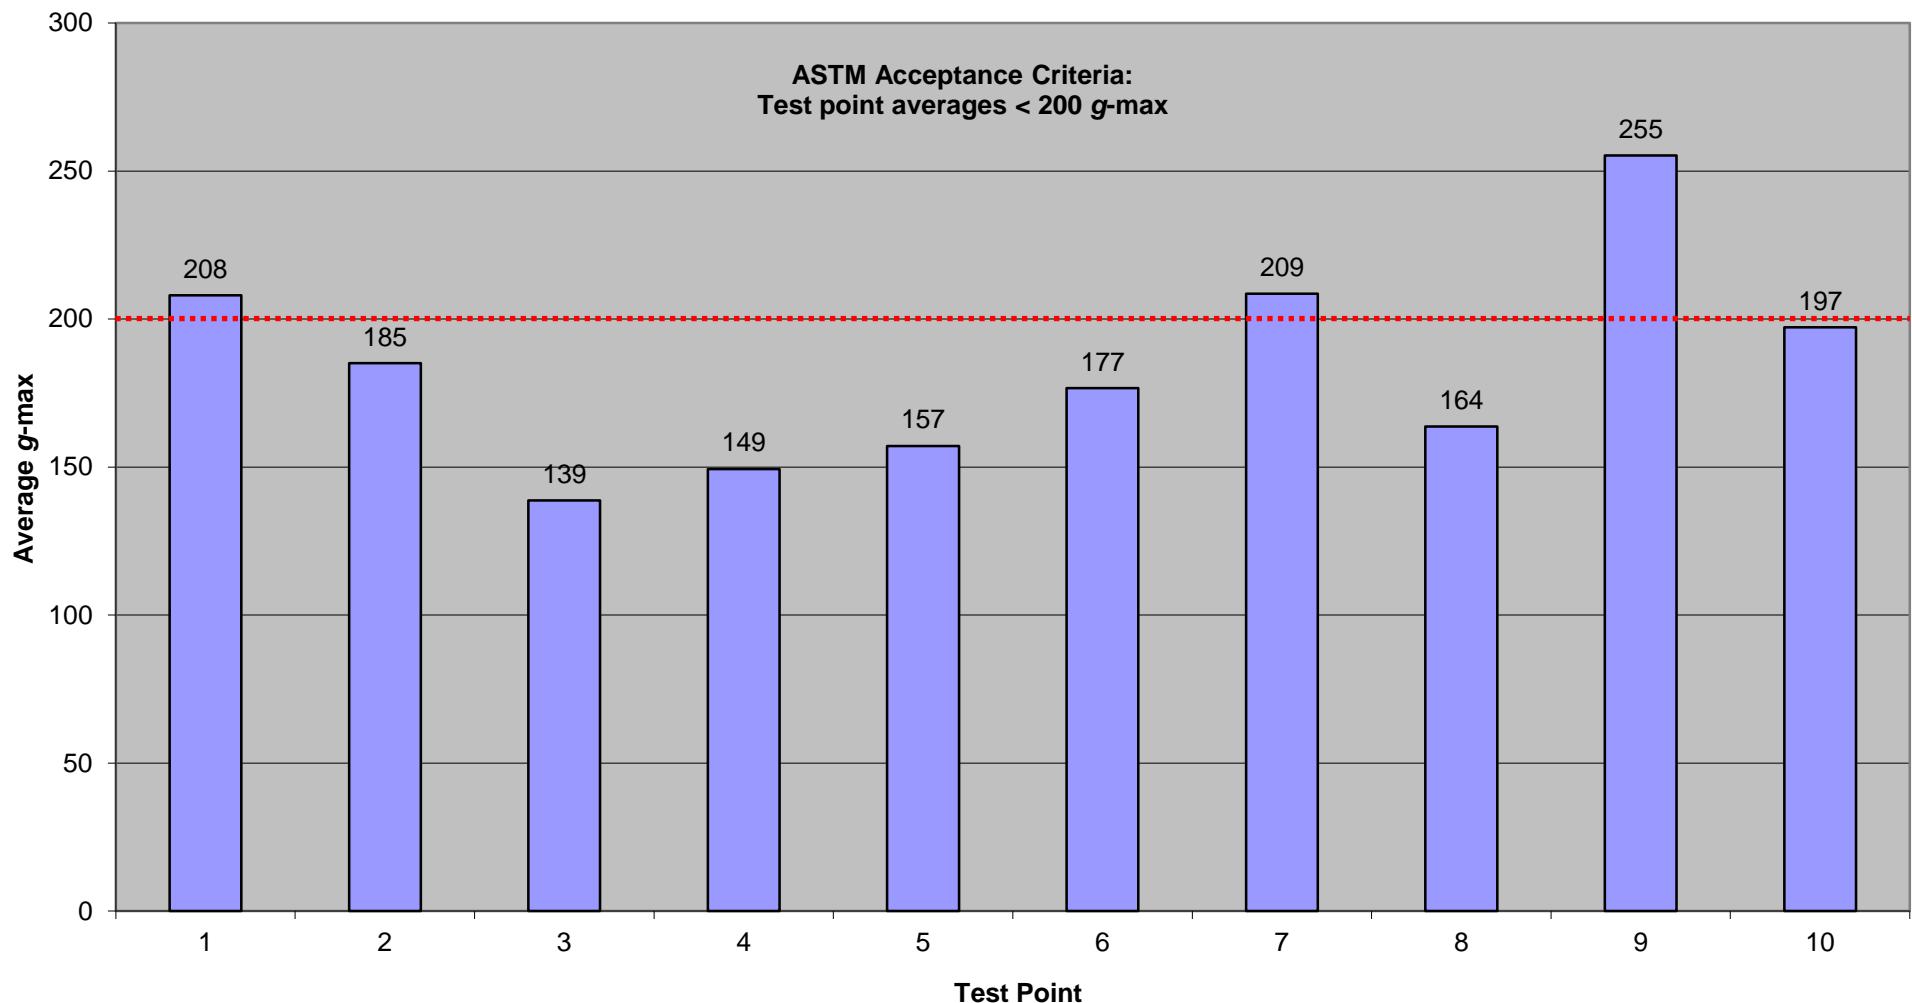
ASFU - Gilman Street Fields - South Field
Average g-max Levels

Highest average reading	255
Lowest average reading	139
Average of the averages	184

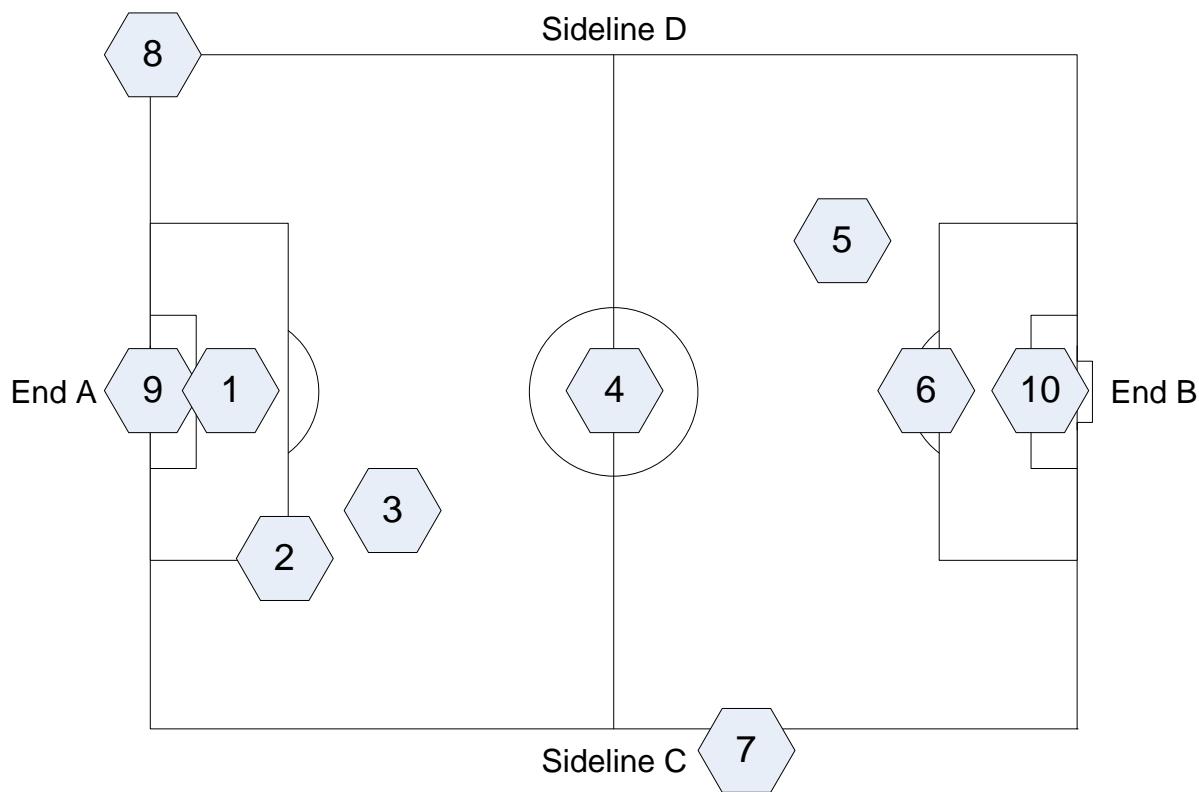
Test Point Reference Guide

- Point 1 – Penalty kick line, end A, center of field
- Point 2 – Corner of penalty box between end A and mid-field line, closest to sideline C
- Point 3 - 75' from mid-field line to end A, 40' from center of field to sideline C
- Point 4 – Mid-field line, center of field
- Point 5 – 75' from mid-field line to end B, 63' from center of field to sideline D
- Point 6 – Half way from restraining arc to edge of penalty box at end B, center of field
- Point 7 – 50' from mid-field line to end B, 5' outside sideline C
- Point 8 – Corner of the field at end A and sideline D
- Point 9 – 3' from goal line to mid-field line, end A, center of field
- Point 10 – 15' from goal line to mid-field line, end B, center of field

Note: Not to scale. Lacrosse lines and small soccer fields not shown.
