State of California – The Resources Agency
DEPARTMENT OF PARKS AND RECREATION
PRIMARY RECORD

*Resource Name or #: (Assigned by recorder) Blake & McGuire Grocery

P1. Other Identifier: Venus Restaurant

Archives & Architecture LLC: Shattuck Avenue Commercial Corridor Historic Context and Survey, 2015.

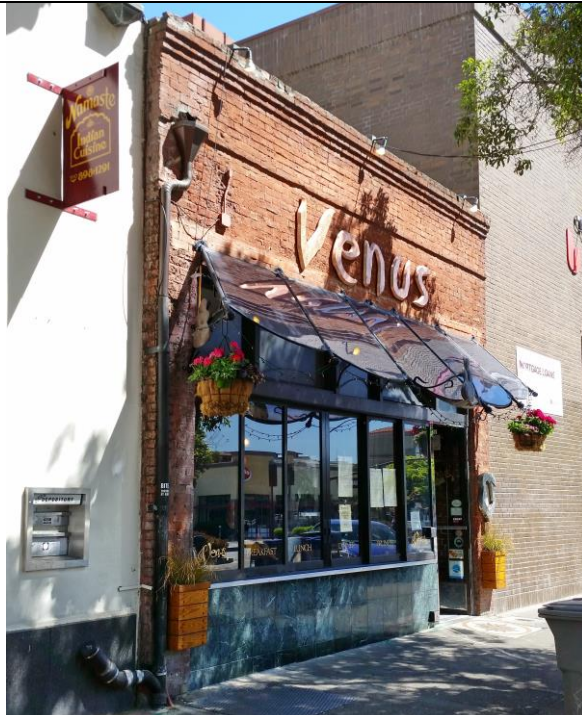
View facing southeast, January 2015.

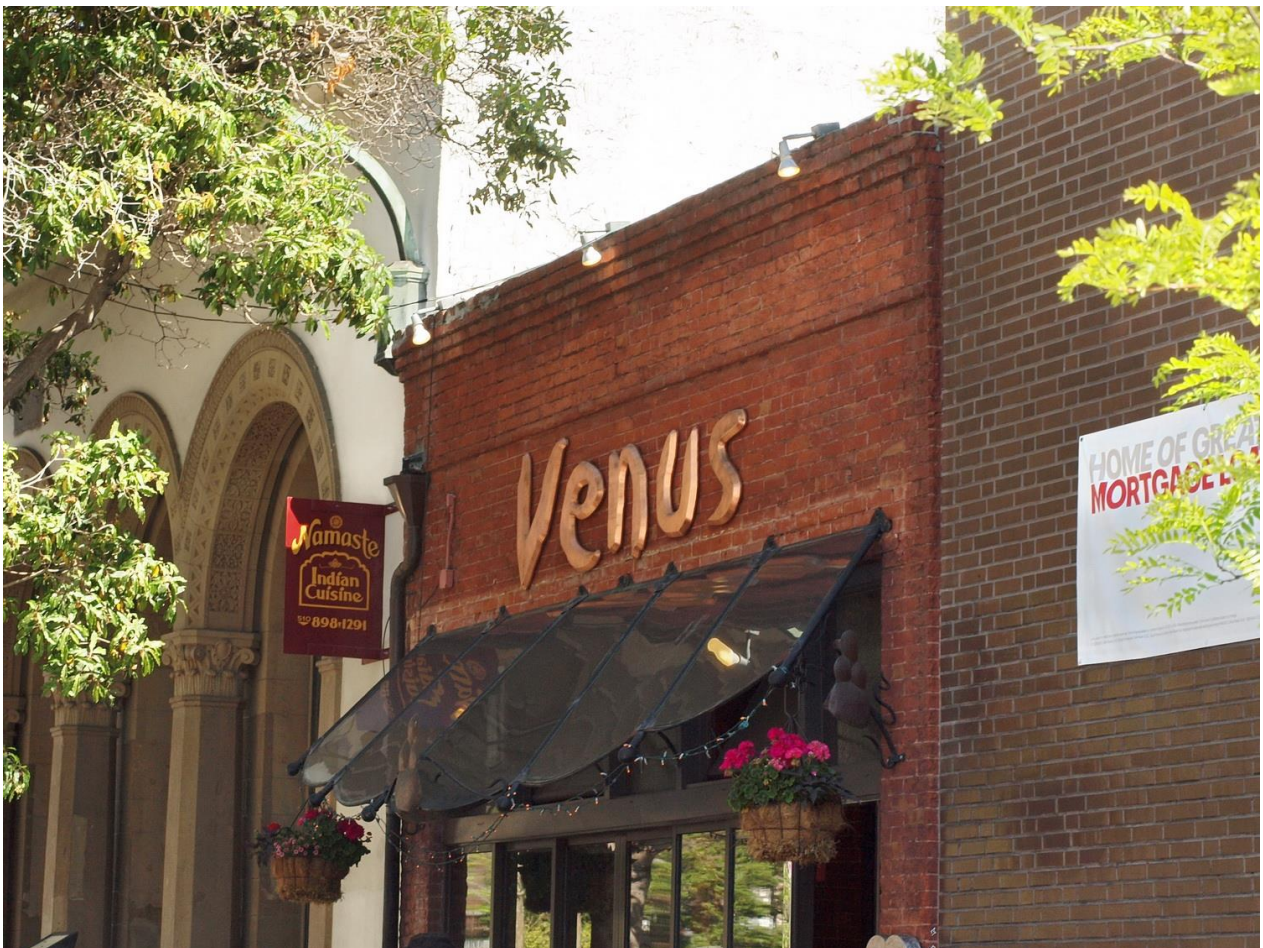
The front façade features an original corbelled brick wall, with clear design associations with the early twentieth century. The side piers and upper wall frame a replacement storefront. The brick has been sandblasted, and a portion of the brick has some staining that indicates the removal of a cornice. The current storefront consists of an upper transom and sliding wood storefront windows that open the restaurant for al fresco dining. A curving glass-and-bronze awning refers to the iconic Art Nouveau Paris Subway Awning design. The bulkhead is clad in green marble tile.

Detail view of upper façade, viewed facing northeast.
