State of California – The Resources Agency
DEPARTMENT OF PARKS AND RECREATION
PRIMARY RECORD

Page 1 of 6 *Resource Name or #: (Assigned by recorder) UC Theater

P1. Other Identifier: Stark Hotel

Archives & Architecture LLC: Shattuck Avenue Commercial Corridor Historic Context and Survey, 2015.

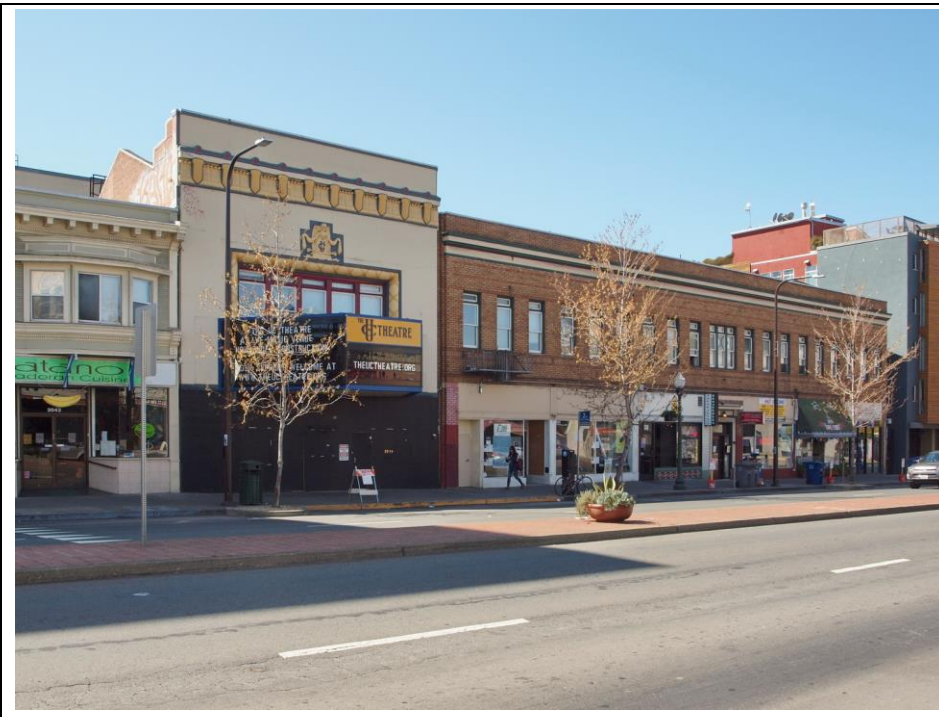
View facing southwest,
February 2015.

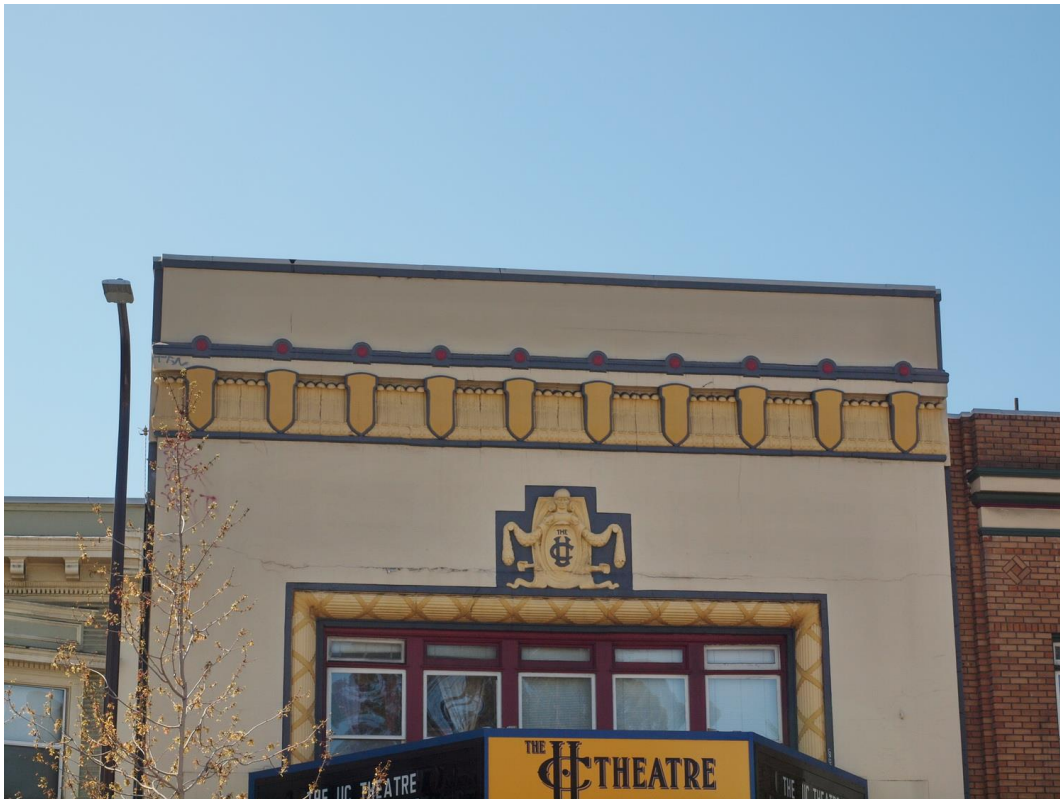
While the upper façade of the theater entry is ornamented with a high parapet, elaborate cornice with shields and bullseyes, fasces window frame, a cast crest with twin initials of UC, the original façade is said to originally have had a brick finish. The marquee is modern, and the entry was under remodeling at the time of this recording.

Upper façade at theater entry, viewed facing south.

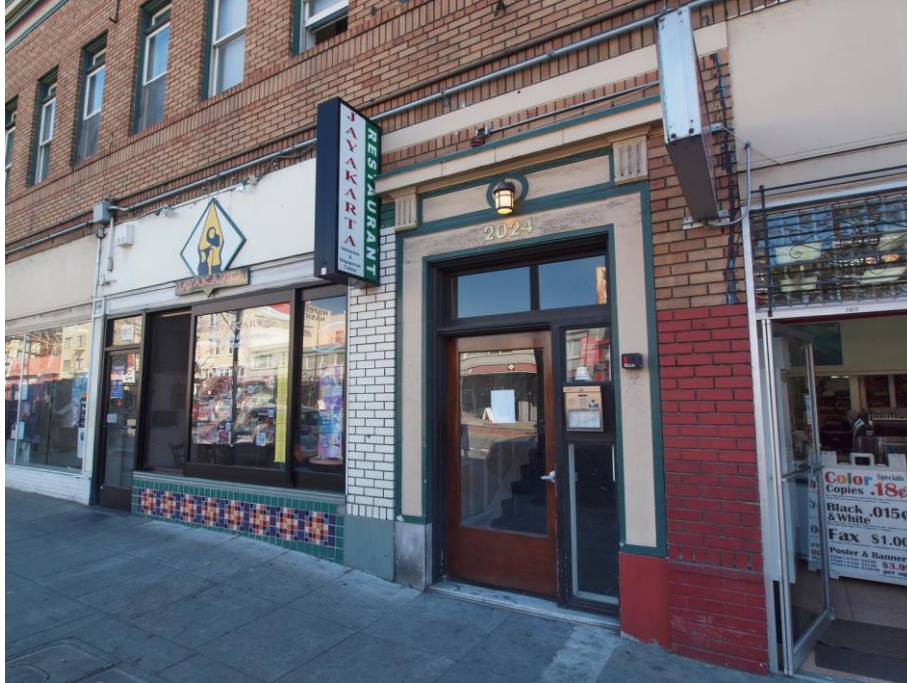
The commercial storefronts to the west of the theater entry have brick clad upper walls with a low parapet, classical cornice, and patterned brickwork. The storefronts originally had transoms, with some remaining and other covered with signage. This commercial section has six storefronts, and an entry to the upper residential studios. The windows above the storefronts are one over one replacement windows with upper fixed sash. The entry appears to be fairly original with an upper transom, although the glass and door are replacements.

Entry to studio apartments, viewed facing southeast.

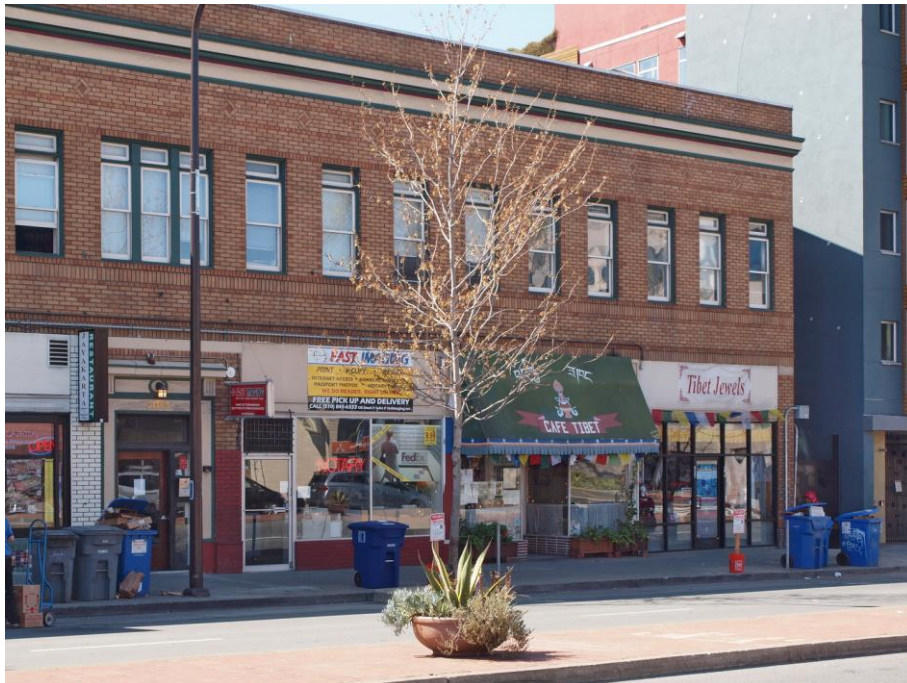
West end of façade with storefronts and upper residential windows, viewed facing southwest.
