## CHAPTER 4

## Historical Overview and Contexts

## Conditions Assessment

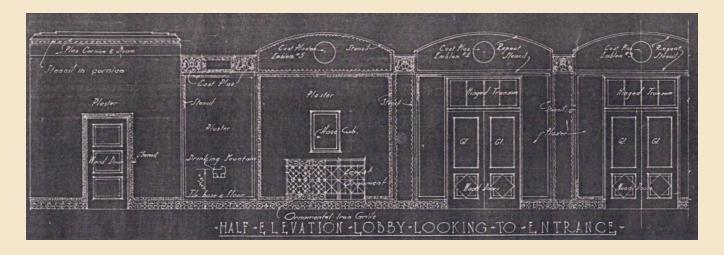
Finishes on wood paneled doors and casework are unevenly worn

Figure 7.11
The original Meyer drawings called for decorative stenciling on the cornices and columns in the lobby.

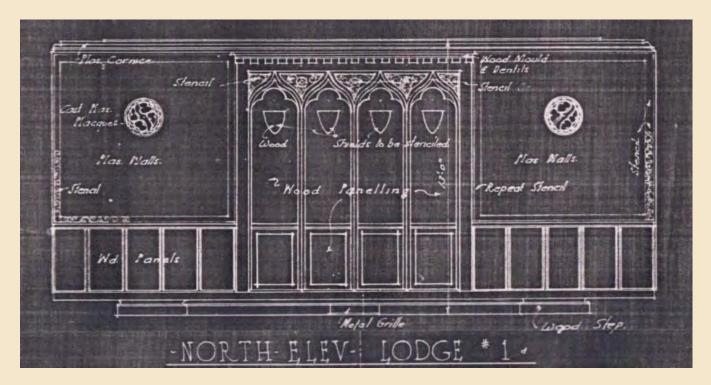
Original drawings show decorative stenciling on the walls and full-height decorative wood paneling in Lodge Room #1. The room is currently painted in solid colors. (Figures 7.25 and 7.26)

Figure 7.25
The original Meyer drawings show decorative stenciling in Lodge Room #1. It is unclear if it was ever completed.

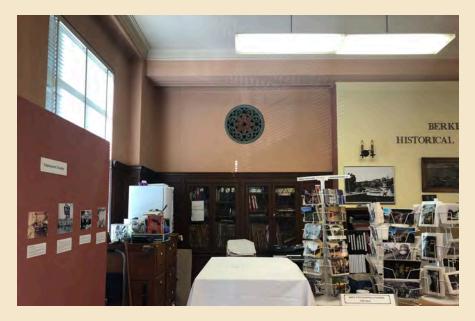
Figure 7.27
The Berkeley Historical Society constructed reversible display walls in front of the wood paneling in the Men's Club Room (seen here at the left).

In 1993, BHS sensitively installed exhibit display walls inboard of the wood paneling on the east and south walls, inhibiting visibility of those walls. If and when the exhibit walls are taken down, the walls should be surveyed for additional material deficiencies. (Figure 7.27)

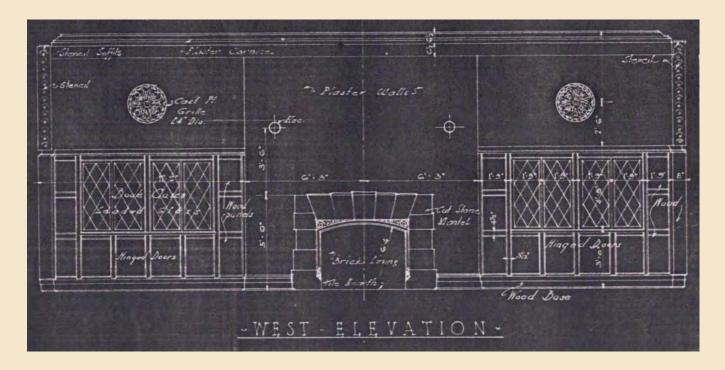
Figure 7.28
The original Meyer's drawings called for decorative stenciling at the soffits and recessed window panels.

The 1927 Henry Meyers drawings show decorative stencil painting the plaster pilasters and ceiling soffits. The walls and ceilings are currently painted in solid colors. (Figure 7.28)

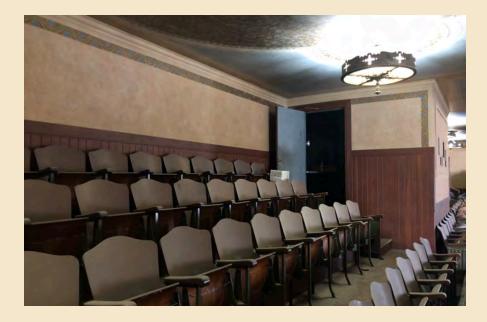
Storage of historically significant furniture and fixtures in balcony

Figure 7.29
The balcony and projection room retain all of their historic finishes.

The historical integrity in the balcony and projection room is very high. Any future programming alternatives for these spaces should carefully consider the fragility and integrity of these spaces. Any changes or modifications should be reversible. (Figure 7.29)

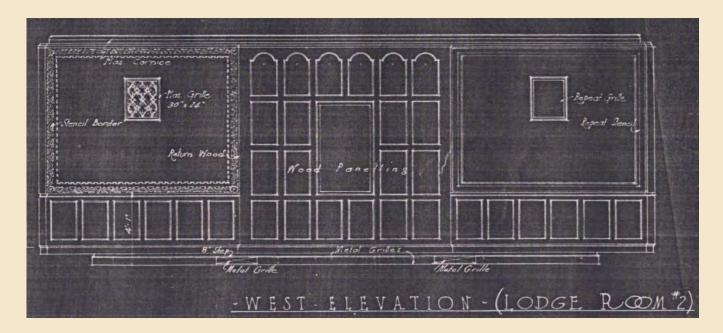
Overpainting of decorative stenciling at plaster walls and wood paneling

Figure 7.31
The original architectural drawings from 1928 call for decorative stenciling on the west wall of Lodge Room #2. It is unknown if the work was completed.

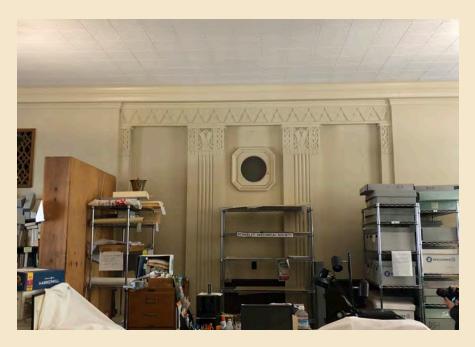
Figure 7.35 The decorative plaster wall paneling at Lodge Room #3 would likely have been different colors originally.

The Henry Meyer drawings call for extensive decorative stenciling at the recessed walls between columns on the east elevation. The room is currently painted beige. (Figures 7.34 and 7.35)

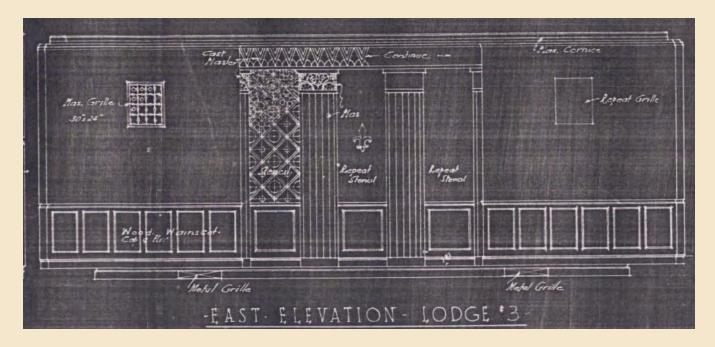
Figure 7.36
The original architectural drawings call for highly decorative stenciling at the recessed portions of the plaster wall paneling on the east wall of Lodge Room #3.
