CHAPTER **5**

Conditions Assessment

Siegel & Strain Architects, Architectural Conservation, Inc. and architecture + history, llc completed a series of site visits to the Berkeley City Hall, Maudelle Shirek Building in November and December, 2019 in order to observe and record typical building deficiencies, confirm the character defining features of the building, and to generally understand the building chronology. Observations were visual only, made from the ground and from easily accessed spaces only. Binoculars were used to see elevated features; although partially viewed from the lower attic windows to observe water drainage system, the roof was not accessed. No material testing, sampling or selective demolition occurred.

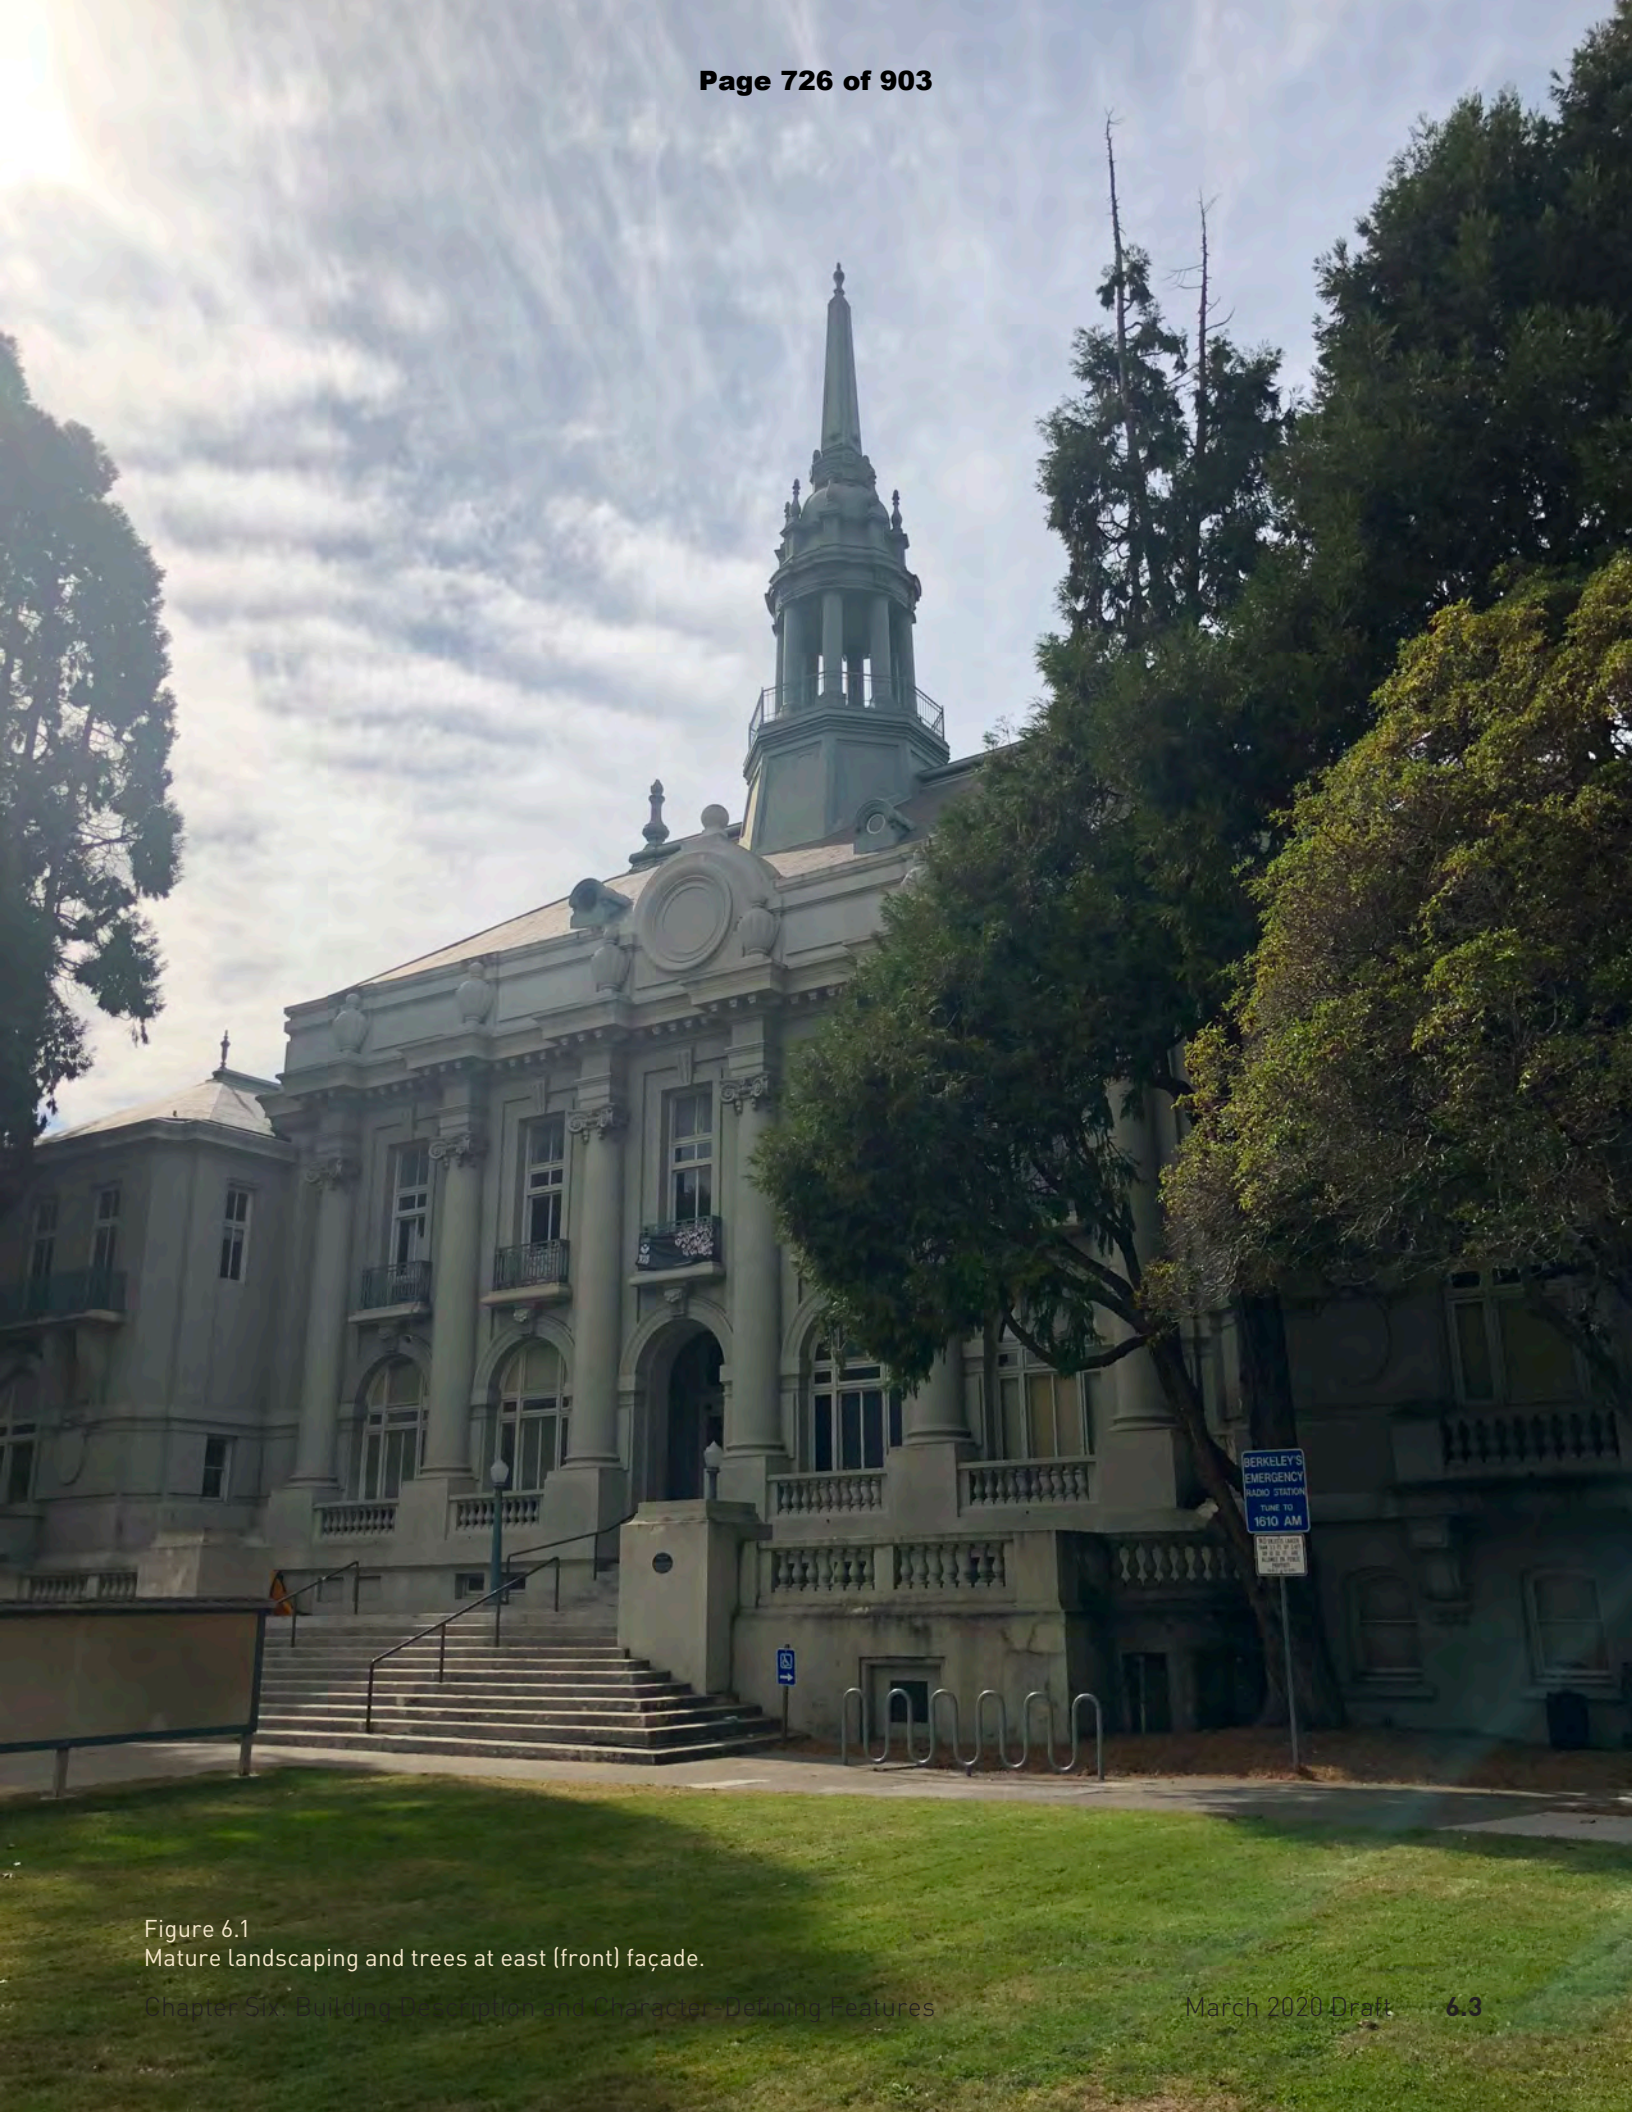
City Hall is set back from Martin Luther King, Jr. Way, and originally had very few plantings near the building. Early photographs show to small palms and a lawn area. Eventually, some low plantings were placed at the building base and taller trees to the north and south sides of a lawn. (Figure 6.2). The building rose well above adjacent trees with the exception of the redwoods to its southeast. Columnar incense cedars established a regular rhythm at the two wings of the building to the north and south; by the 1950s the cedars reached to the lower edge of the third story windows. They are planted very close to the building.

Figure 6.1
Mature landscaping and trees at east (front) façade.

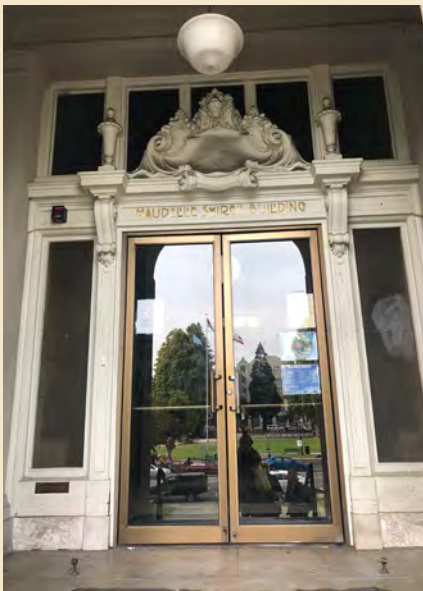
Figure 6.8
Original main entrance surround
with modern replacement doors.

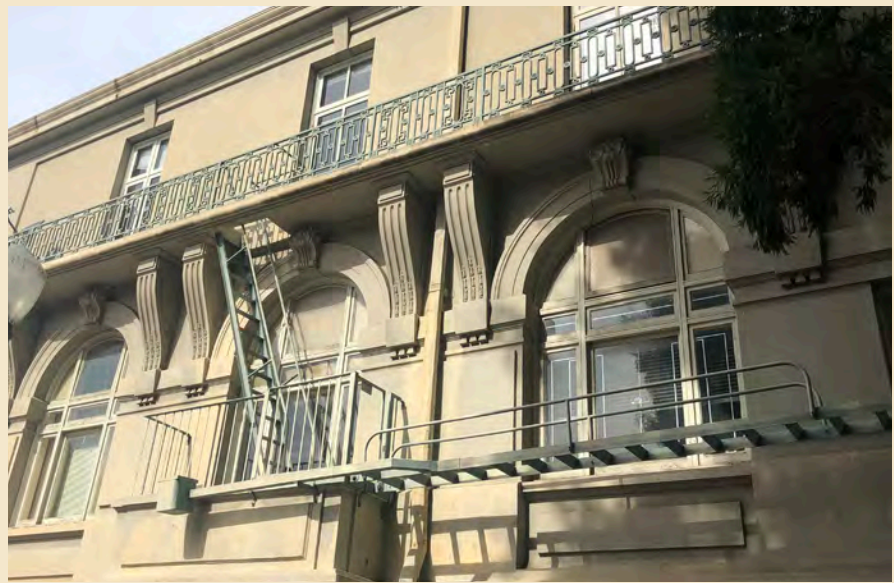
Figure 6.11
First floor balcony and
modern metal fire escape
at south (side) façade.

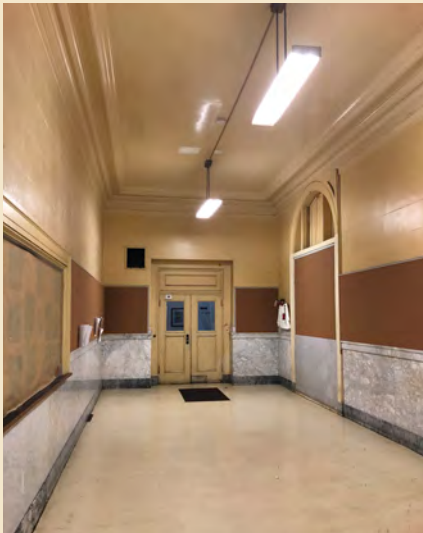
Figure 6.20
Rectangular fluorescent light fixtures in main corridor.

storefront type, glass doors and the transom has been infilled with a solid wall. The corridor has rectangular fluorescent light fixtures (*Figure 6.20*). The original pendant light fixtures are no longer present. The entry vestibule has an original pendant light fixture. There were originally arched windows at the north and south ends of the west wall of the corridor. It is possible the window frames are incased in the later infilled wall.

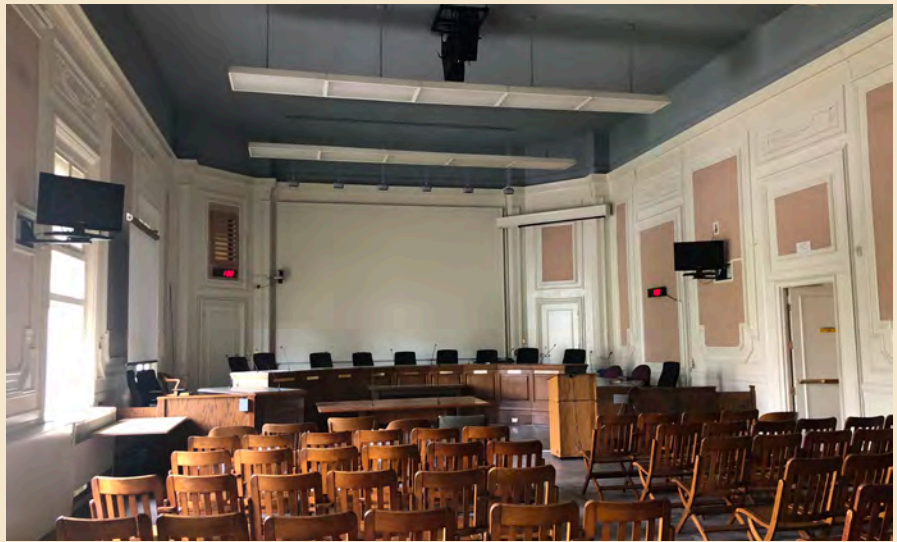
Figure 7.21

The second floor council chambers have been modified over time; the room no longer contains the historic coffered ceiling or lighting fixtures, and has new acoustical wall paneling and new flooring.

The Council Chamber is a character defining space that has been modified numerous times over the years. It is in fair condition. Further study of these deficiencies is included in the recommendations; however, it should be noted that any analysis or treatment of these materials should be conducted by a professional conservator. (See Figure 7.21)

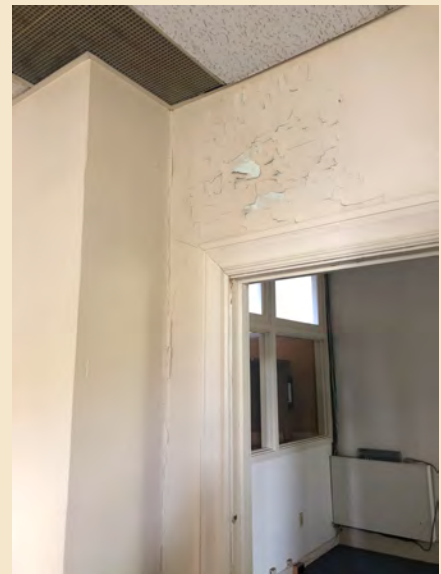
Figure 7.22

Evidence of substantial water damage appears to be directly under the intersection of the north wing and central core of the building (Figure 7.22)

Many of the finishes at the south wall of the north wing show evidence of water intrusion. Additional investigation is required.

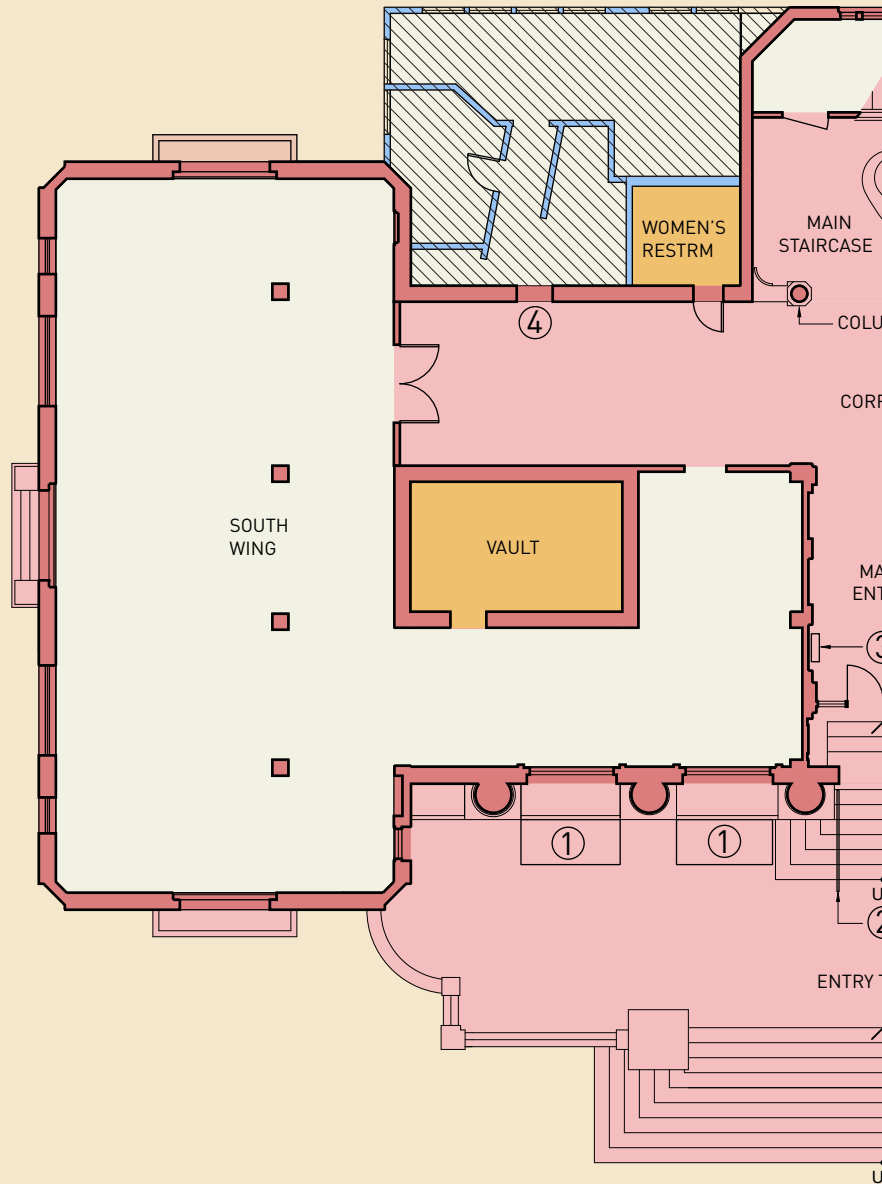
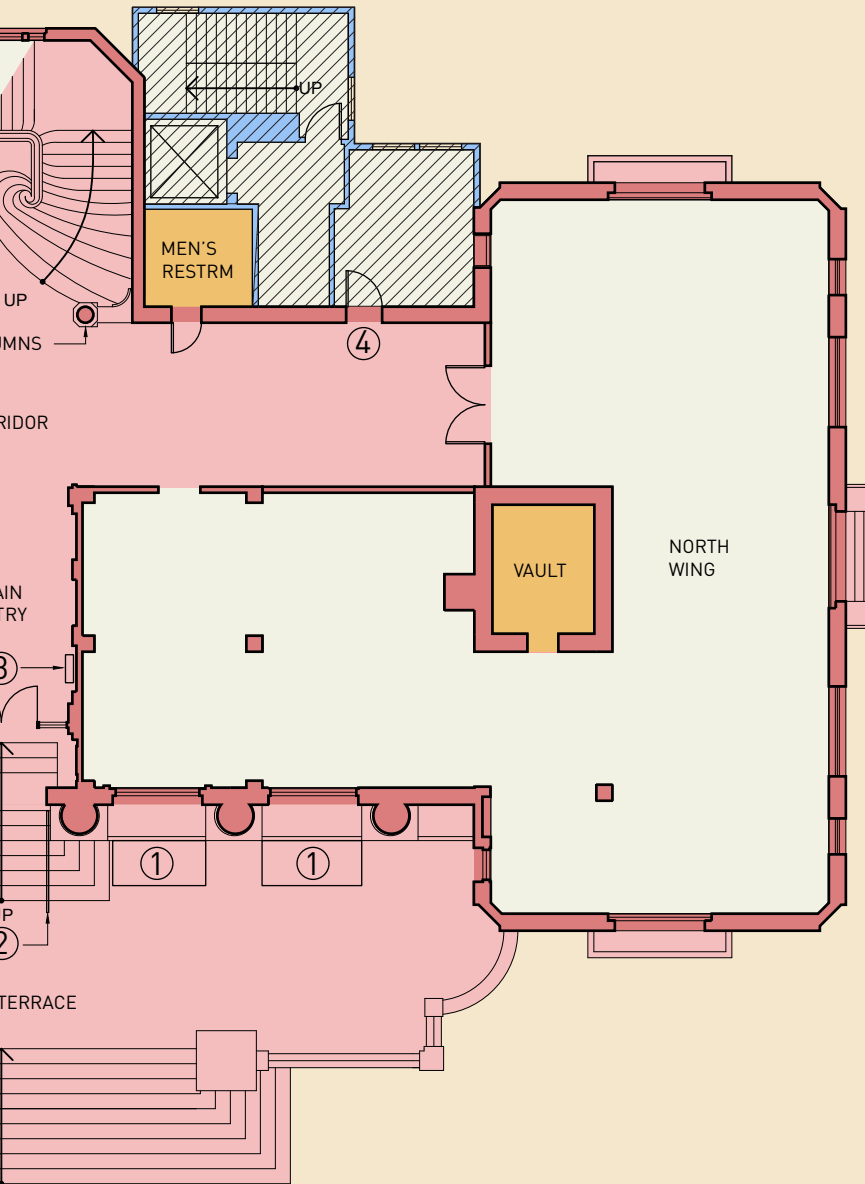
FIRST FLOOR PLAN - SIGNIFICANCE DIAGRAM
Berkeley City Hall

1. Location of original sidewalk lights.
2. Non-compliant inappropriate handrails.
3. Non-original radiators.
4. Location of infilled/modified original window.

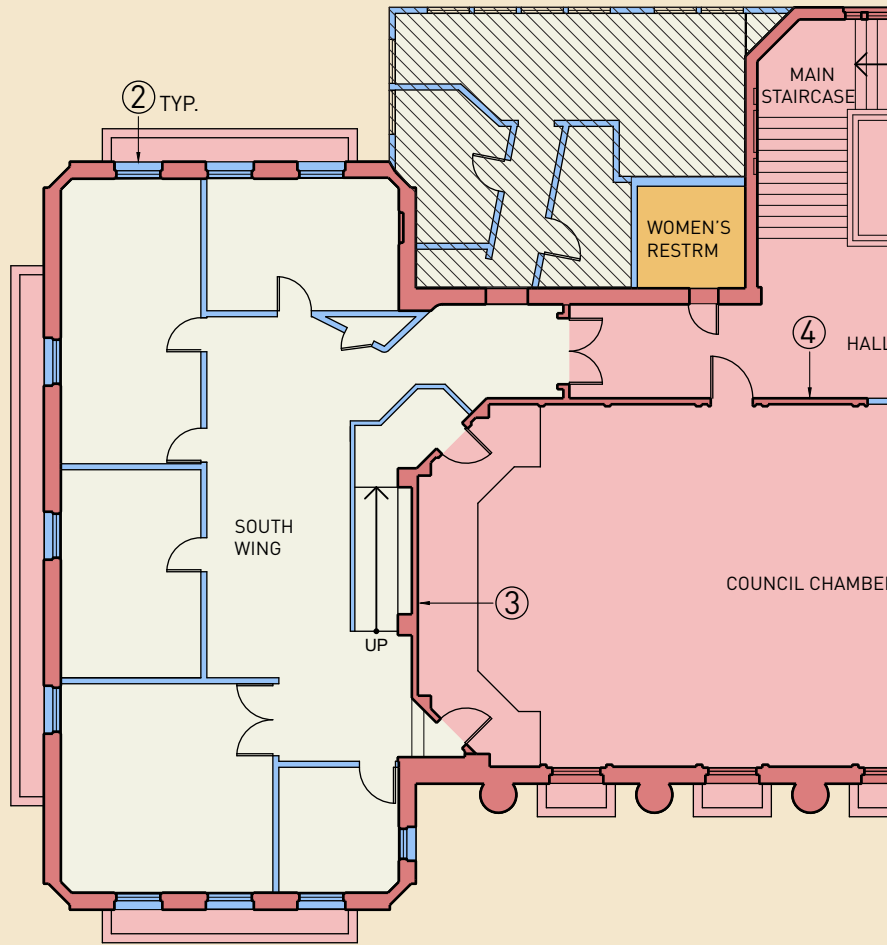
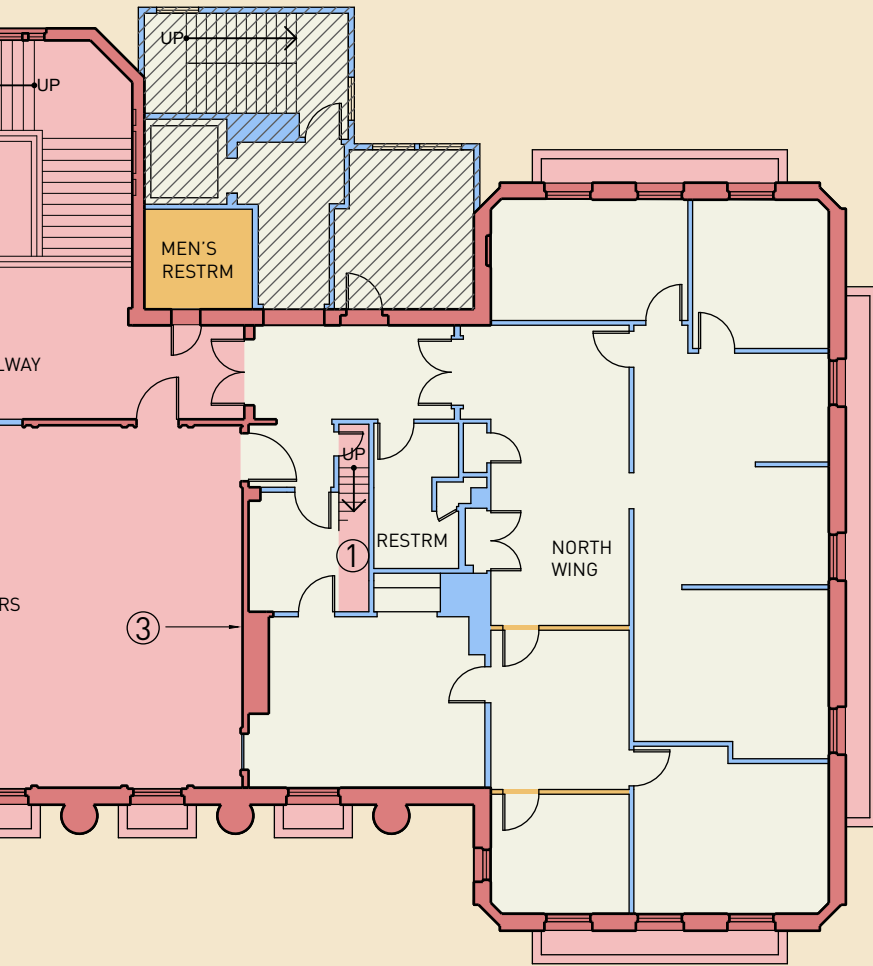
SECOND FLOOR PLAN - SIGNIFICANCE DIAGRAM
Berkeley City Hall

1. Cast iron staircase to attic.
2. Non-original aluminum infill windows.
3. Potential location of historic mural behind acoustical treatment.
4. Maudelle Shirek mural.
