State of California – The Resources Agency
 DEPARTMENT OF PARKS AND RECREATION
PRIMARY RECORD

Page 1 of 6 *Resource Name or #: (Assigned by recorder) Ennor's Restaurant Building

P1. Other Identifier: Act 1 & Act 2 Theater

*b. USGS 7.5' Quad Oakland West Date 1993 Township & Range No data
 c. Address 2128-2130 Center St. City Berkeley Zip 94704
 d. UTM: (Give more than one for large and/or linear resources) Zone 10S; 564461mE/ 4191667mN
 e. Other Locational Data: (e.g., parcel #, directions to resource, elevation, etc., as appropriate)
 Assessor's Parcel Number: 57-2031-11;
 South side of Center Street east of Shattuck Avenue.

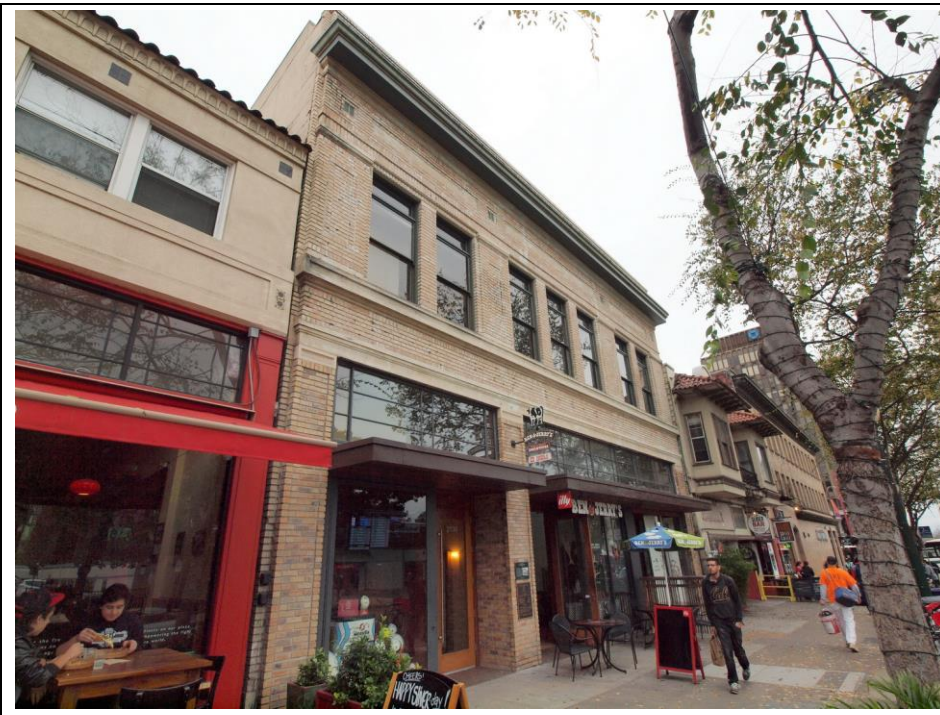
P5b. Description of Photo: (View, date, accession #)
 View facing southwest, December 2014.

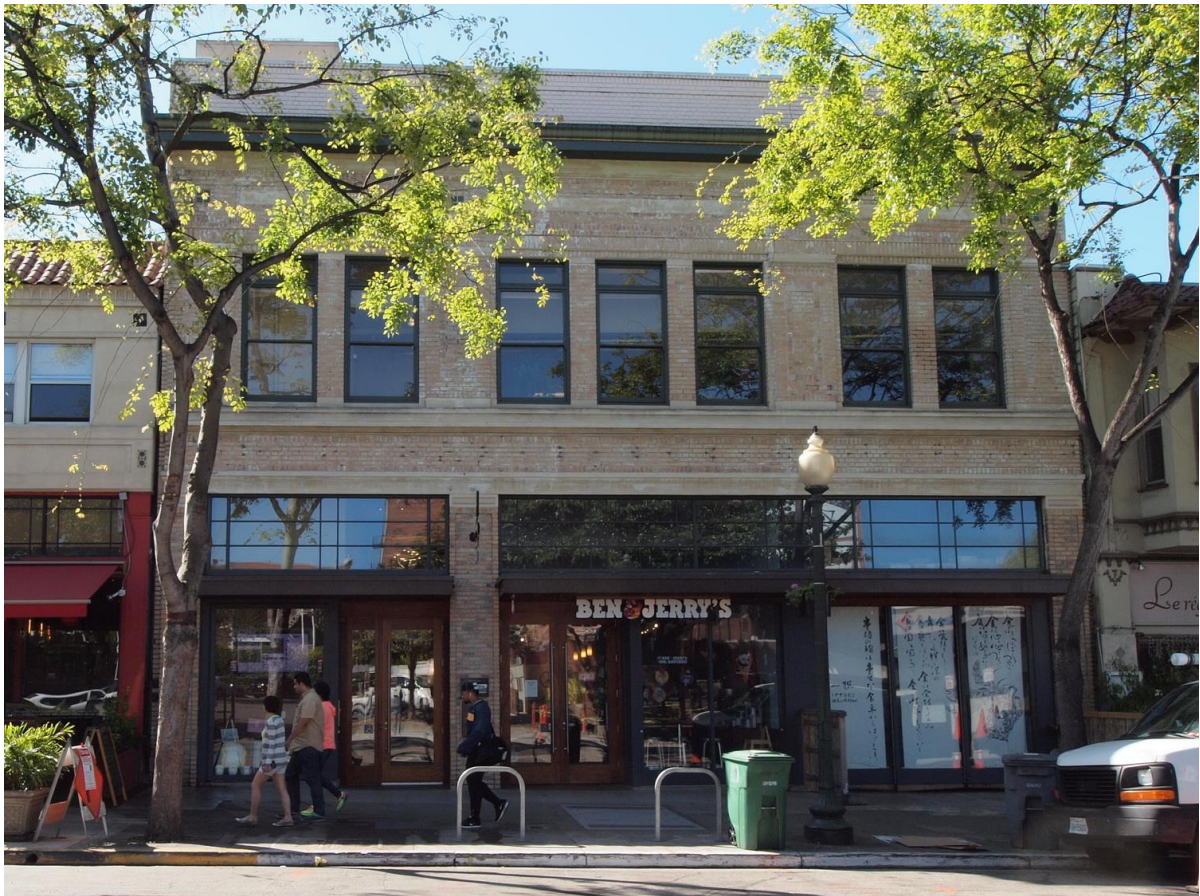
The front wall of the building is constructed of buff brick with cast-stone accents. The symmetrical front façade currently features three upstairs and three ground-floor architectural bays. The upper windows are grouped and separated by varying-width brick pilasters. Two pairs of windows flank a central bay with three windows. The pilasters feature cast stone bases and caps. The wider pilasters are distinguished by a corbelled face and a rectangular bond pattern. The windows are replacement units with one-over-one design and a narrow upper transom. Above the windows, the brick includes a slightly corbelled header row and rectangular bond patterns with green tile insets between the architectural bays. The building includes a large ogee band that acts as a cornice; the brick parapet wall rises above this. Below the windows is a wide sill band of cast stone. This sill course tops a brick fascia band and the narrow storefront cornice of cast stone. The brick band includes some header bond patterns, and has scarring that indicates former metal connectors (for removed signs or previous alterations). At the ground floor are three storefronts, separated by brick piers with cast-stone caps. The storefronts have been altered, but the original transom window openings remain. These feature a multi-lite pattern and indicate that there may have been only two storefronts originally. The storefronts have been altered in a compatible but differentiated design with vertical doors and display windows with low bulkheads.

Façade from Center Street, viewed facing south.
