State of California – The Resources Agency
DEPARTMENT OF PARKS AND RECREATION
PRIMARY RECORD

*Resource Name or #: (Assigned by recorder) Robert Elder House

c. Address 2124-26 Kittredge St. City Berkeley Zip 94704

Archives & Architecture LLC: Shattuck Avenue Commercial Corridor Historic Context and Survey, 2015.

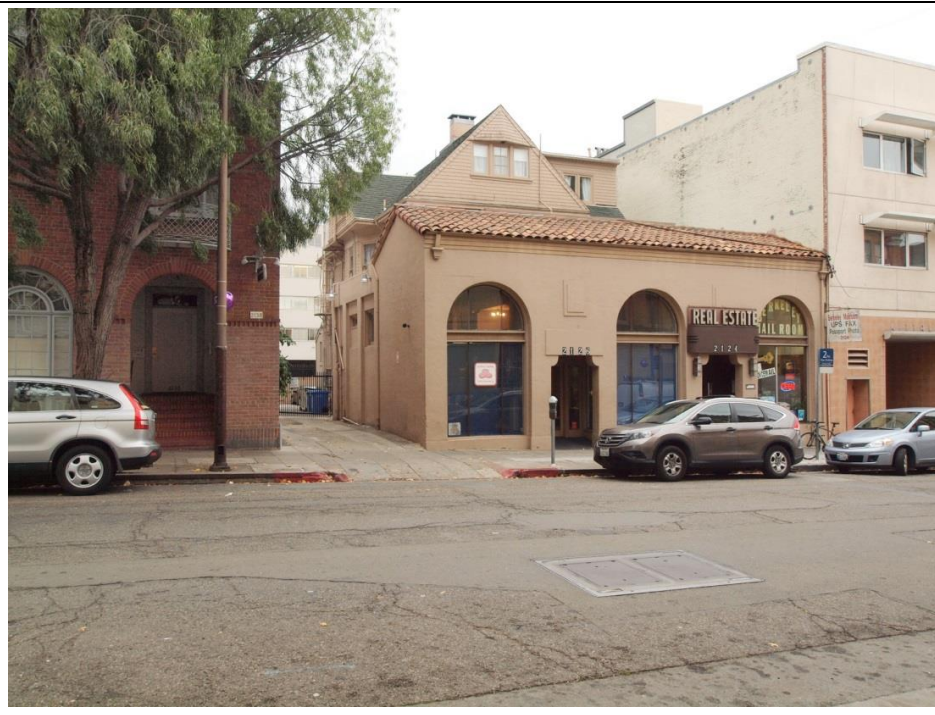
Although altered, the two-and-one-half-story Robert Elder House at 2124-26 Kittredge St. remains one of the oldest structures in the downtown core. In the mid-1920s, a one-story storefront addition changed the property from residential use to mixed-use/commercial. The large house and its front addition are similar in form to the A.H. Broad House across the street at 2117 Kittredge St., altered in 1926. These properties represent a perceptible transition from a more open and mixed-use downtown of the 1800s to the dense urban center of Berkeley today. This property now embodies historical associations with both the late nineteenth and early twentieth centuries.

P5b. Description of Photo: (View, date, accession #)
View facing south, January, 2015.

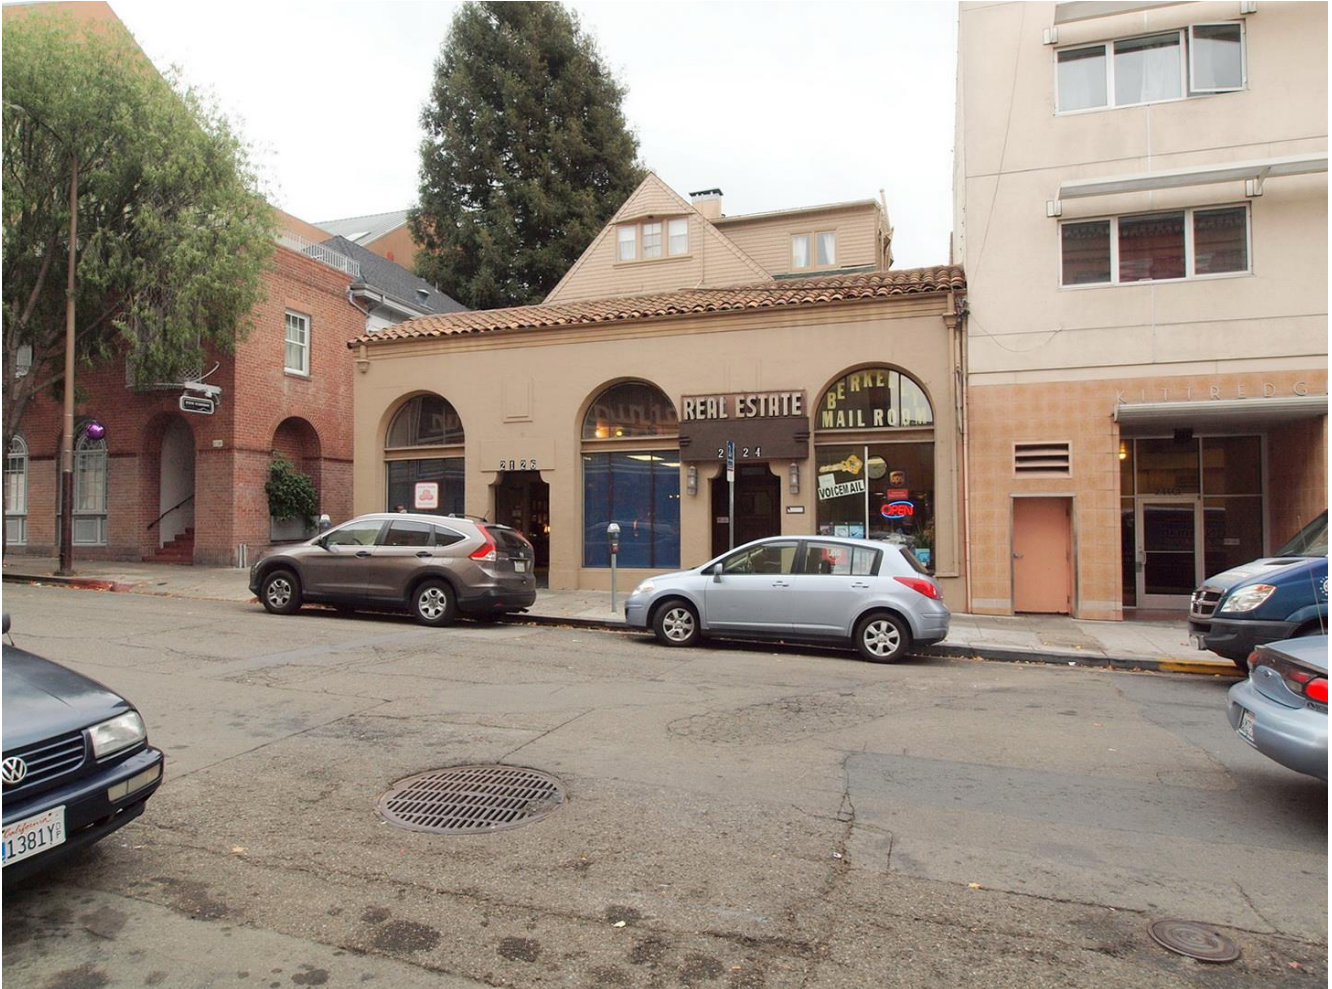
View facing southeast.

The rear residence wing has a form and detailing that embodies California Shingle-style design from the turn of the last century. The house was built when the surrounding neighborhood was still mainly single-family houses. Local houses of this style represent a transition from the more highly decorated and asymmetrical Queen Anne designs of the early 1890s to the blockier and more classically detailed designs of the early 1900s.

The house features a raised, compact form with a roughly rectangular original footprint. It is topped by a cross-gabled main roof that is accented by a small front-facing shed dormer and small side gables. The form includes clipped corners and projecting bay windows. An historic photo shows a partially projecting and partially recessed one-story corner porch with a pyramidal hipped roof, which is now gone. The apex of the front gable is accented by a projecting prow-shaped gable end that shades the tripartite upper focal window unit. The window, one of the most visible historic elements from the street along with the folded gable end, consists of a center fixed two-by-three-lite window flanked by operable single-lite casements; an historic photo shows this window having two-by-three lites in all of the sash.

The house is clad in square-cut shingles, including the projecting gable ends. The eaves are moderate in depth, boxed, and decorated with a twisted soffit molding atop the wide flat frieze band. A paired casement unit is featured in the front-facing dormer. Older photos indicate that they were 2x3-lite sash; currently the windows are single-lite. The remaining fenestration consists generally of double-hung windows placed individually, including the bay window units. Some of the double-hung windows feature a decorative 11-lite (five-by-two small lites over a larger pane) upper sash.

Character-defining features of the house include: Raised compact form, rectangular original footprint; cross-gabled main roof; front-facing shed dormer and small side gables; clipped front corner and projecting bay window; prow-shaped gable end detail; tripartite focal window unit in the front gable end; paired casement at the dormer; boxed eaves, soffit band, and wide frieze band; square-cut shingle siding; double-hung wood windows with multi-lite upper sash and simple trim.

Over time, the one-story Spanish Colonial Revival front addition has gained significance in its own right. This space is used by offices that have large arched display windows and recessed entrances. Built in the mid-1920s, when Eclectic Revival design was at its height, the commercial box form is inspired by Spanish Colonial designs, with heavily textured stucco, modest stucco accents, and a red-tile gabled roof.

Character-defining features of the storefront wing include: Overall simple box footprint that wraps the original house on two sides; side-gabled roof with modest, stepped cornice; red terra-cotta barrel-tile roofing; integral gutter and scuppers; stucco finish; three main arched display windows with horizontal mullions; three original arched transoms with tripartite bronze muntins; two original display windows with bronze muntins; recessed entries with quarter-round stucco side brackets; pair of raised stucco panels above the entrances; one seemingly original front entrance with single-lite commercial entry door. The "Real Estate" sign is historically significant, as well. The aluminum display window muntins are not original; one recessed entrance has been altered with wood paneling.
