State of California – The Resources Agency
DEPARTMENT OF PARKS AND RECREATION
PRIMARY RECORD

*Resource Name or #: (Assigned by recorder) Norton Building

Archives & Architecture LLC: Shattuck Avenue Commercial Corridor Historic Context and Survey, 2015.

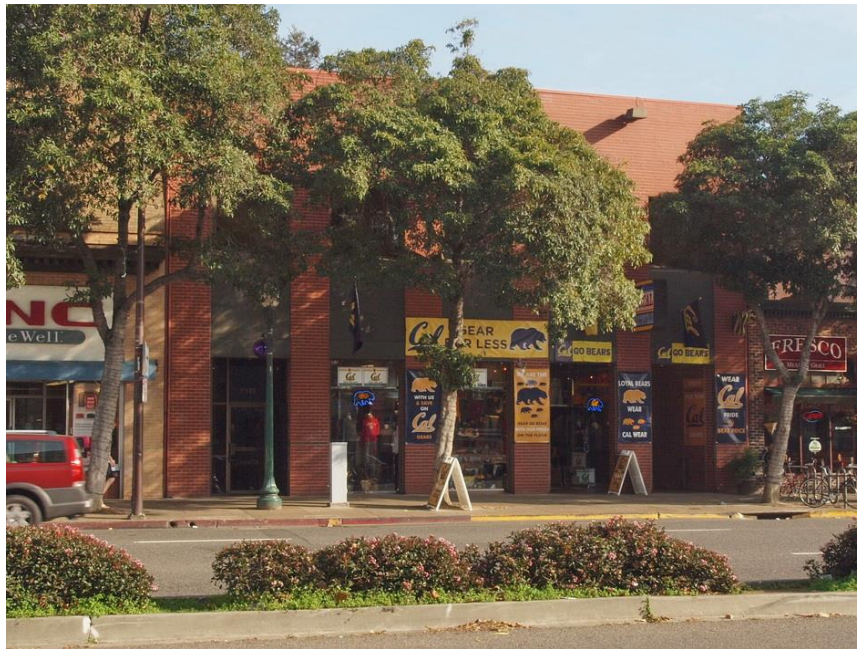
P5b. Description of Photo: (View, date, accession #)

The two-story commercial building currently housing Cal Gear For Less is a remodeled brick structure built in 1905 that originally housed two storefronts. It was modified over time for one to three storefronts. The earliest long-term owner was E. M. Norton, who purchased the building in 1913. The building was originally characterized by a Neoclassical brick façade with cornice and with five window openings in the upper façade above a standard storefront system with transom.

The current remodeled building has lost its physical association with its past. Although the massing and placement on the site remain the same, the façade has been substantially changed, and it could not be determined if the changes are reversible. The property therefore is not a Contributor to the Shattuck Avenue Downtown Historic District at this time.

View facing east, January 2015.

An extensive alteration in 1969 adapted the building for use by United California Bank as a single user. This included a new brick façade that wrapped the upper windows and dropped to the sidewalk in six wide columns. Five new glass storefronts were placed within the columns and separated by the upper windows by flat panels. The five upper windows were likely replaced at that time. Additional work in 1994 was done to seismically upgrade the unreinforced brick structure.

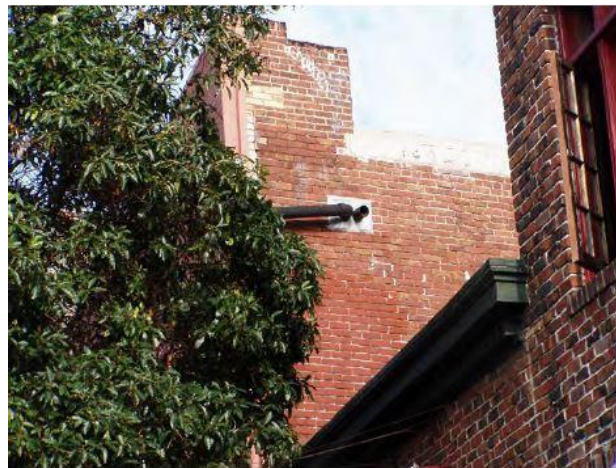
Brick upper south wall near front façade viewed facing north (photo by JRP Historical Consulting, 2004).

The property contributes to the historic character of the Shattuck Avenue commercial district in a secondary way, as it is a remaining brick structure that has been seismically upgraded, from the early years of downtown development prior to the 1906 Earthquake. The building helps to unify the character of historic streetscape. It is not known if the original upper façade remains under the 1969 remodeled front elevation, or if that façade was deconstructed as a part of the new design. With more detailed information and restoration according to the Secretary of the Interior's Standards for Rehabilitation, the property might be eligible for reconsideration as a Contributor to the Historic District.
