State of California – The Resources Agency
DEPARTMENT OF PARKS AND RECREATION
PRIMARY RECORD

Page 1 of 3 *Resource Name or #: (Assigned by recorder) Samson Market

*P2. Location: Not for Publication Unrestricted *a. County Alameda
and (P2b and P2c or P2d. Attach a Location Map as necessary.)
*b. USGS 7.5' Quad Oakland West Date 1993 Township & Range; no data
c. Address 2187 Shattuck Ave. City Berkeley Zip 94704
d. UTM: (Give more than one for large and/or linear resources) Zone 10S; 564426mE/ 4191607mN
e. Other Locational Data: (e.g., parcel #, directions to resource, elevation, etc., as appropriate)
Assessor's Parcel Number: 57-2031-6;
Northeast corner of Shattuck Avenue and Allston Way.

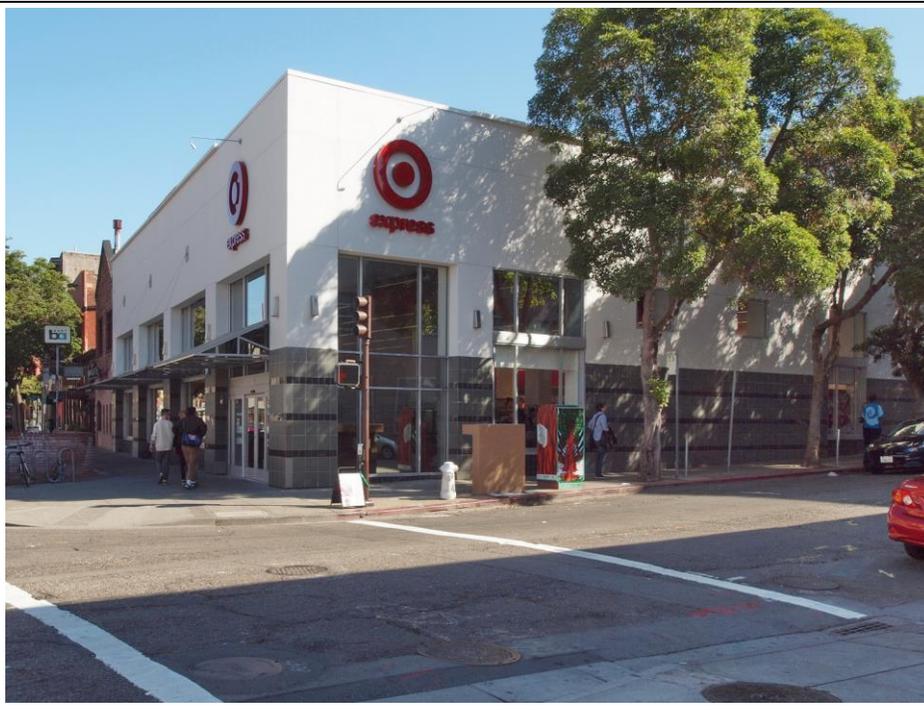
The single-story corner commercial building at 2187 Shattuck Ave. housing Target Stores is a remodeled structure built in 1922 that originally housed multiple retail commercial tenants, including Samson Market, its primary tenant. Samson Market was established on the site in 1902, and the 1922 concrete building, which was designed in the Neoclassical style by architect James Plachek, included a number of additional storefront tenants. The building was characterized by ornamental brickwork and a large multi-lite transom.

The current remodeled building has lost its physical association with its past. Although the massing and placement on the site remain the same, the façade and interior have been substantially changed and the changes do not seem reversible. The property therefore is not a Contributor to the Shattuck Avenue Downtown Historic District.

View facing north, April 2015.

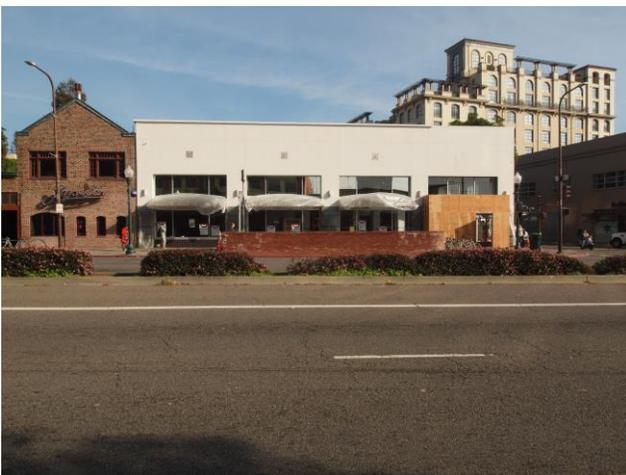
The most recent renovation for Target included removal of the sign cage, resulting in a more muted modern appearance at the street.

Facade along Shattuck under construction in early 2015, viewed facing east.

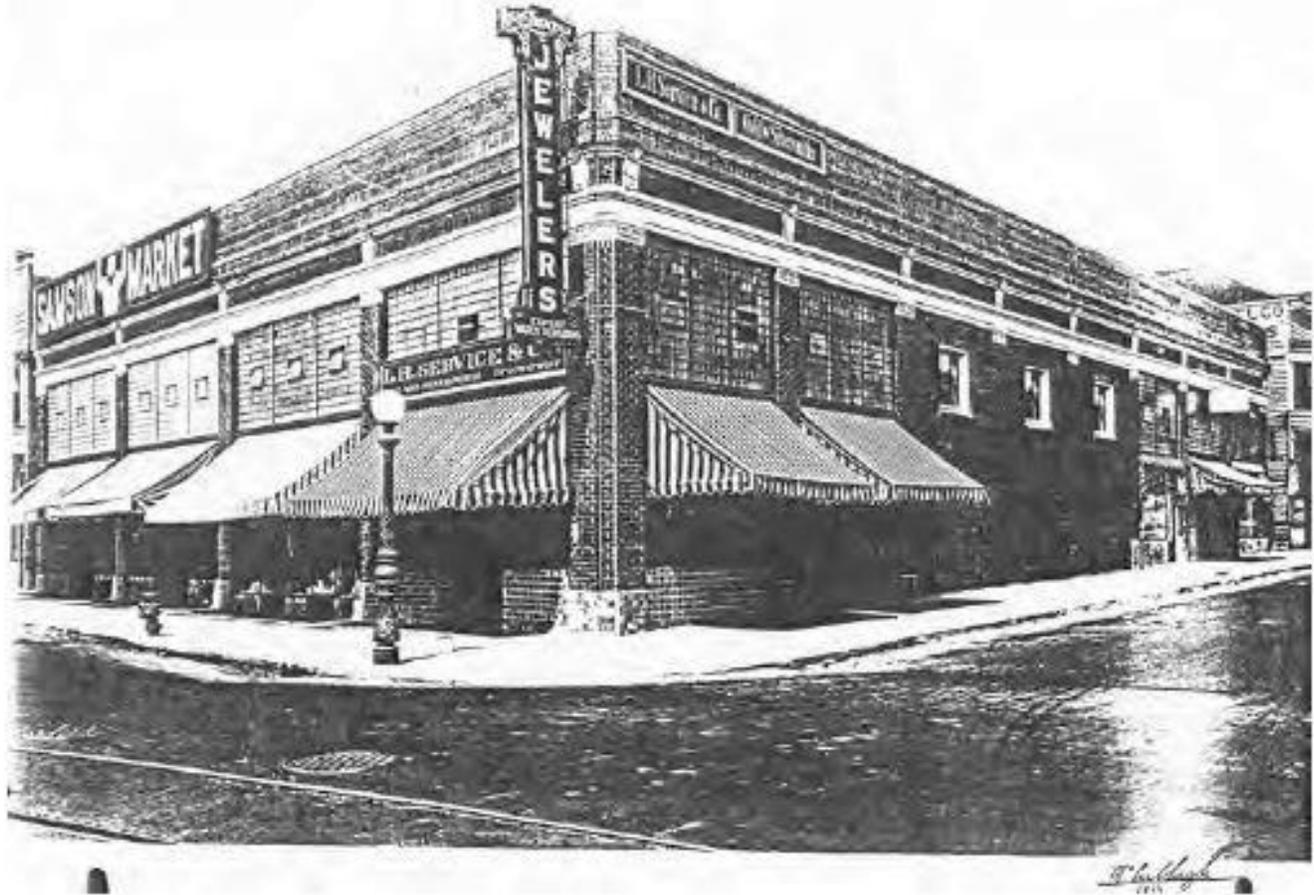
The original building was brick-faced, and had four bays as presently evident on Shattuck Avenue. In 1936, responding to the Chamber of Commerce's modernization program, funded through low-interest loans from FHA, Plachek's detailing was lost or covered with a plaster skin.

Ca. 1920s photograph of original 1922 building (Courtesy of Berkeley Architectural Heritage Association files)
